Fracture of revision modular femoral stem

Volume 6 Issue 6 - 2016

Zoran Sulje,¹ Kresimir Crnoga?²a, Domagoj Delimar,² Goran Bicanic²

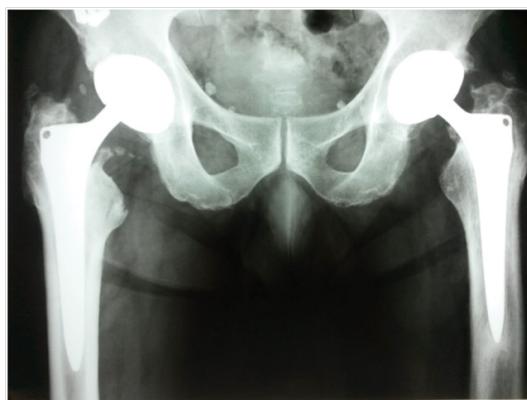
Figure 1 Plain radiograph of primary bilateral total hip endoprostheses.

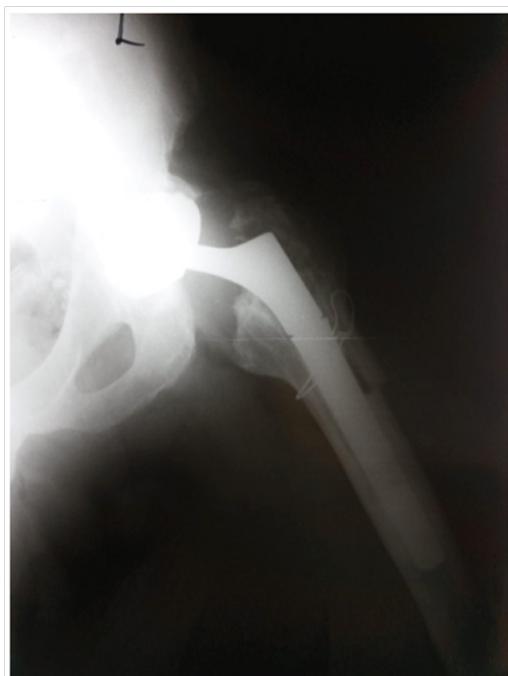
Figure 2 Plain radiograph of revision modular total hip endoprosthesis.

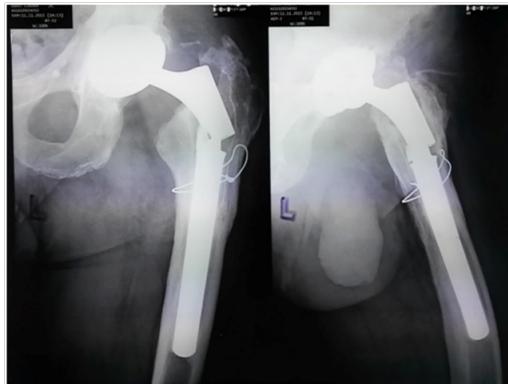
Figure 3 Plain radiograph of fractured modular femoral stem.

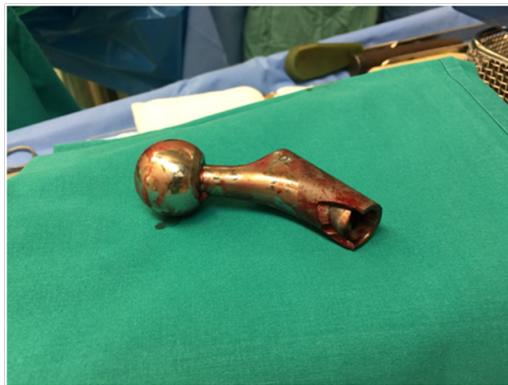
Figure 4 Intraoperative junction fracture.

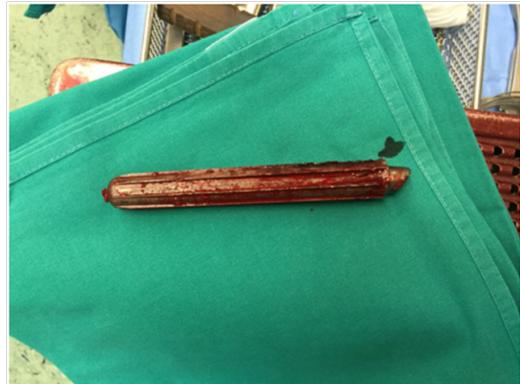
Figure 5 Intraoperative junction fracture.

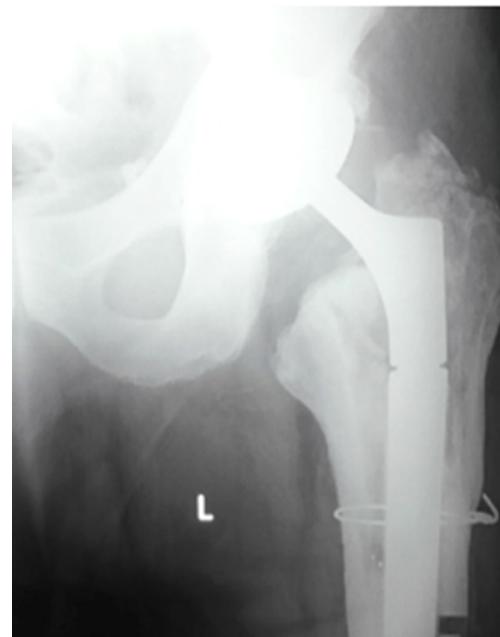
Figure 6 Plain radiograph postoperatively.

loosening of femoral stem (stem subsidence) a revision surgery was made in February 2014. Revision femoral stem was implanted (Lima revision, Lima International, Udine, Italy) (Figure 2) using trans femoral approach according to Wagner in the lateral decubitus position.⁹ Femoral component was a cementless modular porous-coated stem made of titanium alloy with distal anchoring (tapered, fluted). Size of femoral stem was 22x140mm with the proximal part length of 70mm (total stem length 210mm). Postoperative course was without complications. Patient felt a sudden sharp pain in his left hip while walking in October 2015, 20 months after the revision procedure. Limping and the pain in left hip were increasing daily. He presented to our Department with the leg held in the external rotation and with decreased movements in hip joint. Plain radiograph showed a fracture of the revision femoral component of the left hip (Figure 3). The patient underwent a planned revision surgery procedure. Trans femoral approach according to Wagner was used again.⁹ Fracture was found at a junction between proximal and distal part of the stem (Figures 4 & 5). Extraction of the distal part of the stem was performed using technique developed at our Department.¹⁰ Proximal part is easy to extract without any complications. Problem is with distal part that is firmly fixed in the bone. It was removed with a special longitudinal osteotomy through the anterior cortex extending distally for 15cm. It was then followed by a transversal osteotomy 2cm below the tip of the femoral stump to allow enough space for two locking pliers. Simultaneously using a lamina spreader on the distal part, the broken stem was extracted while hammering on two locking pliers. Cementless revision femoral stem was implanted in a standard manner (Figure 6).
