Failure in chain link securing a round cargo on heavy vehicle

Tsadok Tsach, Finkelstein Nir, Nikolai Volkov
Division of Identification and Forensic Science, Israel Police Headquarters, Israel

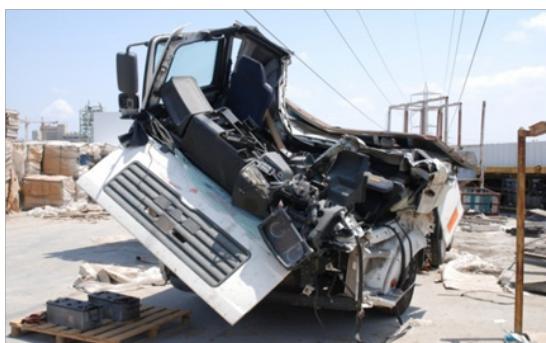
A 10-ton metal sheet rolled was loaded onto a trailer and lashed to the trailer sides using a chain tensioner, similar to Figure 1. Chain link diameter was 10mm. To prevent the cargo from shifting during transport, wooden bars were placed right up against the metal sheets rolled. During the ride, the truck approached a traffic light at a speed of 50 km/hour (according to the tachometer); the light then changed to red and the truck driver braked so that the truck would stop in front of the white line (which defines the junction area). The force of deceleration broke the chain, so the cargo advanced toward the cab and hit the driver (Figure 2). On its way the cargo crushed the truck wall as well as the cab (Figure 3), it then fell on to the road and continued to roll several meters until it was stopped by a street pole.

Figure 2 The truck after the crash.

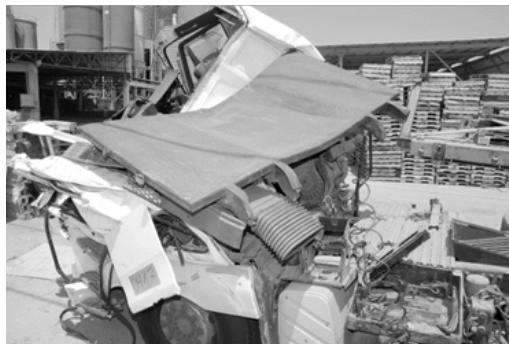
Figure 3 Close-up of the warped wall. Distortions in wall dividing the trailer from the cab.

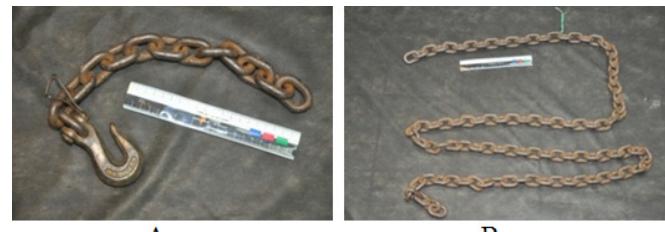
chain that lashed the cargo to the trailer. One segment was 40cm long with a forged 5/16" 9cm hook (Figure 4a). The second piece was 250cm long and had no lashing fitting on it (Figure 4b).

Figure 4 Chain segments (A and B).

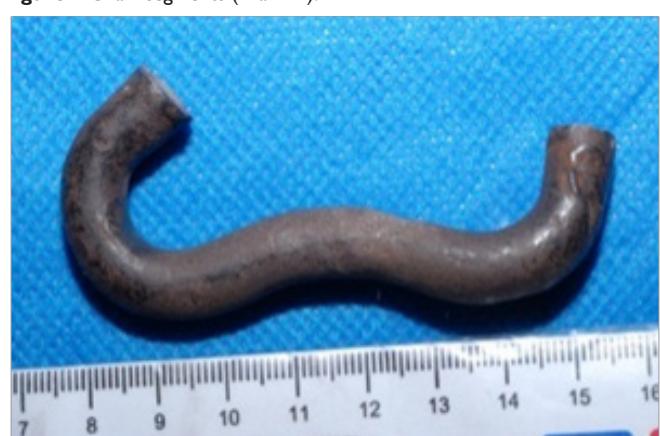
- A link that had connected the two chain segments. The link was open and distorted (Figure 5).

Figure 5 And the opened link.

The metallographic examination of the failed link, connecting the two parts of the chain, showed plastic deformation in its center (Figure 4). The link diameter was narrowed and a bottleneck was formed on it as a result of tensile forces exerted beyond its yield point. Plastic deformation produced a reduced diameter of 8.80 mm, instead of 10 mm, which is a 12% difference. As a result of the plastic distortion developed, the link broke, opened and the two parts of the chain separated. Fatigue fractures generally have an area in which the initial crack formed; the fracture then develops further smooth surfaces around the original crack. A morphological examination of the fracture surface on the failed link showed various areas as shown in Figure 6.

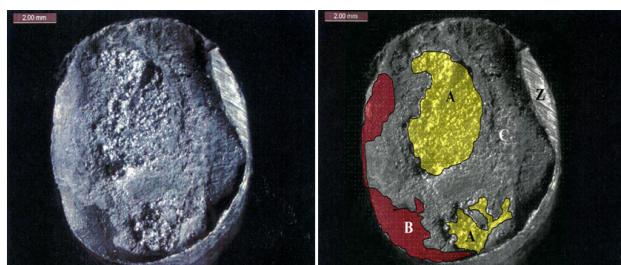
a) Figure 6 zone A shows a planar area with cleavage in the center of the cross-section, compatible with a brittle fracture caused by overload. This area constitutes approximately 20% of the link's cross-section. The chain was quenched during manufacture creating an area with improved erosion resistance; this means that during overload a fracture would present brittle material properties. Cleavage occurred during the last stage of the link breaking, over a short period of time. The images in Figure 7 were taken in the cleavage area of the open link,⁶ at various magnifications. It is possible to discern a brittle fracture mechanism in these images, which is typical of overload.

Figure 6 Various areas on the failed link's fracture surface. Crushed zone (Z), break zone (A), pre-failure rusty zone (B), ductile fracture zone (C).

b) Figure 6 zone B shows a reddish planar area (rust) over 20% of the link cross-section. This rust was formed before the break. Rust decreases the effective cross-section of the link, so the actual maximum load that the chain could bear was lower than what it was designed for, in proportion with the change in cross-section surface area. Figure 8 show this area at several magnifications.

c) Figure 6 zone C shows a planar area with a bumpy surface taking up approximately 60% of the link cross-section. This bumpy texture is typical of a ductile fracture. In addition, zone C has typical corrosion-related tear pits; like pitting associated with long-term corrosion.⁶ Figure 9 show the area at several magnifications.

d) Figure 6 zone Z shows the left edge of the link with the unidirectional crush zone.

the trailer and the hole of the metal sheets rolled. The failed link was placed directly on the sharp edge of the cargo (Figure 6). When the truck decelerated, before the chain broke, additional force was created in the direction of the sharp edge. When the truck decelerated, the force between the metal cargo and the chain grew, caused a plastic deformation that produced a reduced diameter of 8.80 mm, instead of 10 mm, which is a 12% difference. As a result, a high stress-concentration area was developed. This force, in addition to the tensile force, caused the failure of the specific link. The link failed because it was placed directly on the edge of the cargo, where there was a sharp edge that constituted a crush zone and a high stress-concentration area (Figures 13&6 zone Z).

Failure could have been prevented if both the following had occurred: the driver or some other qualified person had inspected the chain before the cargo was lashed, and the contact points between the tie down system and the cargo (mainly for metal cargo) had been inspected to ensure no damage could be incurred to the lashing system through friction on sharp angles or single-point load when braking suddenly. When lashing a sharp-edged cargo, corner shields and protective sleeves must be used wherever indicated. Additional safety measures that can be applied to prevent the cargo shifting during acceleration or deceleration are for example, wooden triangular stoppers (friction coefficient between wood and metal is greater than metal to metal), securing the cargo by lashing it to the lashing surface with an additional chain and shackle.^{1,7}

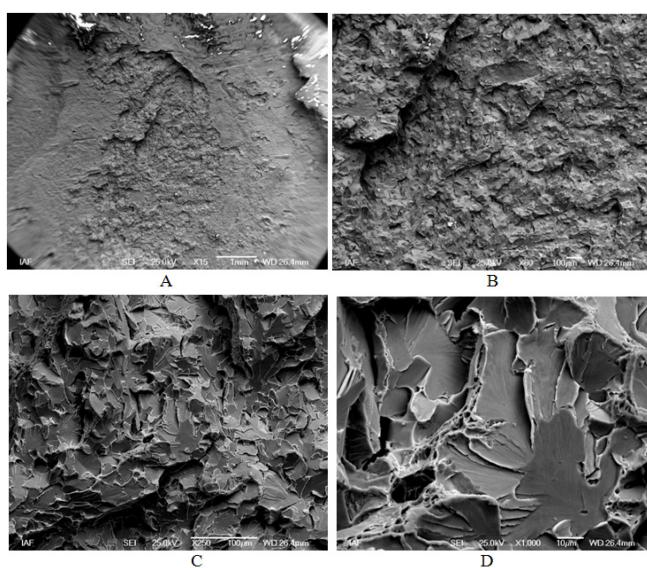
Figure 7 Detail of cleavage (A) caused by overload, magnified x15, x60, x250, and x1000 respectively.

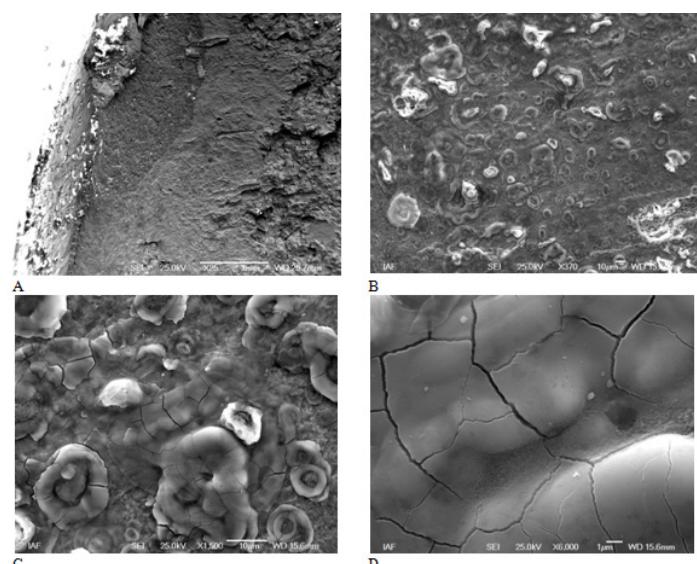
Figure 8 Rusted zone (B) magnified x25, x370, x1500, x6000, respectively.

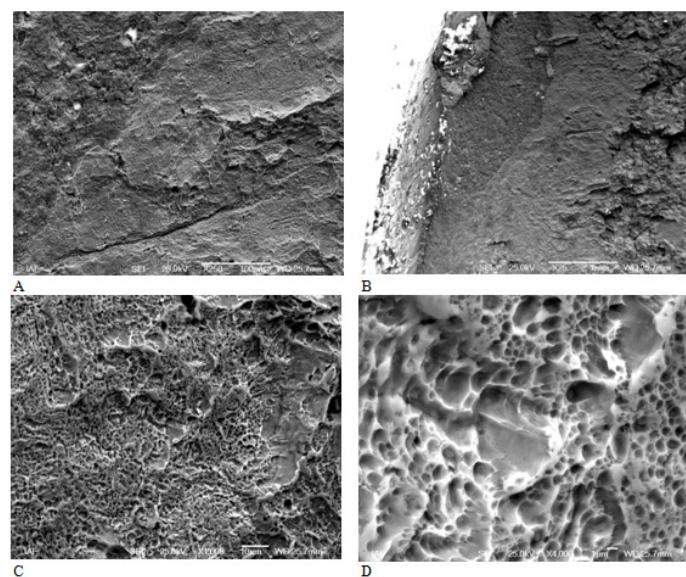
Figure 9 Area C magnified X25, x250, x1000, and x4000, respectively.

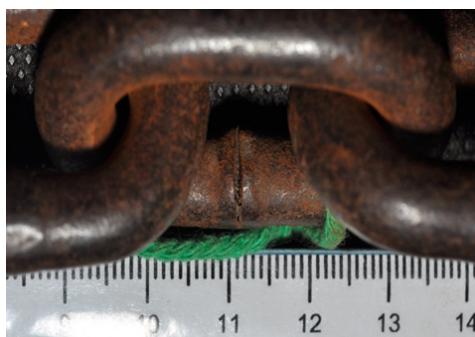
On examining the chain, several more cracked links were found with varying degrees of damage. The link with the largest crack (Figure 10), was tensile tested on an Instron KPX machine. The link collapsed at a 3.8 ton load. Morphology of the fracture surface area on this link, indicated that the link had the same type of zones, although the ratios were different. The most rusted area (Figure 11 zone D) covered close to 70% of the link's surface; 20% is cleaved (Figure 11 area E), and the remaining area is an overload ductile fracture (Figure 11 area F). To test the chain's strength, several tensile tests were conducted on links that showed no visual signs of cracks on initial inspection. Yield load was 5.5-6 tons. All the tested links failed at their weld point. Morphological examination of the fracture surface on these links, showed that some of the links were not rusted. Some had the three areas described earlier, with different ratios. The rusted area takes up less than 10% of the cross-section (Figure 12 area G). When examining the results in view of the theory, it is very evident that the highest load that can be placed on a link is proportional to the effective cross-section of that link, excluding the rusted surface area. The disconnected link that directly caused the accident was only rusted over 20% of its cross-section, this was compared to the most rusted link tested (Figures 10&11) in the lab which was rusted over approximately 70% of its cross-section. The conclusion is that the failed link was exposed to additional force to the tensile force. Otherwise, the failed link would have been the most rusted link (Figures 10&11).

Figure 10 Another cracked link from the chain.

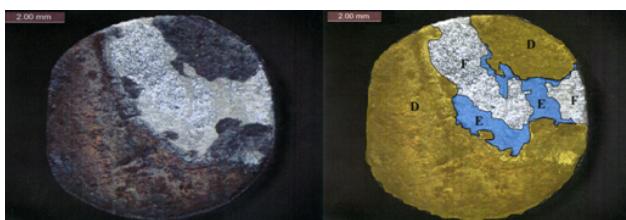
Figure 11 Morphology of a cracked link from the same chain.

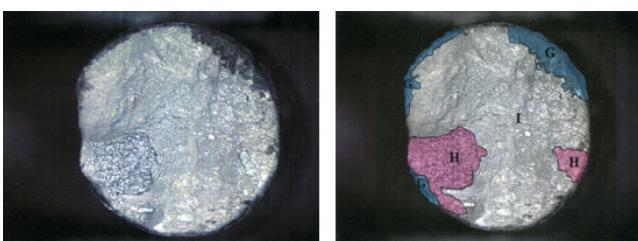
Figure 12 A link showing signs of minor corrosion (under 10%).

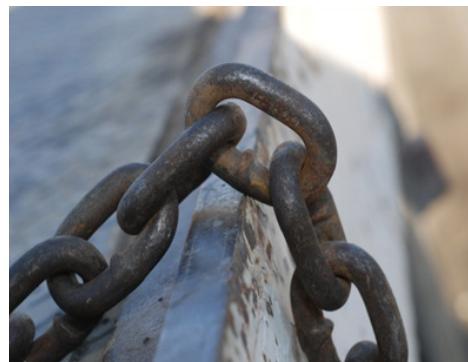
Figure 13 Method of lashing the cargo so that a stress concentration point is created on the chain (simulation).
