Forensic expert work in determining the cause of deaths resulting from airbag system failures

Abstract

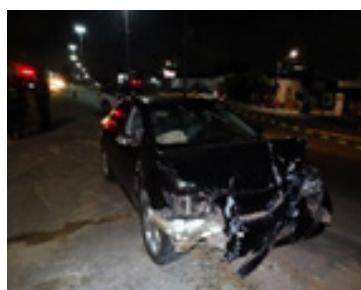
Case 1 refers to a traffic accident involving a 2008 Toyota Corolla (Figure 1), which collided head-on with a fixed obstacle (pole), the determining cause being that the driver of the vehicle left the roadway.

Figure 1 Vehicle from Case 1, showing frontal deformation consistent with a low-to-moderate impact that triggered airbag deployment.

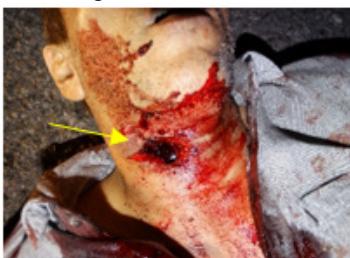
In Case 1, the vehicle was found with damage to the front end after colliding with a pole (Figure 3 and 4). The driver of the vehicle was found unconscious in the driver's seat with a perforating contusion injury to the right side of the neck, which was caused by a rigid object, similar to a 12-gauge shotgun pellet, which lodged in the right rear of the neck, as shown in Figure 5 and 6.

Figure 5 Penetrating-blunt injury observed on the victim's neck in Case 1, representing the primary fatal wound associated with airbag inflator fragmentation.

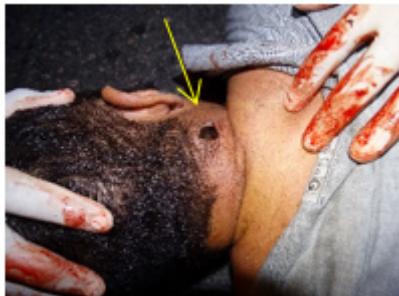
Figure 6 Metallic object recovered from the victim's neck in Case 1, initially suspected to be ballistic but later identified as a fragment of the airbag inflator assembly.

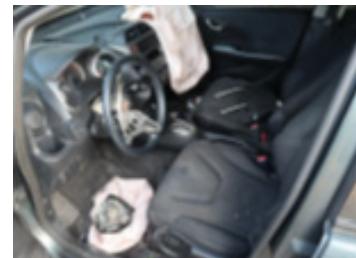
- I. The driver and passenger airbags were deployed (Figure 9);
- II. There was a perforation in the airbag bag (Figure 10);
- III. A piece was found in the center of the vehicle's steering wheel that matched the object removed from the victim's body (Figure 11–14).

Figure 9 Interior of the vehicle from Case 1, showing evidence of airbag deployment and fragmentation-related damage.

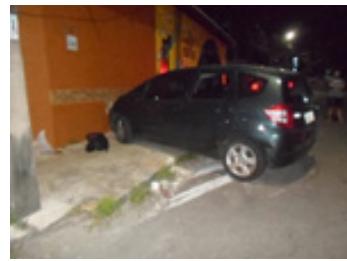
Figure 15 Scene of the incident in Case 2, depicting the vehicle's resting position and surrounding context at the time of forensic examination.

The scene of the incident in Case 2 was characterized by the presence of two damaged vehicles after a collision resulting from one of them failing to yield the right of way. In the case under study, the vehicle of interest is the one in which the fatal victim was driving at the time of the accident. The impact and dynamics on the vehicle were characterized by damage concentrated in the front and rear left areas (Figure 15 and 16).

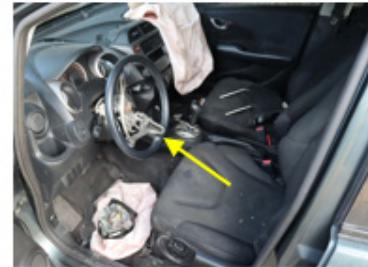
Figure 23 Location within the steering wheel assembly of the airbag component that matched the fragment recovered from the victim in Case 2.

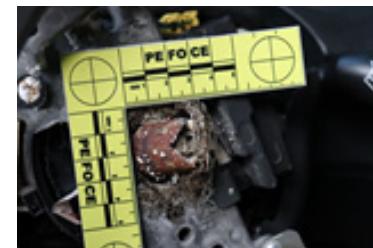
Figure 24 Central steering wheel component corresponding to the fragment removed from the victim's body in Case 2.

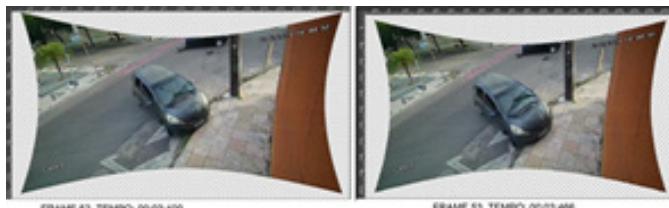
The second methodology was based on the analysis of the video of the moment of impact, which, through the relationship between space and time, made it possible to estimate the speed of the vehicle using photogrammetry procedures, which estimated a speed of **19 km/h**. The video of the moment of the accident was obtained from the police. Some *frames* from the video are shown in Figure 29 and 30.

Figure 29 Frames from the moment the victim's vehicle collides with the wall, analysis using photogrammetry.

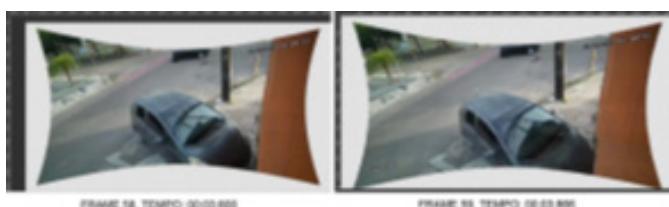
Figure 30 Frames from the moment the victim's vehicle collides with the wall, aiming to estimate the speed using photogrammetry.

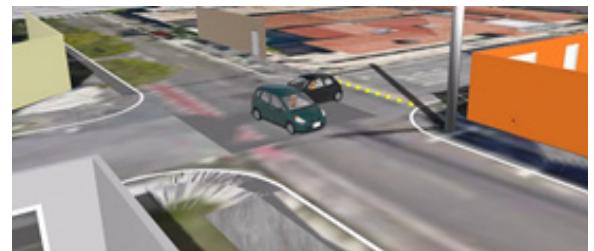
Figure 33 Computer simulation, seen from another angle, of the moment of collision between the vehicles.

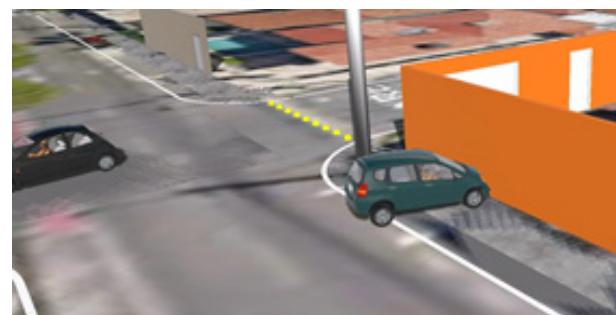
Figure 34 Computer simulation, with a close-up view, of the moment of impact of the Honda vehicle against the wall.

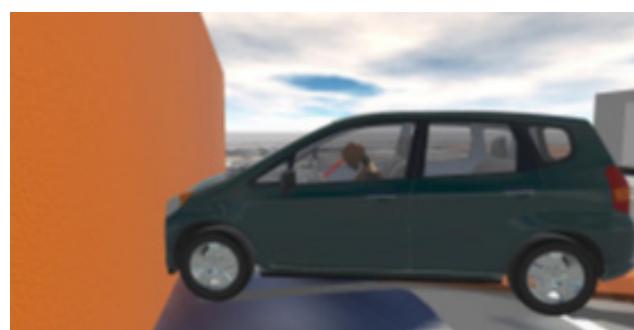
Figure 35 Computer simulation, highlighting the illustration of the driver/victim's position and the trajectory of the fragment that detached from the airbag system.

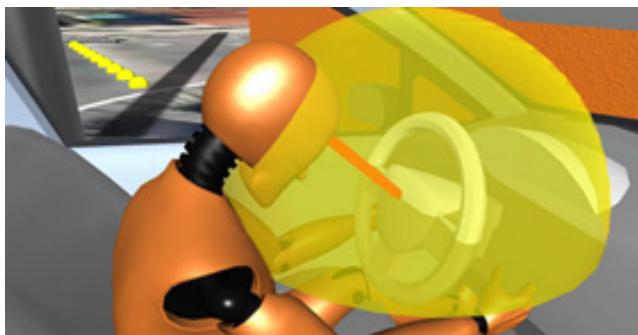
Figure 36 Computer simulation, with a view of the trajectory (in red) of the fragment that hit the victim

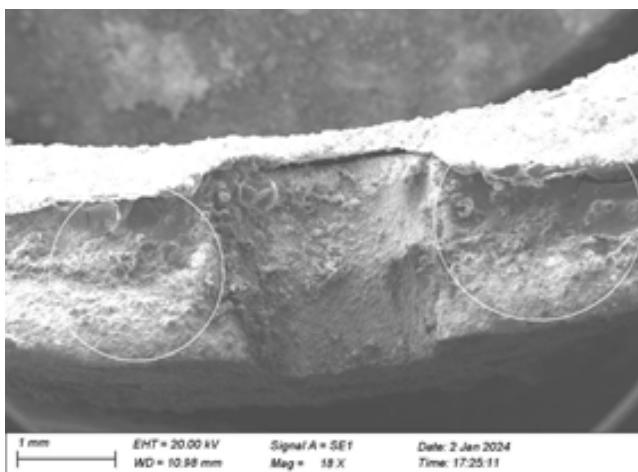
Figure 37 Macrographs of fracture surfaces from the Honda Fit (Case 2) inflator component, showing regions of elevated stress concentration.

Fig. 38 shows that the fractures occurred in the regions of highest residual stress in the material, which is precisely around the holes in the part through which the propellant gases pass during deflagration. It should be noted that this behavior was observed in both cases.

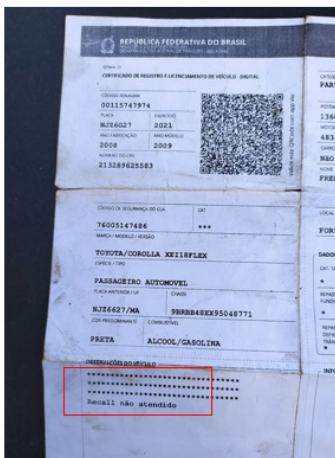
In light of this scenario, this study suggests urgent and comprehensive action by the competent authorities, including a statement through the appropriate agencies and media outlets to alert the population, especially vehicle owners, about the imminent risk to physical integrity, given that the two vehicles in the cases presented contained in their respective documents a note from the manufacturer calling for a *recall* of the airbag system, as shown in Figure 40 and 41.

Figure 41 Vehicle documentation from Case I indicating the recall notice that had not been attended.
