Abandoned borrow pits; risk factors and reclamation procedure

Volume 2 Issue 3 - 2017

**Nwachukwu MA, Nwachukwu MI,
Ahiarkwem CO, Nwankwo GI**

Department of Geosciences, Federal University of Technology, Nigeria

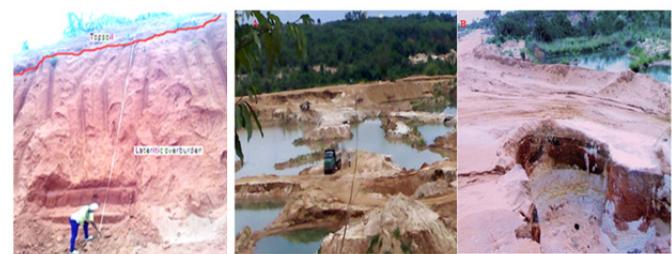
The soil is mostly sandy and gravel-like. The presence of trees, shrubs and grasses is responsible for the dense vegetation within the areas. The topsoil, less than 1m thick, consists of dark humus soil for agriculture. This top soil is followed by the reddish lateritic soil which constitutes the borrow material. Thickness of this red earth or the borrow material as measured in the Emekuku and Ihiagwa pits (Figure 4A) varies between 8m and 11m, and may often have sand lens at some locations. The borrow material was observed to be underlain by sand and gravel beds. The sand and gravel beds may conduct groundwater, causing pockets of ponds in the pits (Figure 4B). Excavation of the water saturated sand and gravel beds for building and other engineering projects other than road, triggers erosion, form cavities or causes landslides (Figure 4C).

Figure 4 (A) Field measurement of pit depth and slope (Left), **(B)** Pit excavation causing pocket of pond (Centre) and **(C)** Pit excavation causing dangerous landscape, destroy access road (Right).

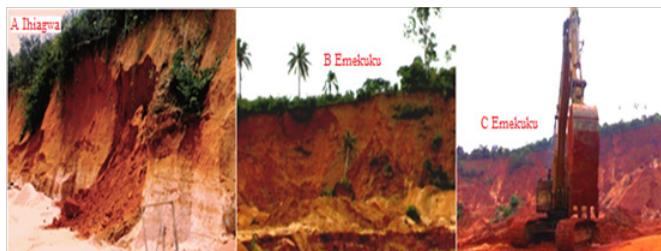
Figures 4-7 are photos illustrating present site conditions. In the two sites visited there were issues of landslide as a serious environmental problem in the area. Landslide which is described as a down slope movement of rock and soil along slip surfaces is also associated with disturbance of the equilibrium which normally exists between stress and strain in material resting on slope. This relationship is dependent on factors like height, steepness of the slope, density and strength (cohesion and friction) of the material on the slope. The geometry of the two sites (Ihiagwa and Emekuku) revealed a slope angle of between 70° and 80° . The slopes were compromised during the excavation process. Also the pit slope has been weakened due to heavy rainfall common to the area from March to September. The resultant effect of landslide in the area has led to loss of lives and damage to properties. Community personnel interviewed affirmed that abandoned borrow pits cause the community un-quantified loss of properties. From the vertical electrical sounding carried out, the study area subsurface is predominantly sandy resulting in high permeability and frequent mass movement of the soil in the pit wall. Active fresh slumping and sliding surfaces of the lateritic soil (Figure 5A & 5B) are common features of an abandoned borrow pit. Sliding of the lateritic face goes on with falling of trees (Figure 5B) due to exceeding overburden pressure and unstable pit slope angle. Often this results in accidents, loss of life and destruction of excavators (Figure 5C).

Figure 5 (A) Abandoned borrow pit showing old slide surface and recent slumping (Left).

(B) Active borrow pit with rapid sliding of palm trees into the pit (Centre).

(C) Heavy duty excavator at work, often affected by sliding (Right). Images created by Nwachukwu MI.

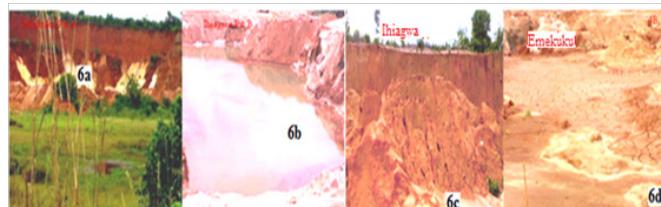
Figure 6 (A) Borrow pit turned swamp; **(B)** Borrow pit turned pond; **(C)** Borrow pit wall with tension cracks; **(D)** Borrow pit floor with mud cracks.

Soon after, abandoned borrow pits in the area could turn to marsh land or swamp (Figure 6A) or turn into pond (Figure 6B). This situation reduces environmental quality by breeding of mosquitoes and polluting the groundwater. Often there is loss of life as children swim or fetch water from the pond. Prevalence of tension cracks on abandoned pits (Figure 6C) and mud cracks on dried marsh land in the area (Figure 6D) also facilitate infiltration and transport of pollutants to groundwater. Surface instability may occur when the material is stressed to its strength limit, thus causing fracture or excessive deformation. Overburden stress, rainfall intensity and water saturation are key factors that initiate pit slope failure. This situation reduces cohesion and sets up a plane of failure, which becomes a sliding surface as soon as the shear strength is exceeded.

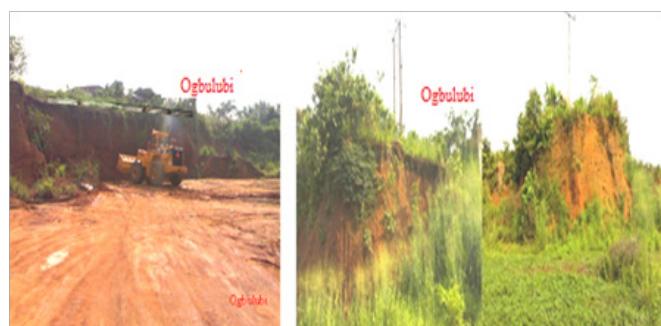
Figure 7 (A) Borrow pit operation threatens collapse of family duplex and fence (Left). **(B)** Borrow pit threaten high tension power pole (Right). Images created by Nwachukwu MI.

At Ogbulubi borrow pit site, about 20m from the edge of the abandoned borrow pit, is a fence and one-story building under threat of sliding (Figure 7A). Because of the fact that heavy duty equipment like bulldozers, pay loader and trucks were used for excavation and loading of the laterite soil to designated construction sites, the equipment have the tendency of causing vibration that sends lateral waves to the surrounding structures which also weaken the foundation of the structures and cause displacement. During the rainy season, the micro cracks created will become water infiltration pathways and finally produce mega cracks that will cause pit slope failure. Incidents of slope failure causing sliding could cause collapse of structures such as buildings, roads and drainage system, certainly causing huge economic loss to the owners. On top of one of the abandoned borrow pits at Owerri-Okigwe highway is a high tension electric pole (Figure 7B). From the edge of the pit to the high tension pole is about a distance of 15m. There is a thick vegetation cover of India bamboo which tends to stabilize the soil, but that cannot prevent sliding soon as it is initiated. The high tension pole poses a lot of threat to the residents and commuters plying that route. The economic and social risks associated with the situation of these high tensions power poles are enormous and should not be compromised.

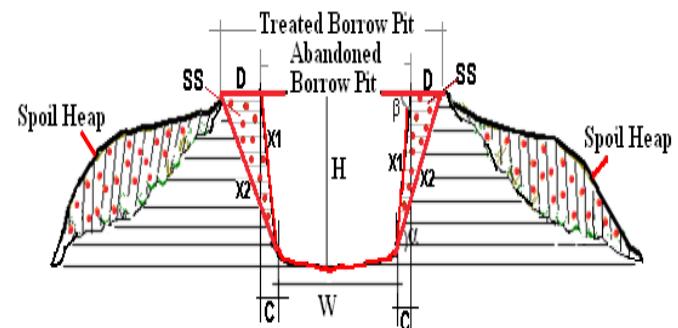
The classical approach used in designing open pit excavation is not applied in the study area. There is no benching or pit bench design; rather there is continuous excavation in a single bench (Figure 8). That implies no proper consideration to safety and possibility of sliding in the pits investigated. Critically, there is no consideration to the relationship between forces resisting sliding (B_f) associated with the sliding base distance (B).

Figure 8 Excavation completed, Borrow pit abandoned.

Probability of sliding: Figure 8 show force resisting sliding (C) possessed by the base rock and the overburden pressure (D) initiating sliding. The Factor of Safety (F) of the pits is defined as

$F=C/D$, and sliding is assumed to occur when F is less than unity. For assurance of safety, C must be greater or at least equal to D . F is controlled by the following factors:

SS=Sliding surface; established by tension crack is enhanced by water saturation, thereby increasing probability of sliding. This surface should be sliced as a treatment to the pit wall to increase slope stability at the landfill.

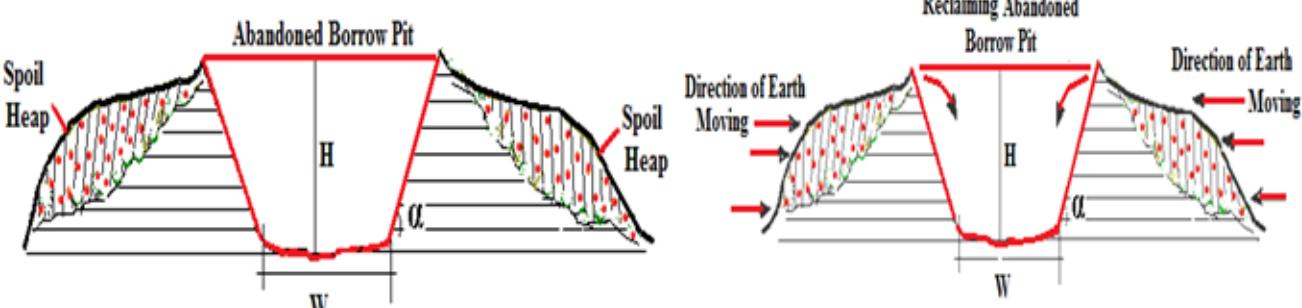
Standard excavators must be used to remove the dark topsoil and expose the red earth borrow material. Usually the excavated topsoil is dumped at the side of the planned pit as spoil heap. Area of topsoil removal and arrangement of spoil heap will depend on design of the borrow pit (Figure 14B). Bench height, width, slope and total depth of pit must be properly designed following information obtained from the preliminary site investigation. Unfortunately, borrow pits under investigation were opened and controlled by excavator operators without supervision. These operators have no knowledge of borrow pit design and slope stability requirements. As a result, both active and abandoned borrow pits in Nigeria have no designed bench heights or excavation plan. There was no consideration of pit slope and stability which results in pits having vertical walls, often with negative slope. This condition increases probability of sliding and risks.

Figure 15A Mining completed, borrow pit abandoned (Left) H =Depth, W =Width, α =Angle of slope **15B** Arrow shows direction of earth moving using bulldozer followed by compaction using compactor or roller (right).

As soon as borrow pit operation at a site is ended, and the project for which the borrow pit was opened is concluded (Figure 15A), reclamation should commence immediately. This is important especially where no new road project is envisaged within the area and any future road project will not be at close proximity for borrowing from the site to be economical. Reclamation is commenced by moving the spoil heap back to the pit, followed by moving adjoining topsoil to fill the pit (Figure 15B). There is no importation of fill material required. This operation goes with compaction of the fill material using roller and testing the compacted earth to achieve the original soil characteristics and ground condition (Figure 16A & 16B), and finally, accomplished by turning the reclaimed site green (Figure 17). The reclaimed site is completed by planting flowers, grass and trees to improve the natural look of a reclaimed site and improve ecosystem services. Reclaimed site can be used for structural development such as recreational activities, holiday resort and community gardens (Figure 17), depending on the land size. Figures 15-17, represents a step by step field operation and completion of a borrow pit reclamation program.

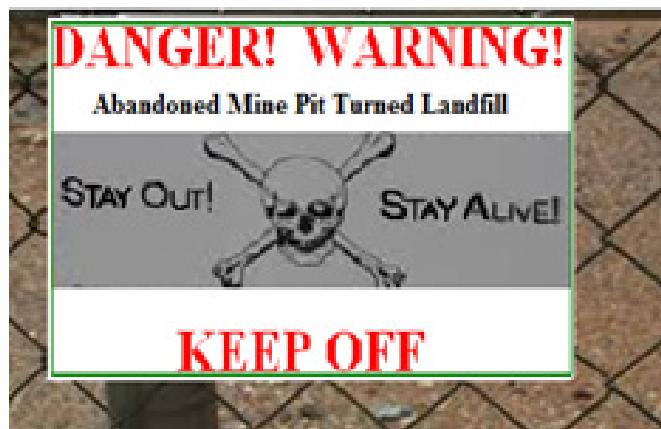
Figure 18 (A) Perimeter fence decorated with safety warning sign.

Borrow pits active or abandoned should be provided some safety measures to reduce accidents and risks. There should be perimeter fencing of the pit area (Figure 18A), to prevent accident to human beings and other roaming animals into the pits. There should be only one gate for both entry and exit into the pit. The pit area and the gate must be guarded 24hours daily by vigilante and security personnel to avert trespassing. Warning signs (Figure 18B) are necessary at strategic locations to inform passersby of the imminent danger ahead. Such signs must be simplified and easily understandable to all, including cattle grazers traversing the area.
