# Fracture of Revision Modular Femoral Stem

## Abstract

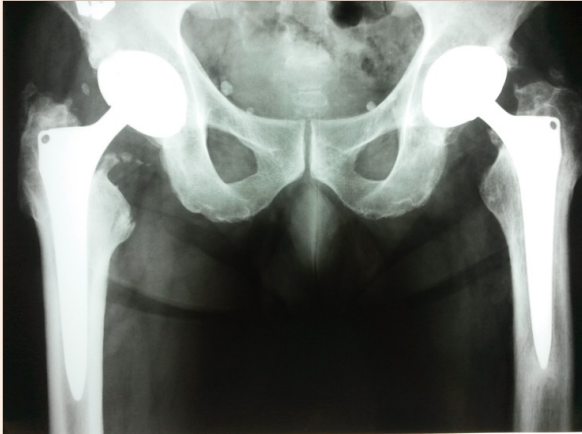
**Figure 1:** Plain radiograph of primary bilateral total hip endoprosthesis.

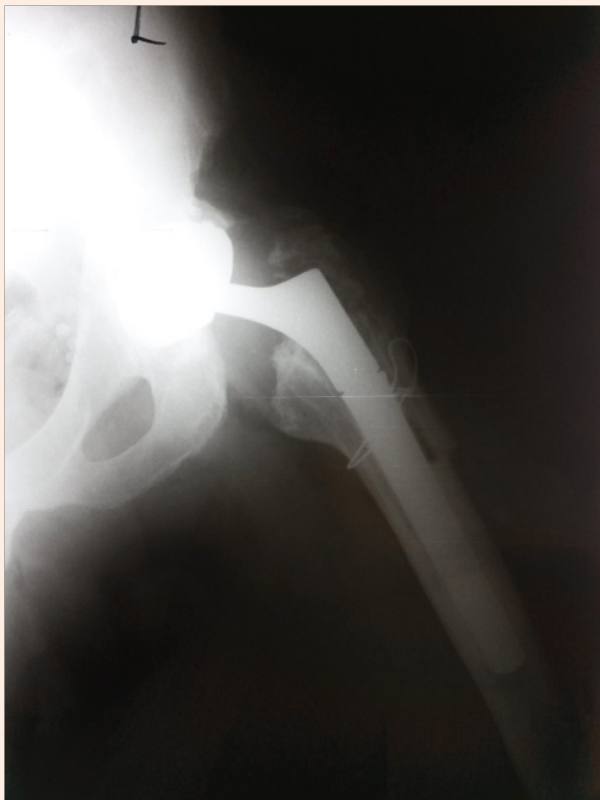
**Figure 2:** Plain radiograph of revision modular total hip endoprosthesis.

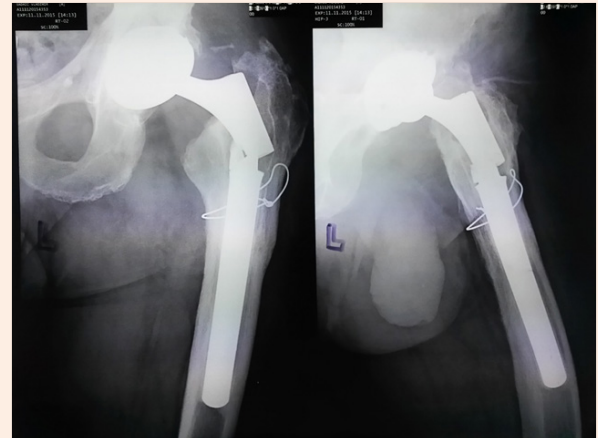
**Figure 3:** Plain radiograph of fractured modular femoral stem.

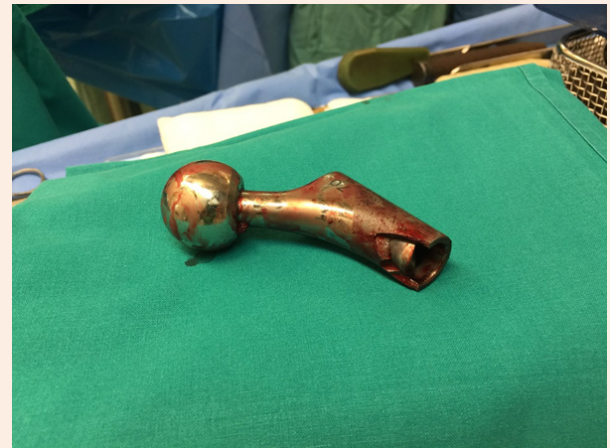
**Figure 4:** Intraoperative junction fracture.

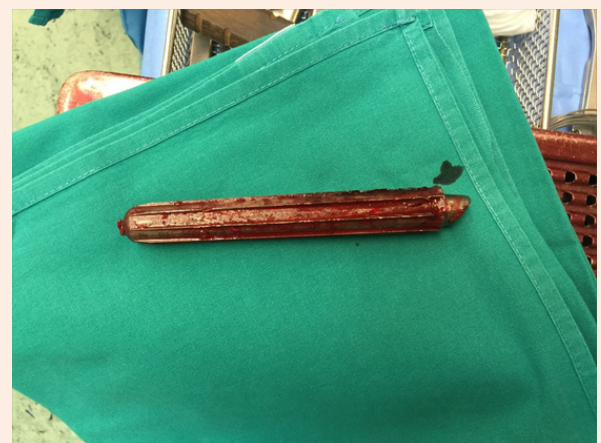
**Figure 5:** Intraoperative junction fracture.

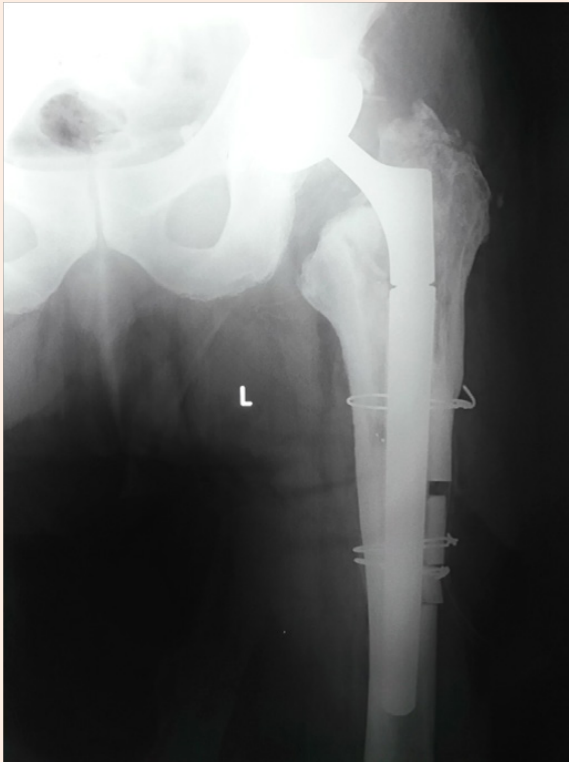
**Figure 6:** Plain radiograph postoperatively.
