# Bleaching Treatment in Devitalised Teeth and the Restoration of Anterior Aesthetics: 2 Case Reports

## Case Report

**Suzan Cangul\* and Salih Aydin**

*Department of Restorative Dentistry, Dicle University, Turkey*

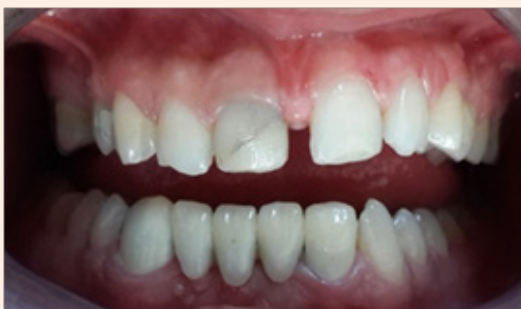
**Figure 1:** Photograph of the first image of the patient's upper central teeth.

A 23-year old male presented at the Restorative Dental Treatment Department of the Dentistry Faculty of Dicle University with the complaint of discolouration in the right upper central tooth and diastema between the central teeth. From the patient anamnesis it was learned that the patient had a history of trauma from 7 years previously. As a result of the clinical and radiological examinations, it was seen that canal treatment had been applied to the right upper central tooth and there was a loss of substance. Before the treatment, intraoral photographs were taken of the patient and it was aimed to provide anesthesia of upper anterior teeth at the request of the patient (Figure 1 & 2). First, gingivectomy was applied to the upper right central tooth with the aim of levelling the crown lengths of the central teeth. Then it was decided to apply devital bleaching to the same tooth. After making an opening to the cavity, the root canal filling was cleaned to 2mm below the enamel cement border. The dentin remnants were cleaned using sodium hypochloride followed by EDTA solutions. The floor of the cavity was then closed with glass ionomer cement. As the bleaching agent, 37% hydrogen peroxide was used and this was applied to the whole pulp chamber. After placing a fine cotton gauze over the bleaching agent, the cavity was temporarily closed with zinc oxide eugenol. The same procedures were repeated in 3 sessions at 2-day intervals. When sufficient bleaching was observed, the cavity was thoroughly washed out with distilled water and dried then a pad of calcium hydroxide ( $\text{Ca}(\text{OH})_2$ ) was placed to neutralise the hydrogen peroxide activity. Cotton gauze was placed over the pad and the cavity was closed with temporary filling material (Figure 3). In the final stage the ( $\text{Ca}(\text{OH})_2$ ) pad was washed and dried, then the cavity was closed with cavite. The length of the tooth crown was extended while performing the gingivectomy operation in the bleaching process. Immediately after this operation and completion of the bleaching treatment, a fibre post was applied (Figure 4). This was placed

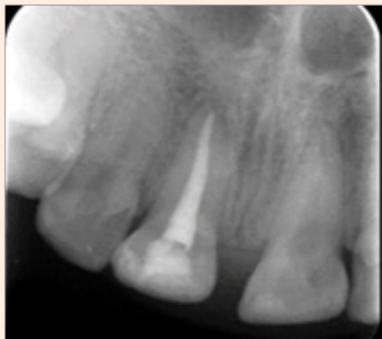
**Figure 2:** Radiographic image of upper right central tooth.

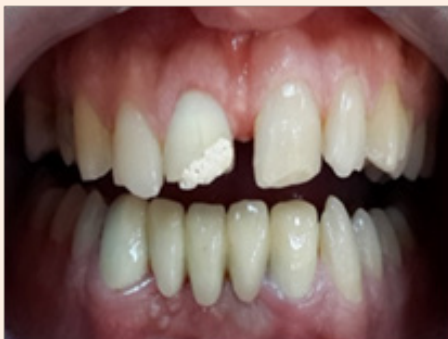
**Figure 3:** Post-bleaching and gingivectomy image of upper right central tooth.

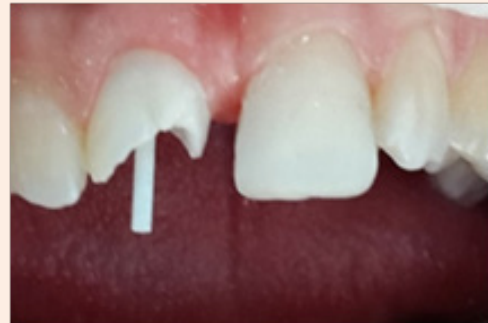
**Figure 4:** Fiber post application in upper right central.

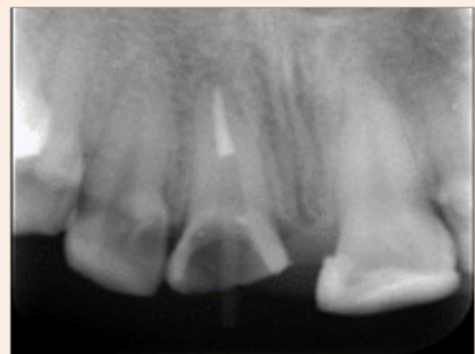
**Figure 5:** Radiographic image of upper right central tooth with fiber post placed.

after cleaning the canal filling material in both the root ends. After evaluation with periapical films, full restoration of the tooth was made with composite resin (Figure 5). Then the procedure was applied to close the diastema between the upper central teeth. The teeth were completely isolated with cotton wool rolls then acid was applied for 15 secs to the surfaces to be restored. After washing and drying the surfaces applied with acid, adhesive resin was applied to these surfaces and polymerisation was made with an LED light source for 10 secs. Then, with the aid of a clear band, composite resin was applied with incremental technique and the diastema was closed. Any excess was removed with microgranulated flame tipped burrs and the finishing and polishing procedures were made with discs and rubbers (Figure 6 & 7). The patient was recalled for control after 6 months. No problems were observed in the teeth.

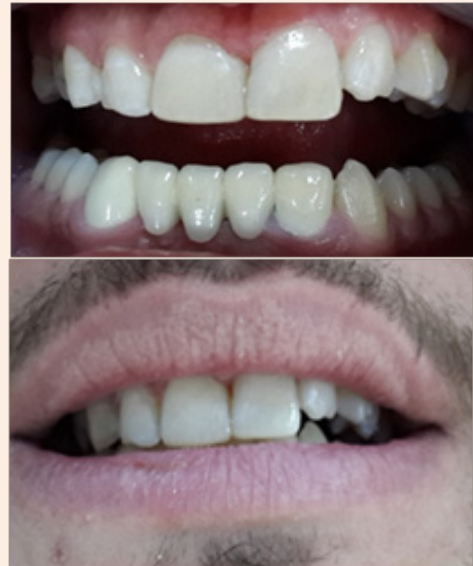
**Figure 6 & 7:** Image of anterior teeth after restoration.

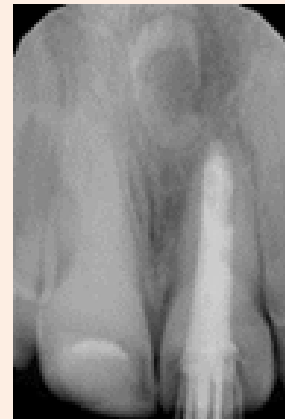
**Figure 10:** Radiographic image of the upper left central tooth after endodontic treatment.

As there was discolouration in the collar section of the upper left central tooth and intercoronally, a vitality test was applied to the tooth, which showed that that the upper left central tooth is devital, right central tooth is vital. In the radiological examination, no pathology was determined in either of the two teeth (Figure 8 & 9). After all the examinations, intraoral photographs were taken and the first treatment was started of canal treatment to the upper left central tooth (Figure 10). Entrance to the cavity was opened from the buccal surface. After the endodontic treatment, the tooth was temporarily closed with zinc oxide eugenol. The patient was recalled one week later for bleaching treatment. The temporary filling was removed and the entry to the cavity was extended to 2mm below the collar level. Then closure was made with zinc phosphate over gutta percha (Figure 11). As the bleaching agent, 37% carbamide peroxide was used and was applied to the whole cavity, which was then covered with a fine sterile gauze. Temporary restoration was made with composite resin. The patient was recalled after 3 days and the tooth bleaching was evaluated. As sufficient bleaching had not been obtained, the cavity was cleaned and the same procedures were repeated. The patient returned after a further 3 days and the tooth colour was observed to have sufficiently lightened. The cavity was opened, washed and dried, then powdered calcium hydroxide was applied to the cavity with an amalgam gun to eliminate the harmful effects of the whitening agent. A small piece of cotton gauze was then applied and temporary closure was made with cavit (Figure 12). One day later, a lamina shape cut was made to the upper right and left central teeth and permanent restoration was made with composite resin (Figure 13 & 14).

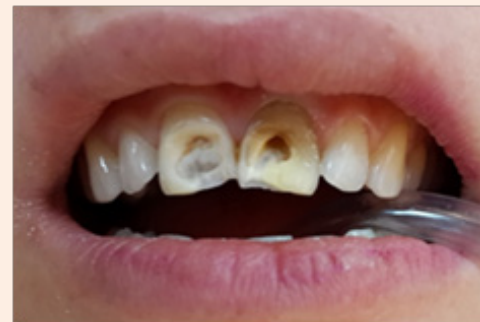
**Figure 11:** The image of the upper central teeth before bleaching treatment.

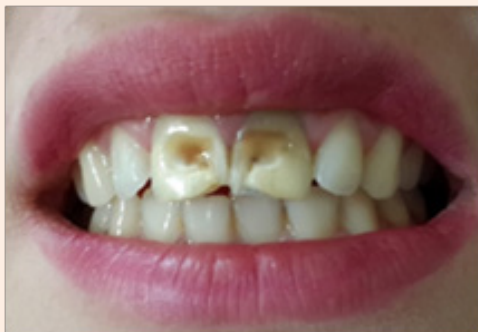
**Figure 8:** First image of upper central teeth.

A 22-year old female who had suffered an accident in childhood presented at the clinic with aesthetic complaints of the upper anterior teeth. In the clinical examination, there was seen to be severe substance loss on the buccal surfaces of the upper right and left central teeth and there was brown discolouration.

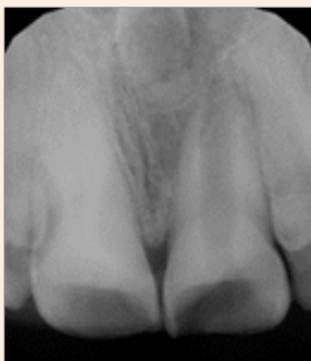
**Figure 9:** Radiographic image of upper central teeth.

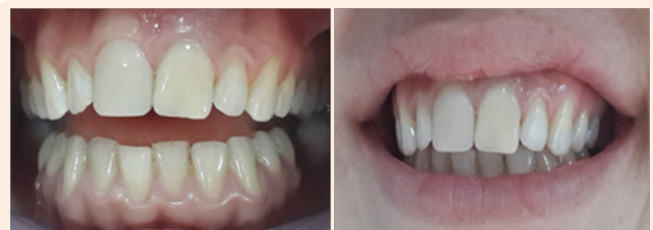
**Figure 13 & 14:** Image of upper anterior central teeth after composite resin restoration.
