# A novel technique for extensor mechanism repair

**Keywords:** Extensor mechanism, Zip Loop Toggle Loc Device

Volume 2 Issue 6 - 2015

**Juluru P Rao, Alvaro Cabezas, Jacob A Spencer, Edward Mastromonaco**  
Jersey City Medical Center, USA

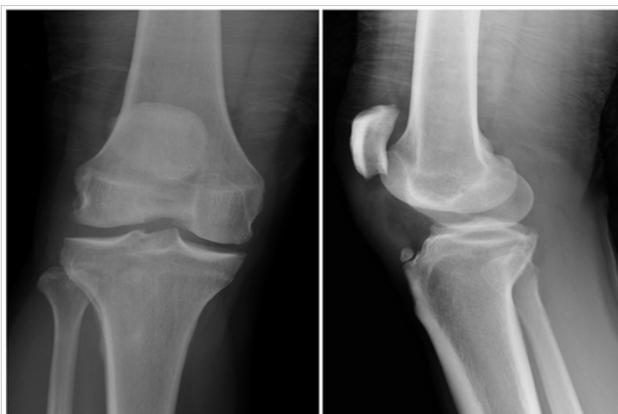
**Figure 1A & 1B** Initial injury anteroposterior and lateral radiographs demonstrating patella alta.

GC, a 38-year-old male, presented to the emergency room with complaints of right knee pain. The patient admitted to landing awkwardly one day ago while playing basketball and heard a popping sound that he localized to the right knee. He had immediate pain and swelling and was unable to bear weight. On exam, he had a palpable defect in his patellar tendon and was unable to straighten his leg against gravity. He was evaluated with x-rays (Figures 1A & 1B), which demonstrated a high riding patella. After discussing the treatment options and risks, benefits and complications of surgery, he was taken to the operating room where his patella tendon was repaired.

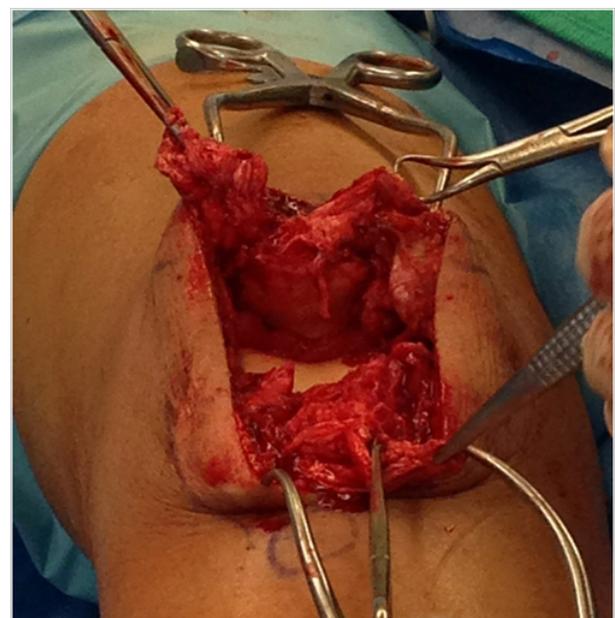
**Figure 2** Intraoperative photograph of exposed patellar tendon demonstrating rupture with frayed ends.

The patient was positioned supine on the operating room table and his right leg was prepped and draped in a sterile fashion. A midline longitudinal incision was made from approximately 2cm proximal to the superior pole of the patella, extending distally to approximately 2cm proximal and 1cm medial to the tibial tuberosity. Careful attention was paid to preserve the paratenon to facilitate closure after repair of the tendon to aid in healing and the prevention of adhesions. The ruptured extensor mechanism was then exposed (Figure 2).

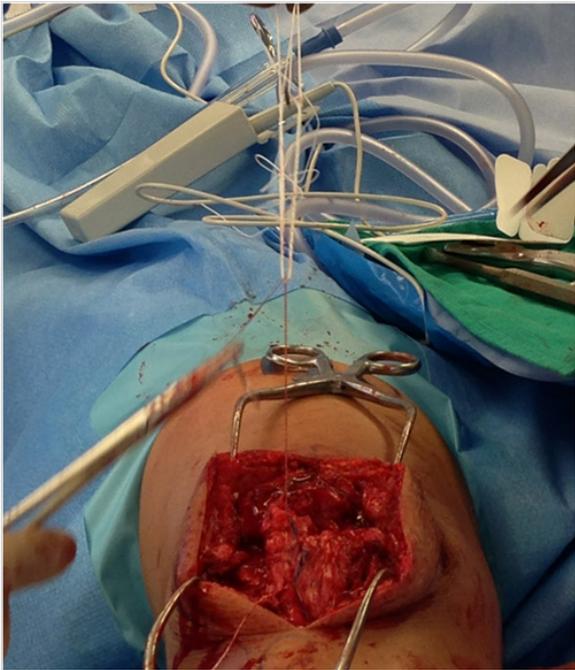
**Figure 3** Intraoperative photograph demonstrating ZipLoop sutures “whipstitched” into the patellar tendon ends.

The disrupted extensor tendon and retinaculum were identified. Macerated tendon edges were sharply debrided. The Zip Loop sutures

(#2 Max Braid) with attached tapered needles were attached to the end of the torn patellar tendon utilizing a whipstitch technique (Figure 3).

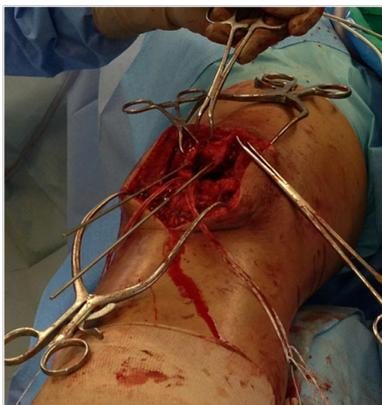
**Figure 4** Intraoperative photograph demonstrating the passage of two 2.4mm guide wires through the patella in preparation for drilling with a 4.5mm cannulated drill and then passage of the ToggleLoc sutures.

The origin of the patellar tendon was identified and debrided to bleeding bone. After identifying the medial and lateral borders of the patella, the patella was visually divided into thirds and the starting points for the guide wires were marked with a bovie at the one-third and two-thirds margin to ensure appropriate spacing between tunnels. Under fluoroscopic guidance, two 2.4 mm guide wires were inserted through the patella, starting from the anterior edge of the inferior pole to the posterior aspect of the superior pole in a parallel fashion. The articular surface of the patella was palpated to ensure there was no penetration. The tips of the guide wires were palpated with a freer, then advanced through the quadriceps tendon and secured with Kocher clamps (Figure 4). As recommended by the manufacturer for passage of the Toggle Loc device, a 4.5 mm cannulated drill was carefully passed through bone.

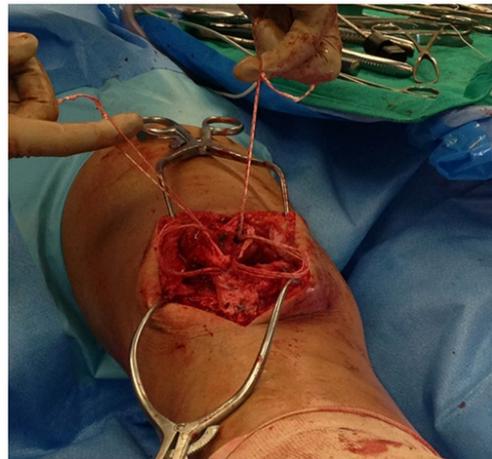
**Figure 5** Intraoperative photograph demonstrating the passage of the ZipLoop sutures through the 4.5mm tunnels in the patella.

Abeath pin and passing suture (#1 Vicryl) for the Toggle Loc fixation device were carefully passed through the 4.5mm tunnels in the patella (Figure 5). The Toggle Loc device was then pushed through using the Toggle Loc pusher and flipped with an obturator. The sutures were then gently tensioned to ensure the device was secure. With the knee in full extension and the patella centered in its anatomic position within the trochlea, the zip strand of the Zip Loop device was pulled to close the gap between the repair site and superior pole of the patella. The strands were individually tensioned to remove any excess slack, while maintaining the patella’s position. The knee was then ranged and assessed for gapping of the repair, tracking of the patella and tension of the extensor mechanism during flexion.

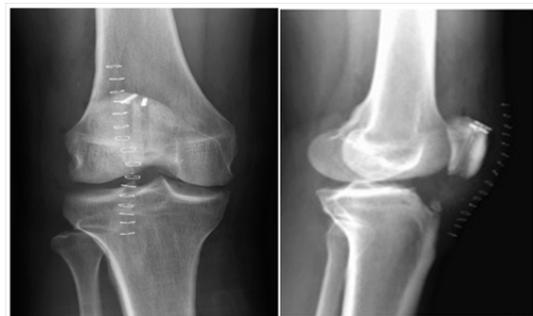
**Figure 6A & 6B** Postoperative anteroposterior and lateral radiographs of the knee demonstrating successful ToggleLoc deployment and restoration of the patella’s orientation.

The wound was irrigated followed by a layered closure. The retinaculum was repaired with #1 Vicryl and #0 Vicryl was used to augment portions of the patellar tendon repair near the origin to debulk and reinforce the repair site. #0 Vicryl was then used to close the paratenon and then the deep fascia. 2-0 Vicryl was then used for subcutaneous fascia followed by staples for the skin. Early flexion was determined intraoperatively by the quality of tendon tissue and the repair. The knee could be flexed up to 90 degrees without any gaping of the repair. Sterile dressing was applied and the knee was placed in a knee immobilizer, locked in extension. Radiographs done immediately postoperatively revealed the Toggle Loc deployed and securely in place with good anatomic alignment of the patella within the trochlear groove (Figures 6A & 6B).

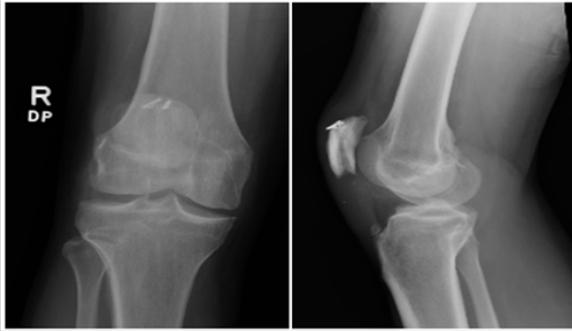
**Figure 7A & 7B** 11-month postoperative follow-up anteroposterior and lateral radiographs of the knee demonstrating no change in position of the patella or ToggleLoc devices.

The patient was made full weight bearing with crutch assistance immediately after surgery. Progressive active flexion was initiated at approximately two weeks, after the wound had healed. Active assisted range of motion was implemented at four weeks, with the goal of 90 degrees by six weeks and full ROM by 12 weeks. A strengthening program of isometric straight leg raises was started at six weeks. Radiographs performed at 11 months postoperatively demonstrated no displacement of the ToggleLoc or loss of fixation and the patella remained in its original postoperative position within the trochlear groove (Figures 7A & 7B).

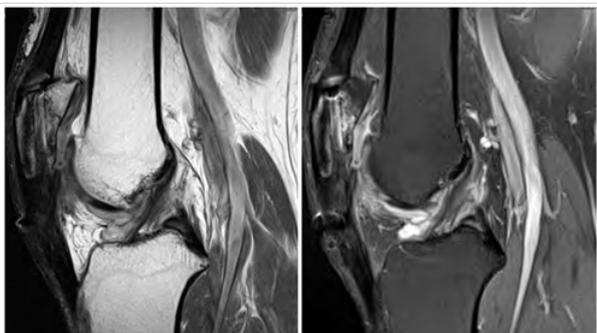
**Figure 8A & 8B** 13-month follow-up MRI of the knee demonstrating no change in position of the patella or ToggleLoc devices.

The patient was last seen at 13 months postoperatively and demonstrated symmetric quadriceps size, mild tenderness at the superior-medial pole of the patella, 0-125° of active knee ROM, 5/5 quadriceps strength and an intact straight leg raise with 4/5 strength to resisted straight leg raise. The patient subsequently received an MRI at 13 months postoperatively as part of a work-up to re-evaluate the repair after the patient reported a fall. The MRI demonstrated an intact repair with no migration of the Toggle Locs or change in position of the patella relative to the joint line when compared to prior radiographs (Figures 8A & 8B).
