Geological and geotechnical evaluation for the stabilization of tail race tunnel outfall slope – a case study of tehri pump storage plant (1000 MW), tehri garhwal (Uttarakhand)

Volume 2 Issue 5 - 2018

Nishith sharma, Rajeev Prasad
Hindustan Construction Company, India

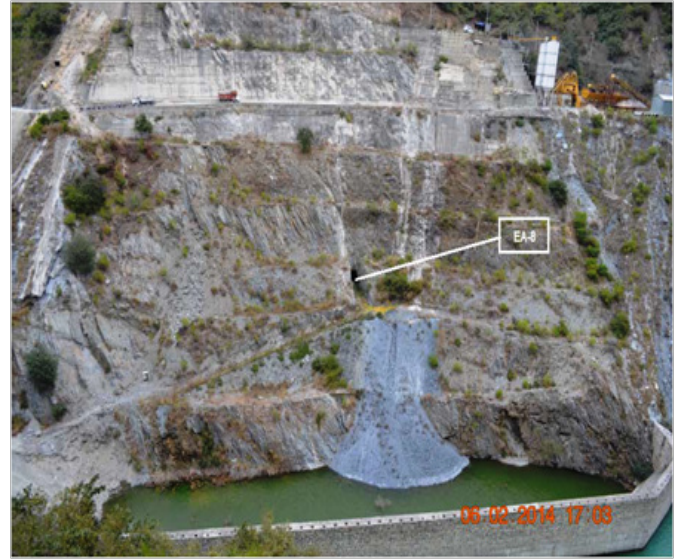
Figure 3 TRT outfall natural slopes (i.e before excavation)

view of these issues detailed surface geological mapping, core drilling at various locations suggested by designers as well as exploratory cross cut drifts(ea-08)³ has been excavated to explore the subsurface geological conditions behind the slope. Based on all above information geological model of slope has been developed. To support the findings a geological plant and sections have been developed using geological information of ea-08 and core logs drilled at various locations in trt outfall area.⁴ In addition to this geotechnical parameters such as ucs and gsi have also been taken using schmidt hammer readings and geological strength index chart⁵ after carried out detailed geological/geotechnical investigations, a methodology was chalk out to strengthened the outfall slope with detail excavation sequence using geological/geotechnical data obtained from monitoring instruments installed at site described briefly in this paper. The typical excavation plan of trt outfall /intake and natural slope are shown in Figure 2 & Figure 3.

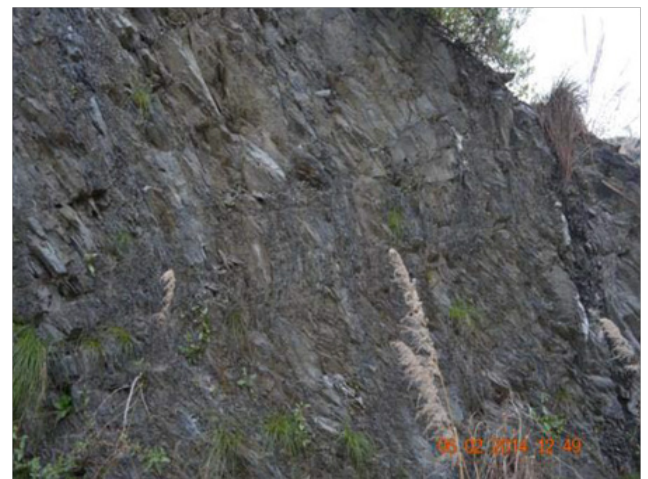
Figure 4 Kink Bands in SP occupied Zone

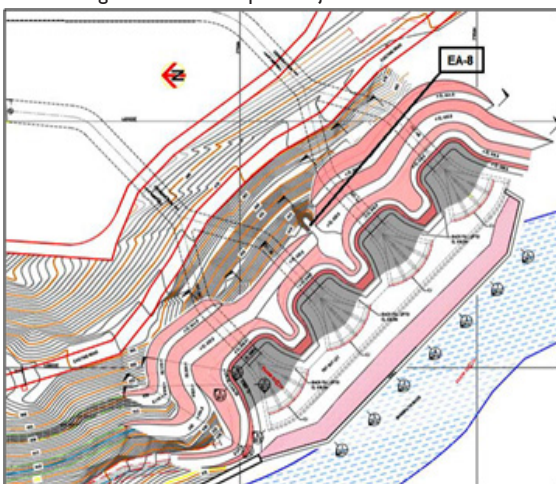
Figure 2 Plan view of TRT outfall cut slopes

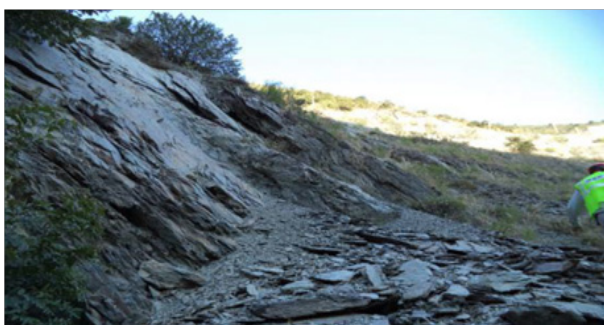
Figure 5 Dip slope about 30-40m upstream of EA-08 portal

set j2:n150°/35°-45°, j3:n20°/60°-65° and j4:n295°/60°-70° other than the foliation joint j1. This foliation joint is represented by smooth and slightly undulating surfaces. Very closely to closely spaced and have persistence and have persistence along strike of 3-10m joint sets j2 and j3 are slightly rough, planar to slightly undulating, closely to widely spaced and have a persistence of generally <10m joint set j4 is rough, planar and discontinuous with persistence of < 3 to 4 m details of discontinuity data observed in trt outfall area mentioned in Table 1. On the nw side of the cutting several shear bands within the phyllites are exposed and these can be traced 20-30m along the slope, but appear to not extend as far as the ea-08 portal area. These shear zones are the major cause of planar/polygonal failure as they are dipping along the direction of cut slope. Some kink bands have been observed in the upstream part of slope which can also be the cause of failure along with other joints as shown in Figure 4. Overburden observed just downstream of trt-4 portal and also towards upstream of trt-3 portal comprises the colluviums limit of rock exposure. The thickness of overburden increases at higher reaches, however in general it has been expected less than 3.0meters in both directions. The present slope is moderately inclined; dipping towards sw direction i.e. N225°. Overall this slope is concave in disposition and the slope is sub-parallel to strike of foliation towards upstream (near ridge i.e. 30-40m upstream of ea-08 portal) and is oblique at an angle of 40°-45° towards downstream (Figure 5).

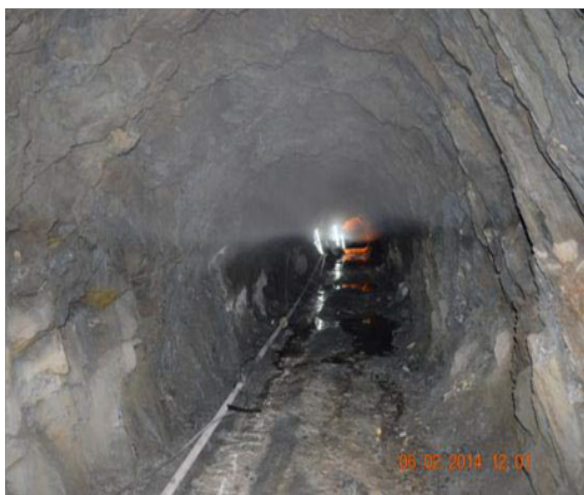
Figure 6 Encountered Rock mass during drifting of EA-08

cross cut at rd:-70.0m was excavated to explore the subsurface geological condition behind the slope. Rock is well exposed throughout the excavated length of tunnel and gives a very good section with varying in lithology (Figure 6), detail of rock type encountered during drifting representing geological mapping with trends of attitude is shown in Figure 7, sp is initially encountered up to 5-7m followed by pqt+ pqm.sp has shearing effects give rise to kink bands. Shear zones are oriented along foliation and having the swelling/pinching in nature. Wet to damp ground water condition observed throughout the drift except one or two location where dripping observed. The rock mass is slightly weathered up to rd:-25.0m where iron staining has been noticed along joint planes particularly in pqt+pqm occupied zones. In the rest portion of drift rock mass has been found to be fresh and devoid of any discoloration. Apart from shear zones encountered, the joints have been found to be tight. No kinking and buckling effects have been found in drift except the sp occupied reach which is the characteristics feature of it.

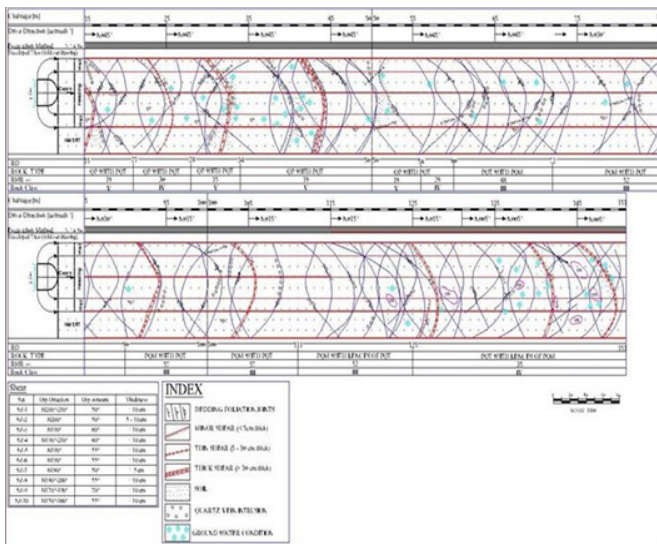
Figure 7 Three Dimensional Geological mapping representing rock type and trends of joints/shears

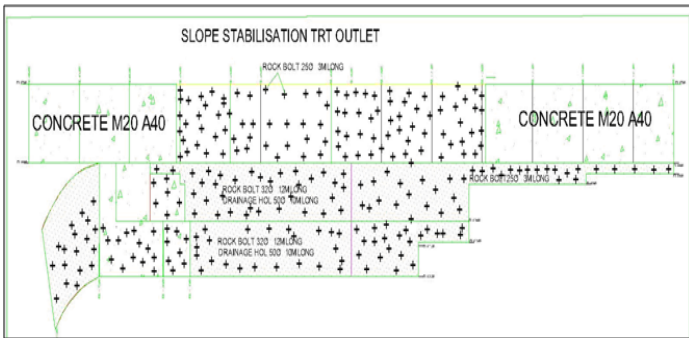
Figure 11 Present Status of TRT outfall slope

Excavation sequence and support system provided as per approved methodology with proper monitoring. Benches are properly monitored and geologically mapped to know the structural behavior of rock mass. Details of support system installed till date is shown in Figure 11. A geological surprise was encountered during excavation in the downstream area from el:-660.0 to 641.0m where rbm (rive borne material) and talus/filled muck were observed. The thickness of this band is± 60.0 m. It was decided to protect this zone by single layer of wire fixed with soil nails along with 100 mm thick dry shotcrete (m25 a10). Self drill anchors (25ø), 3.0m in length with a spacing 1.5m c/c has been provided. Till date support system provided up to el:±652.0m in rbm and el:± 634.0m in rocky strata (Figure 12). On the basis of surface geological map two numbers of sections were developed to know the accuracy of rbm and talus deposit thickness (Figure 13). Designed methodology reviewed and support system recommended for this area is slightly changed .high tensile rolled cable with secondary mesh along 32ø self drill anchor, 12.0 m in length to be provided. Instead of shotcrete, non woven geogreen erosion control blanket for plantation will be used in such type of exposure.^{12,13} The typical tensile strength is more than 7.5 kn/m in machine direction and 1.5 kn/m in cross direction the specified nominal weight of blanket is 600 gm/sqm and thickness is 6 mm. Installation of self drill anchors was not smooth in rbm due to encounter of boulders and pebbles. Further excavation in rbm at el:-646.00m gabions were provided to support the toe. The high tensile cable net will also be anchored through the bottom of gabion walls. Slope is being cut in bench depth of 1:5 with application of simultaneously support system. The soil nails will also be used in excavation to hold the rbm behind the treated area while excavating below the treated portion of rbm for each bench. Excavation is in progress and support system shall be provided based on geological features and geotechnical monitoring.

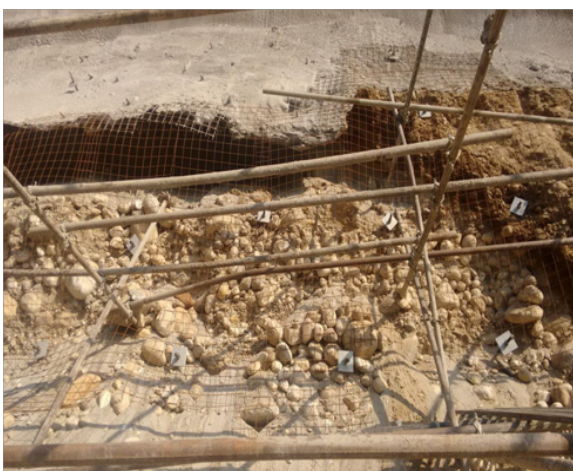
Figure 12 View of RBM & Talus/Filled Muck in TRT Outfall Area
