Hydrosedimentological monitoring in runoff plots of a degraded tropical area under restoration of the Brazilian Atlantic Forest

Abstract

Volume 8 Issue 1 - 2024

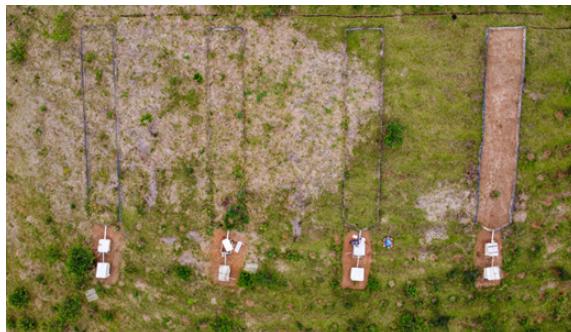
Figure 1 Runoff plots, from left to right: Nature Seedling (P1), Green Manure (P2), Natural Regeneration (P3), and Exposed Soil (P4).

The initial phase of the work involved selecting the installation area for the experimental station within the rural property. Although this area may not represent the location with the highest erosive potential to be monitored, it signifies the region where the Payment for Environmental Services initiative has led to forest restoration practices. Four blocks measuring 25m x 12m were marked in parallel for the construction of four runoff plots, each measuring 22m x 4m x 0.5m. Each plot was built at the center of a block, maintaining a buffer zone of 8 meters between them.

The plots were connected to two sediment catchment tanks, each with a capacity of 1000 liters. The quantification of surface runoff and soil loss was conducted through a linear regression test, involving the gradual emptying of each tank to obtain the equation. Thus, by measuring the height of the collected water layer, the volume of runoff from the sampling area can be determined.

Soil samples were also collected before the start of the operation and at the end of the project. Sampling was carried out at six different points per plot, with two depths each (0-10cm and 10-20cm), both in undisturbed and disturbed conditions Figure 1.

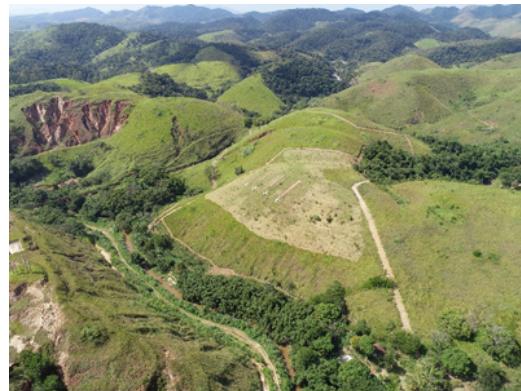
Figure 3 Farm where the plots were installed.

The region's topography is distinguished by undulating hills that have withstood the processes of differential denudation, thereby providing energy to hydrological flows on the slopes and influencing erosive processes related to the headwaters and local base levels. Latosols, cambisols, and compacted and dystrophic argisols define the soil composition of the area, products and results of intemperate alteration of granite and gneiss and some metamorphic rocks related to a particular geotectonical offset of this region. Erosive features, such as gullies and ravines, are prevalent on the slopes, shaping the landscape and contributing to the formation of sedimentary packages Figure 3.
