Morphology of Spearfish Creek, Lawrence County, South Dakota, USA

Abstract

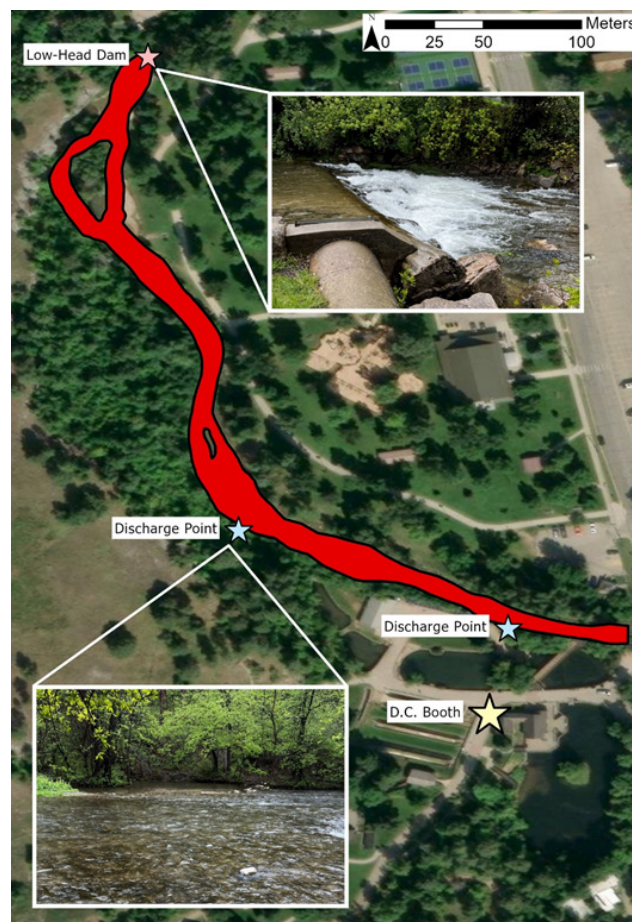
Figure 3 Image of Site 1 (City Park) on Spearfish Creek in the city of Spearfish, South Dakota, USA with points of interest noted.

Site 1 was the southernmost and furthest upstream site. It began at the intersection of the creek and South Canyon Street (44.48145° N, 103.85999° W) and ended with a low-head dam (44.48409° N, 103.8622° W) at the north end of Spearfish City Park. Spearfish City Park runs the length of this reach along on the right bank. The D. C. Booth Historic National Fish Hatchery is located to the south of the creek and discharges into two locations within this reach. Site 1 also included two locations where the creek divided into two channels around small islands (Figure 3).

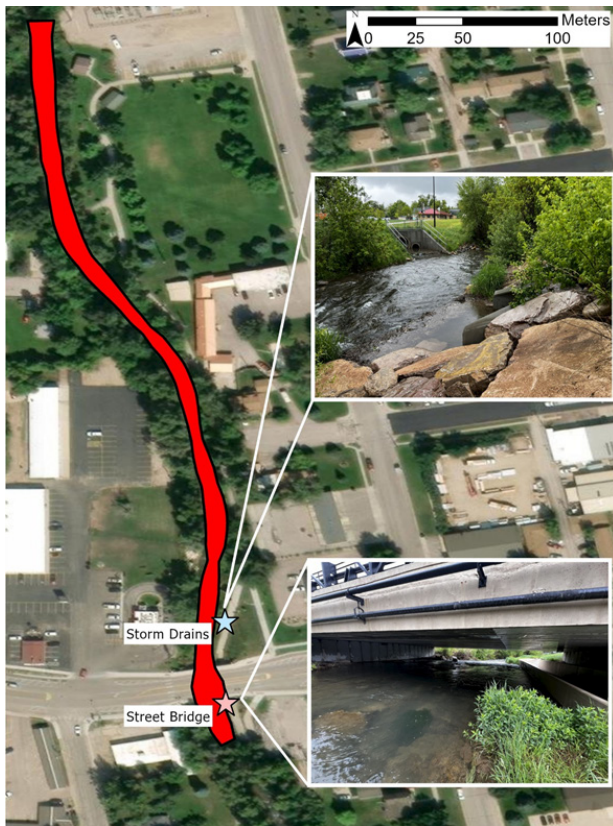
Figure 4 Image of Site 2 (Lions Park) on Spearfish Creek in the city of Spearfish, South Dakota, USA with points of interest noted.

Site 2 began just south (upstream) of the intersection of Spearfish creek and Jackson Boulevard (44.49006° N, 103.86476° W). The reach contained all of Lions Park, ending just after the north end of the park (44.49349° N, 103.86565° W). A recreational path ran along the right bank, nearly through the entire reach. Site 2 contained multiple storm drain discharge points (Figure 4). The banks of the creek in this site were predominantly man-made.

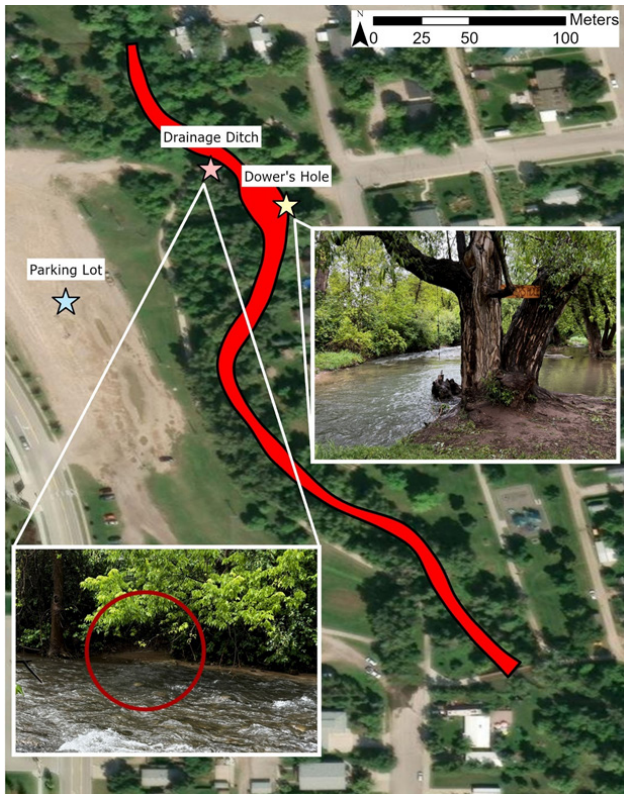
Figure 5 Image of Site 3 (Salem Park) on Spearfish Creek in the city of Spearfish, South Dakota, USA with points of interest noted.

Site 3 began at a pedestrian bridge on the north side of Salem Park (44.49658° N, 103.86675° W). It contained all of Salem Park and ended near Kampus Court (44.49951° N, 103.86854° W). Salem Park is on the right bank on the upstream part of the site. On the other side (left bank) of the creek is a gravel parking lot where erosion created a ditch leading directly to the stream. Dower's Hole, a man-made pool with depths greater than 3 meters, is located towards the south end of this reach. The pool is a popular area for recreation and minor creek bank degradation is visible (Figure 5).

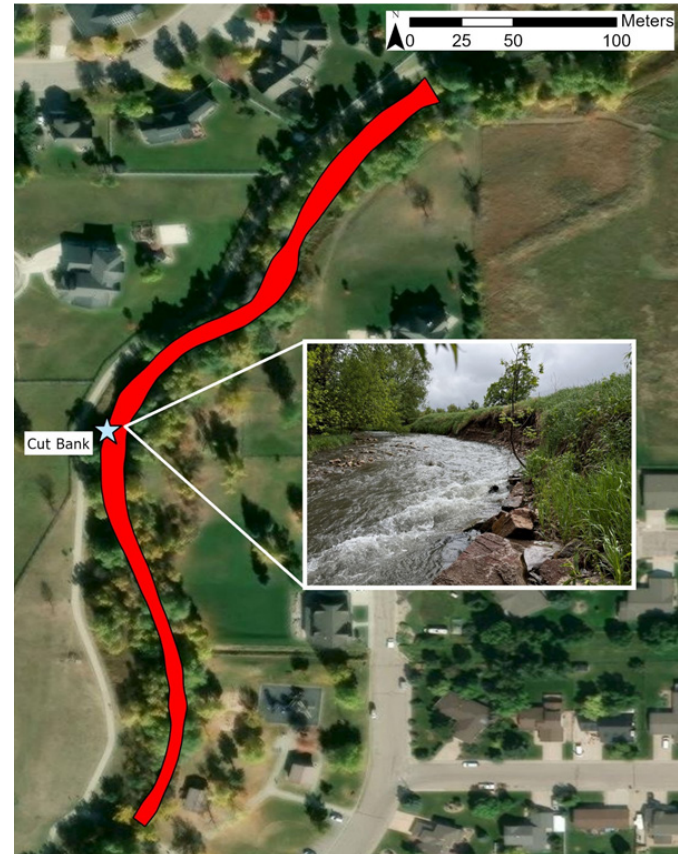
Figure 6 Image of Site 3 (Jorgenson Park) on Spearfish Creek in the city of Spearfish, South Dakota, USA with points of interest noted.

Site 4 was the northernmost and furthest downstream site. It began within Jorgensen Park near a small pedestrian bridge (44.50592° N, 103.86633° W) and extended north of the park to 44.5091° N, 103.86505° W. The upstream half of the reach lay within park boundaries, while the downstream half was influenced by adjacent residential development (Figure 6). A recreational path ran along the left bank of the creek for nearly the entire reach. Table 1 shows the sampling days, along with discharge and gauge height data for the days the sites were sampled from the USGS gage located in Spearfish City Park (United States Geological Survey).²⁵

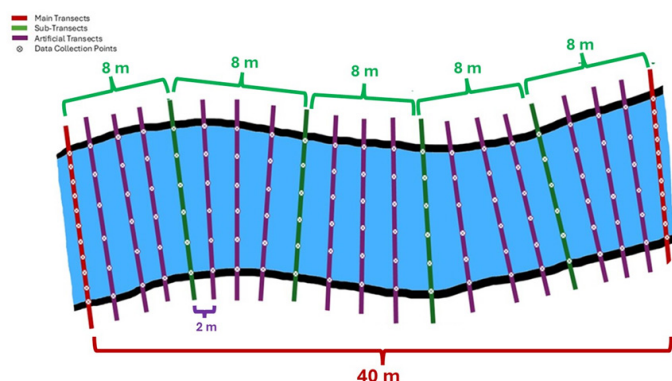
Figure 7 Equally-spaced model of main transects (across 40 m), sub-transects (8 m apart), and artificial (2 m apart) transects with data collection points along each transect (not to scale).

Stream width was measured using a tape with 0 placed on the left bank at the water's edge. Eleven transect data points were equally-spaced across the stream, with one point at either bank and nine equally-spaced points within the water. Henceforth the left bank will be referred to as 0% across the transect and the right referred to as 100%. Six sub-transect points of collection were also equally-spaced with one point at either bank and four equally-placed within the water.

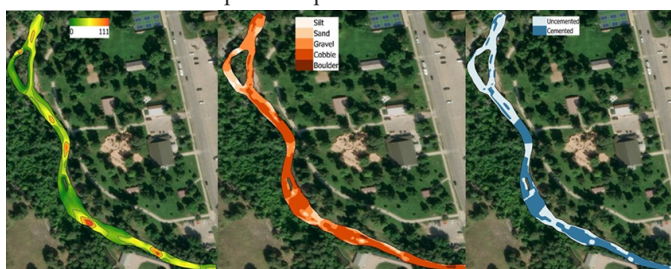
Figure 8 Site 1 bathymetric (left), grain size (center), and cementation (right) maps. Bathymetric chart represents stream depth in cm with contours at an interval of 30 cm.

A bathymetric chart, grain size map, and cementation map for site 1 are shown in Figure 8. The deepest points at this site were located in two pools on the southern end of the reach. The bed form followed a typical trend, with deeper areas in the middle of the stream and graduating to shallower on the banks. This reach also contained two areas where the channel was divided into two. Generally, the grain

size map follows a similar pattern to the depth, graduating for larger sizes in the deeper middle to finer grains along the shallower banks. However, in some areas an inverse of this pattern was observed, with finer grains in the middle and larger sizes along the banks. The cementation map illustrates the positive relationship between cementation and the occurrence of cobble-sized substrate, along with no obvious relationship with depth.

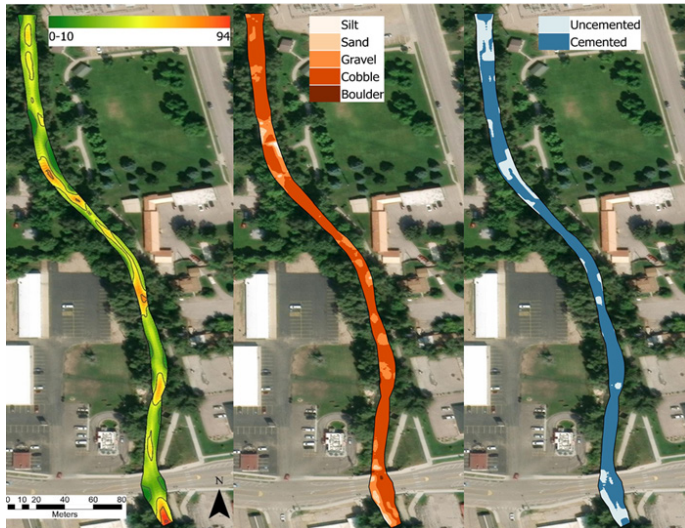
Figure 9 Site 2 bathymetric (left), grain size (center), and cementation (right) maps. Bathymetric chart represents stream depth in cm with contours at an interval of 30 cm.

Similar to site 1, the bathymetric chart for site 2 shows the channel bed is lowest in the middle and graduates upwards to the banks (Figure 9). The grain size map illustrates how this site was dominated by cobble, with only pockets of smaller (gravel-silt) or larger (boulder) grain size within channel bed. The cementation map shows again the positive relationship between cobble-size grains and cementation. Cementation is wide-spread in this cobble-dominated site, with only pockets of uncemented substrate. The bathymetric chart for site 3 indicates a relatively gradual gradient, similar to sites 1 and 2 (Figure

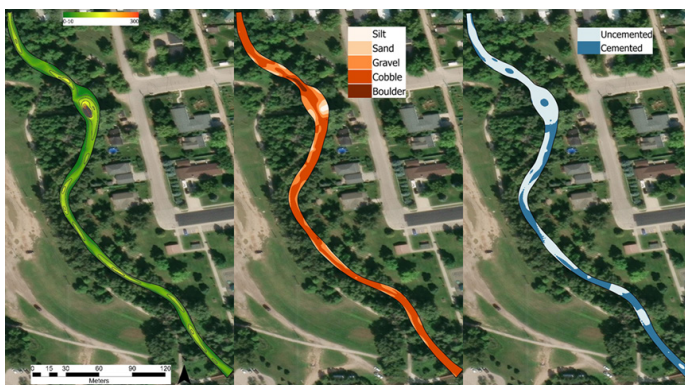
Figure 10 Site 3 bathymetric, grain size, and cementation maps. Bathymetric chart shows values in cm with contours at an interval of 30 cm.

10). Unique to this site is one point 3 m deep in the middle of a stream bend. Cobble dominates in this site and is again associated with high cementation. The bathymetric chart for site 4 shows a depth gradient in the same pattern as the three upstream sites (Figure 11). The grain size patterns are similar to sites 1 and 3, with larger grain size found in the lower areas of the bed channel. However, unlike the other sites, this site is dominated by gravel. There is little cementation, and the cementation that does occur is associated with cobble-sized substrate.

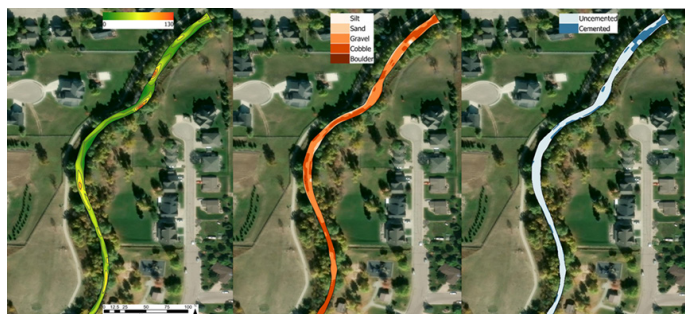
Figure 11 Site 4 bathymetric, grain size, and cementation maps. Bathymetric chart shows values in cm with contours at an interval of 30 cm.
