# Guidelines for the assessment of viable fungal hygiene on indoor surfaces using RODAC petri plates

Volume 7 Issue 5 - 2019

**Cameron L Jones<sup>1,2</sup>**

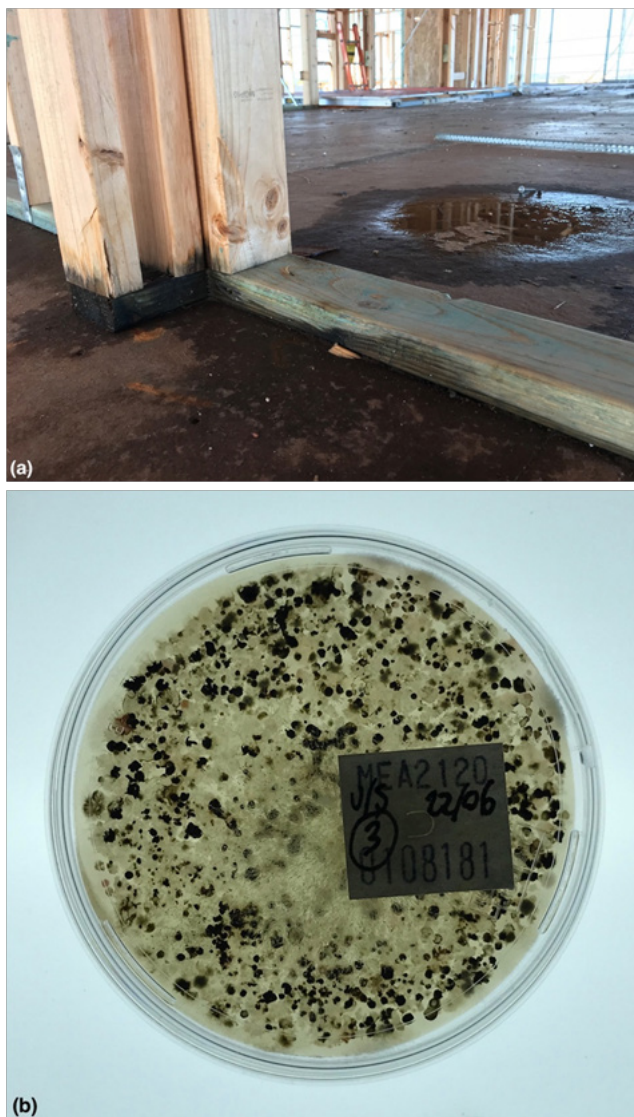
The following examples illustrate in brief some of the diverse applications where surface sampling has been used as part of mould and water damage inspections. The pairs of photos show the region of interest within the building and the viable growth (or not) that developed at culture. I will provide some background context to this information so the reader can appreciate the nature of the foreseeable problems. Figure 1 (A & B) is from a new home construction where the owner was concerned about the rainwater affecting flooring and timber framing due to the fact the roof did not go on in a timely manner during construction. The builder was of the view that the affected materials would naturally dry out and would soon be sheeted over with plasterboard wall linings. The owners were therefore concerned about mould being effectively sealed into their wall cavities and flooring. The destructive impact of fungal lignin and cellulose degrading enzymes causing timber damage is well known.<sup>26,27</sup> Figure

**Figure 1** (A) Timber framing that had become wet during construction and (B) corresponding RODAC petri plate (top side view). Species types included: *Chaetomium*, *Stachybotrys*, *Dreschlera australiensis*, *Aureobasidium pullulans*, *Rhodotorula*, Unidentified yeast, Unidentified fungus, Bacteria, *Candida* sp., *Nigrospora*. The Hygiene rating was assessed overall as: EXTREMELY HIGH (extreme contamination), Hygiene  $\geq 300+$  CFU/Plate + dominant species + confluent growth using the AMG 2010 Guideline and  $>50$  colonies: Heavy (unacceptable), TNTC: Too Numerous to count (unacceptable) using the Purdue University RODAC hygiene rating scale. This is a FAIL result.

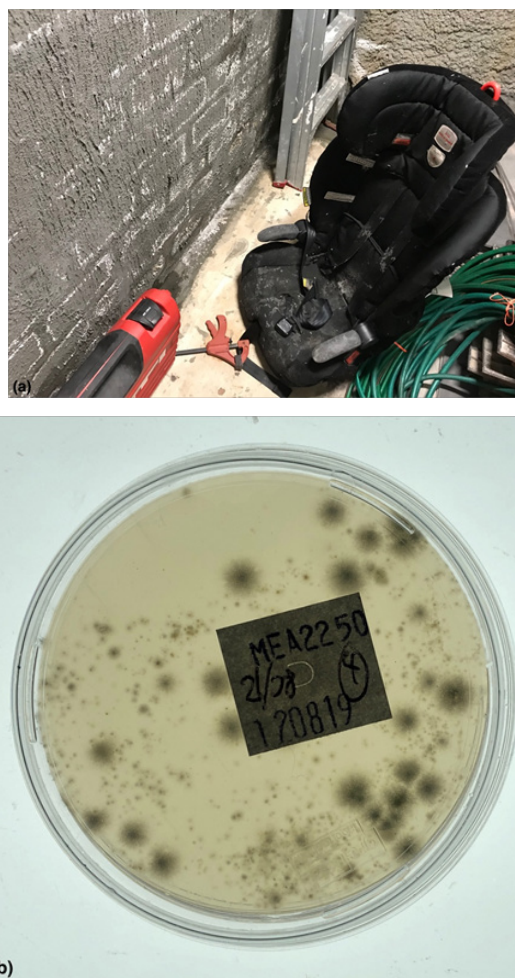
2 (A & B) is from a home where the building warranty was about to expire. The owners had noted that one of their basement rooms was showing severe signs of efflorescence. There was also a strong odour and water could be seen from time to time, leaking through the wall from above. All items of personal property stored in this room showed visible signs of mould. The abutting room was used as an office and the owners were concerned about transfer of mould into that room and sick building syndrome as well as the fact the room showing efflorescence was obviously leaking and a defect. These salt deposits are commonly referred to as efflorescence and are often considered not to be 'alive' and just a 'chemical reaction'. But an important paper<sup>28</sup> by Masaphy et al.<sup>28</sup> confirmed that efflorescence deposits are extensively contaminated with fungi. Growth in controlled experiments further showed that acids released by the growing fungus were responsible for the biodeterioration effects.

**Figure 2** (A) Wall efflorescence that developed in a basement due to defective wall tanking and (B) the corresponding RODAC petri plate (top side view). A single dominant fungus of *Aspergillus fumigatus* was cultured. The Hygiene rating was assessed overall as: HIGH (contaminated), Hygiene  $\geq 60$  CFU/Plate + dominant species using the AMG 2010 Guideline and  $>50$  colonies: Heavy (unacceptable), TNTC: Too numerous to count (unacceptable) using the Purdue University RODAC hygiene rating scale. This is a FAIL result.

The results from Figure 2 were used to demonstrate again to a builder that waterproofing and tanking had failed and that the water ingress was causing mould to grow in this basement room. The tanking was an example of defective work that resulted in a potential health risk which was confirmed by surface hygiene testing of the efflorescence material. Water damage and mould claims under residential or commercial tenancy agreements generally appeal to amenity and health as the basis of contract breach between landlord and occupier. In this situation (Figure 3), the claim by the landlord was that the apartment had just been freshly painted so how could it be mouldy? The claim by the tenant was that the fresh paint concealed a known rising damp problem and that mould was more or less inevitable and could be seen breaking through the fresh paint within the first three weeks of occupancy. The tenant’s case used the surface hygiene results to seek redress as part of a civil claims process. As such the common law rule of *Browne v Dunn* applies where this is implemented as part of the Evidence Act 2008 (Vic). Courtroom practice means that if party A alleges that X occurred as part of its case against party B and party B as part of its case denies X occurred (and that Y occurred instead), then both parties may need to call witnesses to give evidence. The hygiene data then becomes of central importance as factual evidence. In turn, and under cross-examination, either witness needs to comment on the alternative conflicting propositions and that such efforts must demonstrate fairness to the witness, fairness to the party calling the witness and fairness to the court.<sup>57–59</sup>

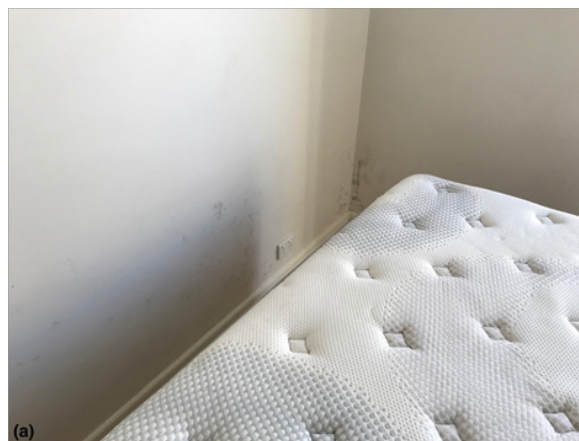
Figure 3 (A & B) is from an apartment which had been freshly painted and the occupant had only moved in 3-weeks prior. In that time, severe mould grew through the bedroom wall and she said her bed felt damp. On inspection, visible mould was found at the rear of the bed abutting the mattress and base as well as on items of furniture. The landlord maintained that the tenant caused the mould, despite clear evidence of rising damp and condensation issues at the apartment complex. Of significance is the common use of concrete render especially common in renovated ageing apartment complexes. Microbial induced concrete corrosion is a well-known example of how biogenic acids damage cement-based construction materials.<sup>29</sup> Figure 4 (A & B) is from a house where there were no obvious signs of water ingress or history of any leaks. The occupants were however experiencing a range of adverse health complaints consistent with mould exposure. The home had many down light fittings and sampling in the roof revealed extensive weathering to the truss and signs of dirt and debris and plant litter and vermin waste. Human exposure to mould likely occurs by convective air currents in the roof void leading to migration into the habitable parts of the home around the perimeters of ceiling cut-outs for the down lights. Roof void condensation is a major problem especially in new homes constructed with tight ventilation. If no overt leak events or building defects are found to be contributing factors, then the likely cause in these situations is roof void condensation.<sup>4,5</sup>

**Figure 3** (A) Tenancy related contents mould exposure causing the edge of mattress to become damp due to rising damp across the wall in a ground floor apartment. The mattress did not show any signs of growth and appeared normal in appearance. (B) The corresponding petri plate (bottom side view). Species types included: *Aspergillus sydowii*, *Aspergillus fumigatus*, *Chaetomium*. The Hygiene rating was assessed overall as: ELEVATED Hygiene = 26-59 CFU/Plate + prevailing species using the AMG 2010 Guideline and Significant (poor) using the Purdue University RODAC hygiene rating scale. This is a FAIL result.

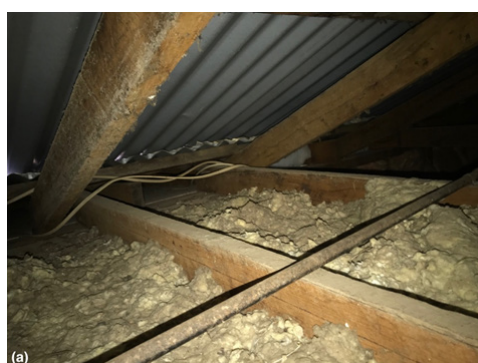
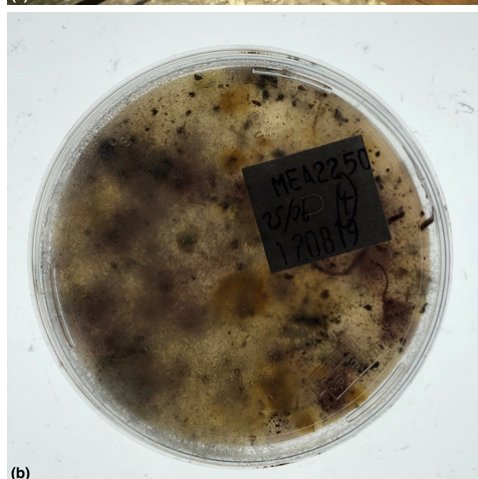
**Figure 4** (A) Roof void insulation contamination caused by active water leaks, condensation, ventilation and vapor related issues and (B) the corresponding petri plate (top side view). Species types included: *Aspergillus niger*, *Aspergillus versicolor*, *Chaetomium*, *Chrysosporium*, *Epicoccum*, *Penicillium chrysogenum*, *Penicillium purpogenum*, *Stachybotrys*, *Syncephalastrum*, Unidentified yeast, Unidentified fungus. The Hygiene rating was assessed overall as: EXTREMELY HIGH (extreme contamination) Hygiene  $\geq 300+$  CFU/Plate + dominant species + confluent growth using the AMG 2010 Guideline and  $>50$  colonies: Heavy (unacceptable), TNTC: Too numerous to count (unacceptable) using the Purdue University RODAC hygiene rating scale. This is a FAIL result.

Similarly, surface hygiene results are often needed to prove to an owner/occupier that their home is potentially toxic. In Figure 4, the owner and his wife had inherited the property by his parents on their wedding. For the last decade his wife had been increasingly ill with a range of unexplained and other respiratory and cognitive complaints. Her medical practitioner had recommended the owners obtain an indoor air quality and mould assessment to determine if the home was a contributing factor. The surface hygiene results provided compelling evidence that resulted in a scope of works for significant strip out of multiple mould-affected regions of the home, including the roof void. Home contents mould contamination is often dismissed as an over-reaction. Often this can be due to a lack of visual evidence or only odour cues. In this circumstance (Figure 5) the surface hygiene results prompted the Insurer to agree to professional contents remediation or replacement with new as required.

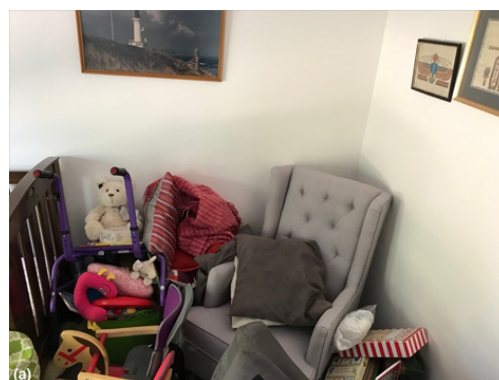
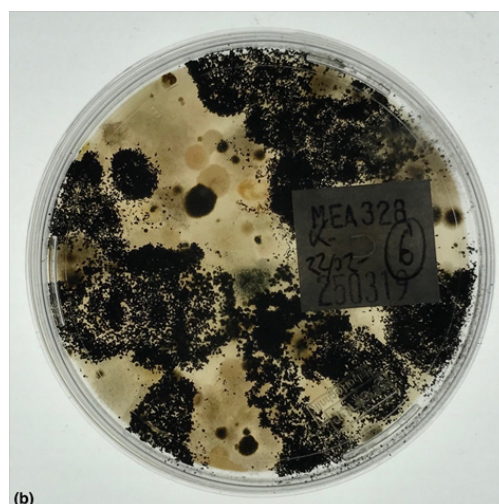
Figure 5 (A & B) shows an example of contents that have been moved from room to room when the Insurance-appointed contractors have first attended following a burst pipe and extensive indoor

flooding. Many months later as the insurance claim started, then stopped for various reasons, the owners became concerned that their daughter who had an immunosuppressive condition was reacting to her toys. From time to time the parents removed toys from the flooded home and took them to their temporary accommodation. Sampling was conducted to confirm or refute if the contents were in fact contaminated which was vigorously denied by the first responders sent in by the Insurer. Environmental exposure to fungi is known to compromise the respiratory tract even during health and create a cycle of inflammation that can create dysbiosis that is perfect for aspergillosis.<sup>30</sup>

**Figure 5** (A) Often during flood damage claims, personal property is moved away from the source of the water ingress. In this example, the owners were concerned that their personal property was damaged by mould since it now "smelt mouldy". A series of RODAC plates were used to sample representative items of personal property and (B) one example is shown (top side view). Species types included: *Aspergillus niger*, *Candida* sp., Unidentified yeast, *Trichoderma*, *Aspergillus nidulans*, *Scedosporium*, *Aspergillus sydowii*, *Aspergillus flavus*, *Penicillium brevicompactum*, *Chaetomium*. The Hygiene rating was assessed overall as: EXTREMELY HIGH (extreme contamination) Hygiene  $\geq 300+$  CFU/Plate + dominant species + confluent growth using the AMG 2010 Guideline and  $>50$  colonies: Heavy (unacceptable), TNTC: Too Numerous to count (unacceptable) using the Purdue University RODAC hygiene rating scale. This is a FAIL result.

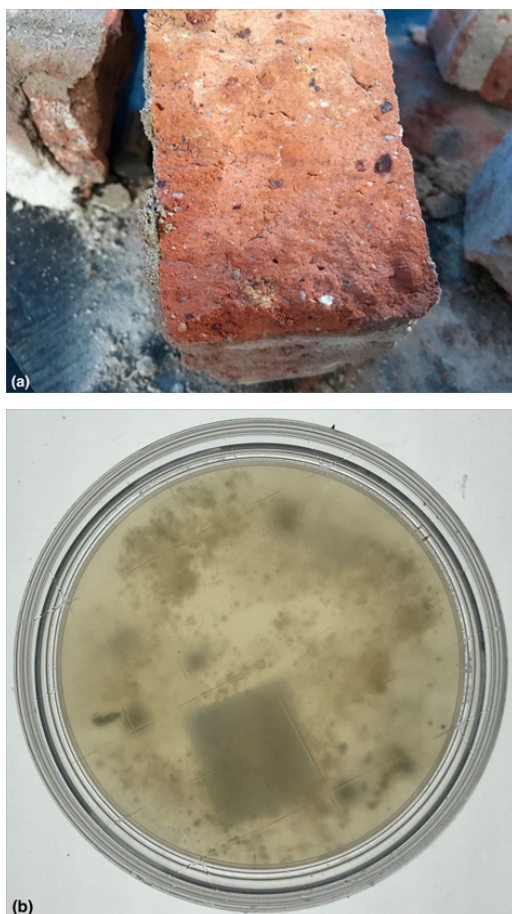
Figure 6 (A & B) shows an example of how viable mould can grow even within brickwork and behind plaster and within a wall. Following a fire, this home became extensively water damaged. The indoor air quality showed high levels of airborne mould. However, one of the key questions was about whether or not the bricks and mortar were contaminated with mould? If mould had gotten into the brick walls across the mortar joints or into the bricks themselves, then remediation would become extraordinarily difficult, if not impossible. There was a contention that there was only superficial mould damage and that remediation to the ceiling, wall and floor linings would be an achievable outcome. The walls were in some areas covered with wallpaper over aged plaster covering double brick walls. Some stakeholders considered that the mould was only affecting the internal wall linings. To determine if this was in fact the case, the internal plaster, mortar joints, bricks, internal brick surface (when broken open) and the void left by the excised bricks were all tested spanning a large and representative sample across the walls of the home. Remarkably, many examples of active and profuse mycelium were discovered

growing deep inside the wall around, into and across the bricks and this was confirmed by culture. This is a fascinating example of fungal biodeterioration and is a practical example of what has only recently been discussed in the literature.<sup>31</sup> For example, Yakovela et al.<sup>32</sup> showed that two fungi, *Aspergillus fumigatus* and *Penicillium brevicompactum* were capable of attacking and colonizing concrete.<sup>32</sup> Concrete is a common component of mortar and used to hold the bricks together. After 28-days there was a loss of calcium content of between 32-41% depending on the extent to which the concrete was wetted. This caused in 1-month a 1% loss in concrete stability. Figure 7 (A & B) shows how the internal cross section of a non-water damaged brick does not show abnormal levels of viable mould by way of comparison with many of the excised bricks that showed active moisture discoloration that was shown to penetrate inside. Figure 8 (A & B) shows two further examples of active fungal colonization of the internal wall when it was dissected from inside-out. Very evident mycelium was found in many areas of wall and this mould was confirmed to be viable using a combination of RODAC and standard petri plates at culture.

**Figure 6** (A) A brick was excised from the wall and cracked open with a single blunt force to its edge. Note the darkening to the left-hand side of the brick showing the moisture gradient that extends inside. (B) The inside surface was then immediately sampled with a RODAC plate (bottom side). Species types included: *Scedosporium*, *Rhizopus*, *Aspergillus sydowii*, *Chaetomium*, *Bacteria*, *Candida* sp., Unidentified fungus, Unidentified yeast, *Penicillium brevicompactum*. Number of colonies (either fungi and/or bacteria) showing evidence of confluence. Therefore, accurate numbers cannot be assessed and is very likely to be much higher than can be measured. The Hygiene rating was assessed overall as: HIGH (contaminated) Hygiene =>60 CFU/Plate + dominant species using the AMG 2010 Guideline and >50 colonies: Heavy (unacceptable), TNTC: Too numerous to count (unacceptable) using the Purdue University RODAC hygiene rating scale. This is a FAIL result.

A common lay assumption is that since bricks and concrete are exposed to the elements that they are inert and don't readily support microbial growth. The issues of biodeterioration are in some cases more extreme depending on context. The examples given in Figures 6-8 demonstrate that mould can grow around, on and inside water-damaged bricks and behind plaster wall render. These surface hygiene results are important for developing appropriate scope of works with regard to which masonry materials can be remediated and those that are unlikely to result in a normal mould ecology after remediation. For example, if a brick is excised from a mouldy wall and the brick itself is found to be mouldy inside, then how can the wall be remediated? Even on a brick-by-brick basis, there is no known method to implement 'source removal' even if localized mould killing could be achieved - the allergen risks would still be present to a greater or lesser extent. Without a foreseeable likelihood of passing post remediation verification, any remediation scope excepting strip out and extensive demolition would be unlikely to return the home to a normal mould ecology. This is the truest practical articulation of 'source removal' for this circumstance. The surface hygiene results were used to explore the various probabilities attached to different remediation scenarios from a risk management perspective.

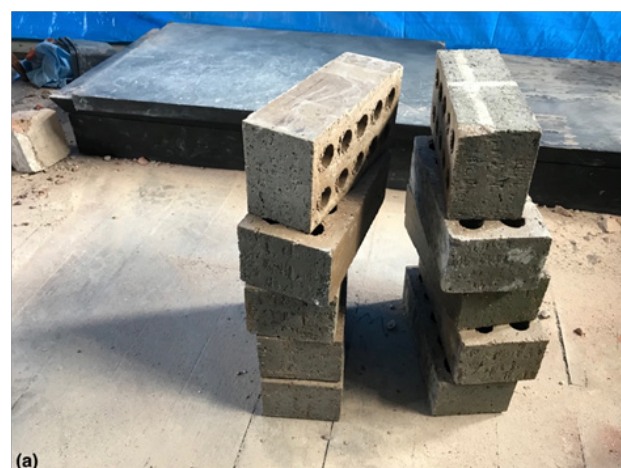
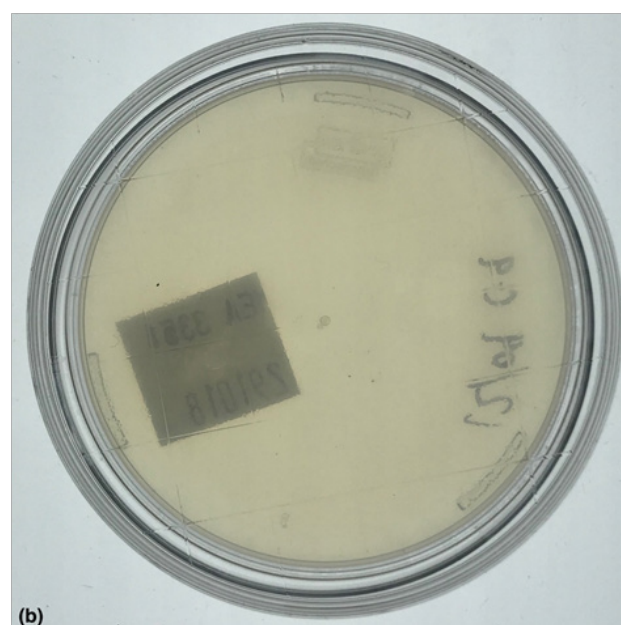
**Figure 7** (A) Bricks that were non-water damaged were used as a control. (B) A typical RODAC plate showed no viable fungi inside after culture (bottom side). Species types included: NIL growth. The Hygiene rating was assessed overall as: LOW Hygiene  $\leq 12$  using the AMG 2010 Guideline and None or very slight colonies (considered excellent) using the Purdue University RODAC hygiene rating scale. This is a PASS result.

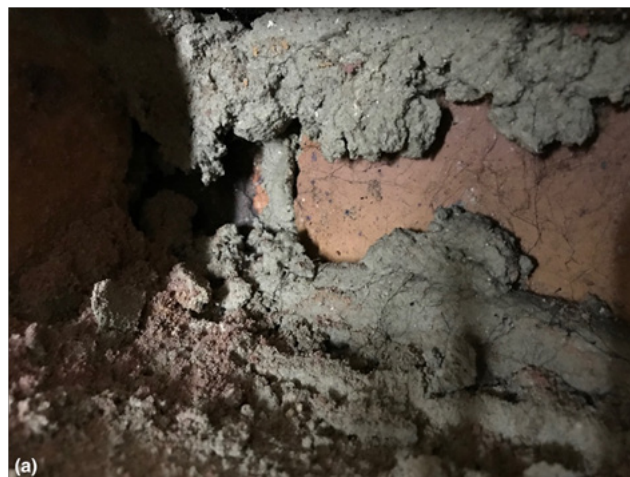
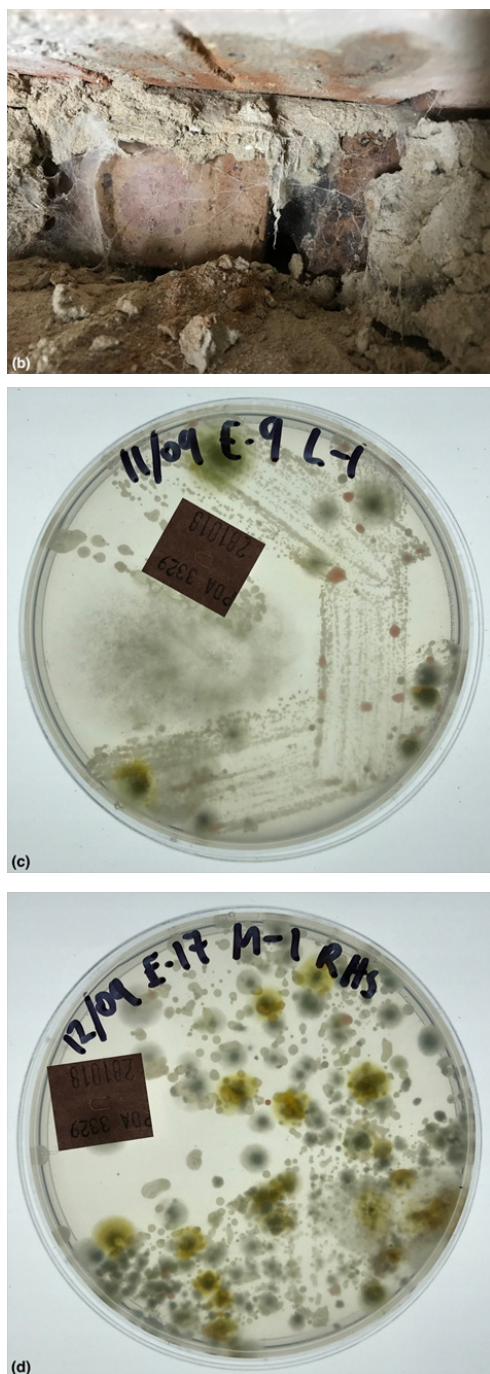
**Figure 8** (A & B) Further examples of fungal infestation inside a wall that was covered with plaster and wallpaper. (C-D) When the wall was cut into, some sections showed very obvious mycelium and could be sampled instead using swab culture to 90mm petri plates. For (C) Species types included: *Trichoderma*, *Scedosporium*, *Penicillium brevicompactum*, *Rhodotorula*, *Epicoccum*, *Penicillium corylophilum*, *Penicillium* sp. (Genus only), Unidentified yeast, Bacteria. Hygiene was assessed as: EXTREMELY HIGH (contaminated) Hygiene = 151-300+ CFU/Plate + dominant species + confluent growth using the revised AMG 2010 but note that a corresponding risk rating cannot be assessed using swabs since no control is possible. This is a FAIL result. For (D) Species types included: *Candida* sp., Unidentified yeast, Bacteria, *Penicillium brevicompactum*, *Aspergillus sydowii*, *Penicillium corylophilum*, *Penicillium crustosum*, *Epicoccum*, *Rhodotorula*. Hygiene was assessed as: HIGH (contaminated) Hygiene = 58-150 CFU/Plate + dominant species using the revised AMG 2010 but note that a corresponding risk rating cannot be assessed using swabs since no control is possible. This is a FAIL result.
