Sinus of Valsalva Fistula

Case Report

Volume 4 Issue 1 - 2015

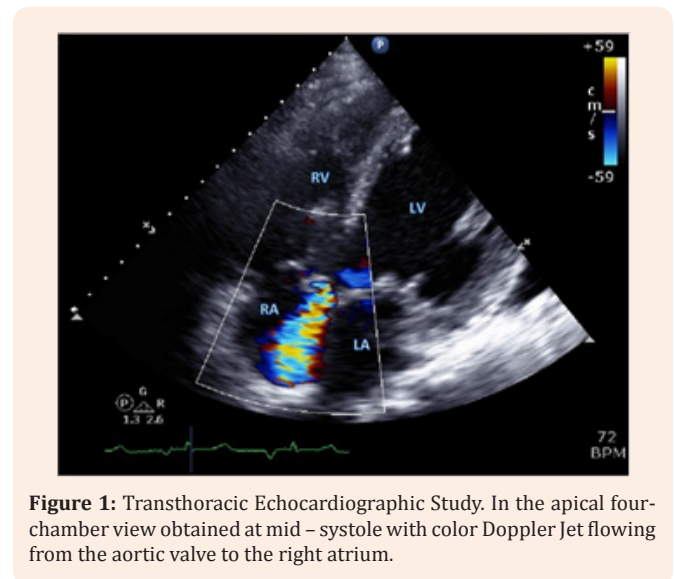
Figure 1: Transthoracic Echocardiographic Study. In the apical four-chamber view obtained at mid-systole with color Doppler Jet flowing from the aortic valve to the right atrium.

RA denotes right atrium, RV right ventricle, LA left atrium and LV left ventricle. RA denotes right atrium, RV right ventricle, LA

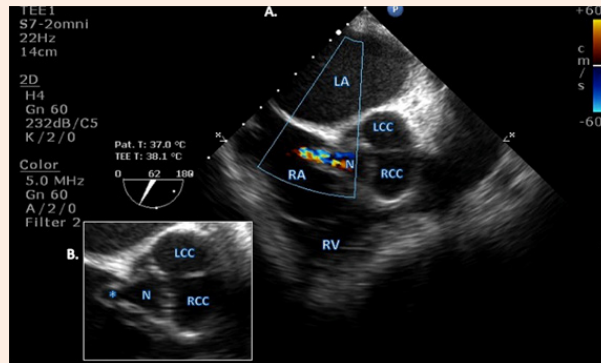
Figure 2: Trans Esophageal Echocardiographic Study. In the short axis view at the level of the aortic valve obtained at early-diastole with color Doppler we could locate the jet flow between the non-coronary cusp and the right atrium. (Panel A). Small magnification of the aortic valve without Doppler color reveals an aneurysm at the sinus of Valsalva of the non-coronary cusp, approximately 10x10 mm in size, marked by asterisk.

left atrium, RCC right coronary cusp, LCC left coronary cusp, N non-coronary cusp and asterisk aneurysm.

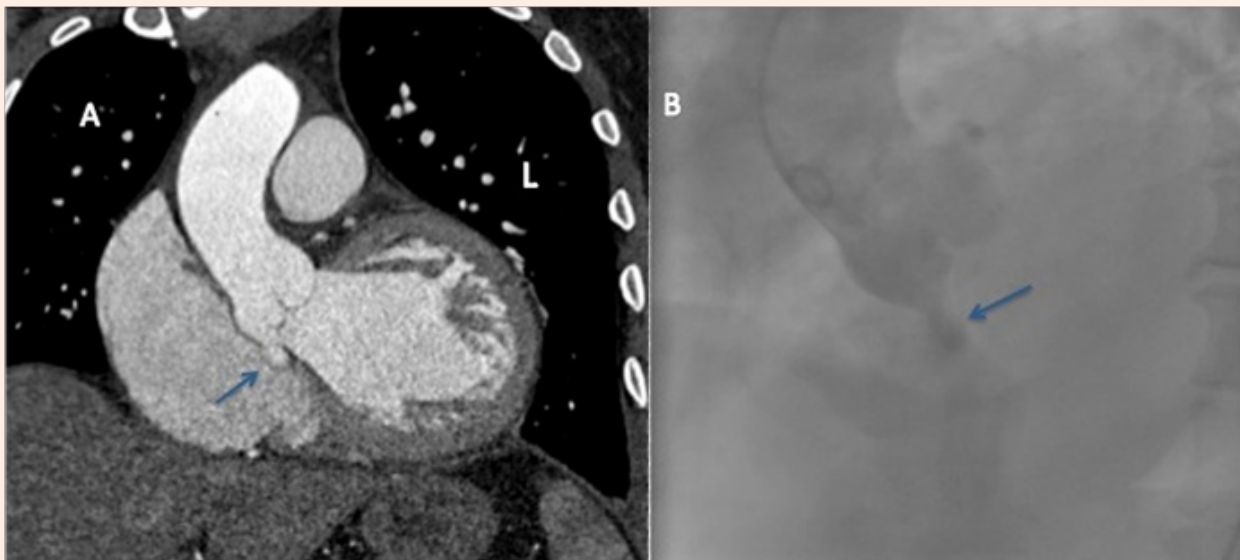
Figure 3: Cardiac CT (Panel A) and Cardiac catheterization (Panel B).

The arrow in panel A points the location of the sinus of Valsalva aneurysm, approximately one cubic centimeter in size. Please note that the color of contrast material is similar in the aorta and the aneurysm, signifying its origin. The arrow in Panel B points to the same structure. The contrast material fills the space and then fades into the chamber.

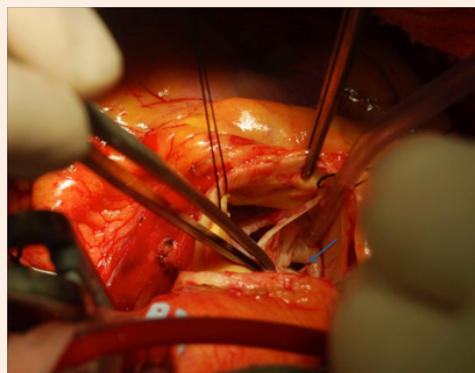
Figure 4: The aorta is cut while the patient is on cardiac bypass machine. The arrow points to the location of the aneurysm and resulting fistula, at the base of the non-coronary cusp of the aortic valve.
