Acute stroke secondary to AICD lead malposition in the left ventricle

Volume 12 Issue 3 - 2019

Ahmad Nawid Latifi, Uzochukwu Ibe, Nasheena Jiwa

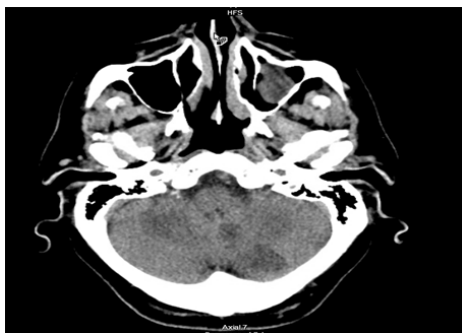
Figure 1 CT of the head showing hypodensity within the left cerebellum.

The next morning, the patient was noted to have a change in his neurological exam. He developed dysarthria and ataxia. A stat CT of the head was ordered and showed a new hypodensity within the left cerebellum and chronic periventricular small vessel ischemic changes. An MRI of the brain showed areas of acute infarction in the left parietal lobe, left occipital lobe and left cerebellum with small areas of hemorrhagic transformation in the left parietal lobe infarct. A subsequent MRA of the neck with Intravenous contrast showed a hypointensity in the visualized left subclavian artery which could represent a contrast mixing artifact or thrombus. The stroke was thought to be embolic in nature given the multiple territories involved. Given the MRA findings, a stat CTA of the neck and chest was done for further evaluation. The imaging studies showed the left ICD lead located in the left subclavian artery extending into the aorta and into the left ventricle of the heart. The patient was started on a heparin

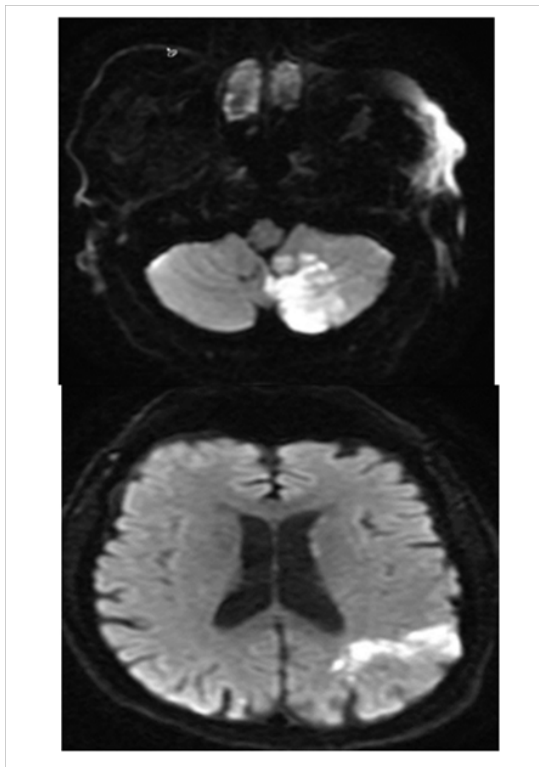
Figure 2 MRI of the brain showing left Cerebellar and left occipital lesions.

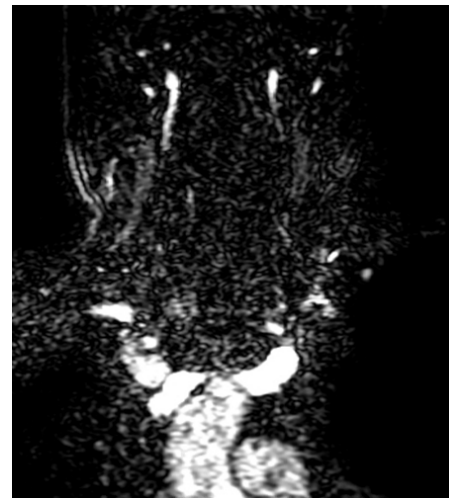
Figure 3 CTA of the neck showing a linear filling defect within the aorta.

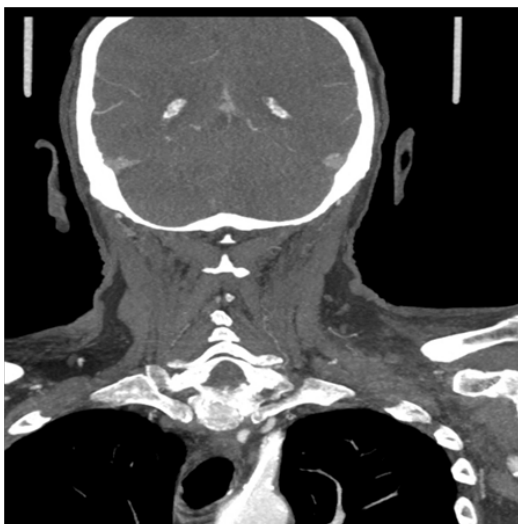
Figure 4 CTA of the neck with IV contrast showing the AICD lead within the aorta.

Management of inadvertent left ventricle lead placement is not well defined. If diagnosed immediately, it is recommended to remove the lead to avoid future thromboembolic complication. Serious complications with percutaneous lead extraction can happen including fatal hemorrhage, pseudoaneurysm formation, arterial dissection or occlusion, and distal embolism.¹³ Sheaths that are advanced over the lead may dislodge thrombi and cause systemic emboli.⁷ Our patient was on heparin drip during the procedure and fortunately, the lead extraction was uneventful. Treatment of malpositioned lead in the left heart diagnosed late includes anticoagulant therapy or lead removal. Lead extraction can be considered and is most appropriate if cardiac surgery has to be performed for other indications. If the malpositioned lead in the left ventricle is not extracted, then lifelong anticoagulant therapy needs to be commenced. Warfarin seems to be effective in primary and secondary prevention of thromboembolic events as antiplatelet therapy as thromboembolism prophylaxis is not recommended.⁷ The role of direct oral anticoagulants (DOAD) in these patients is not known (Figure 4 & Figure 5).

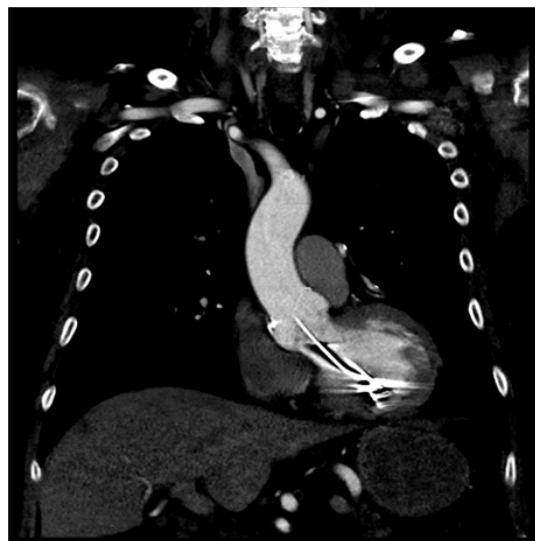
Figure 5 CT of the chest with IV contrast showing the AICD lead within the left ventricle.
