# Higher specialty of fixed and removable prosthodontics

## Case I

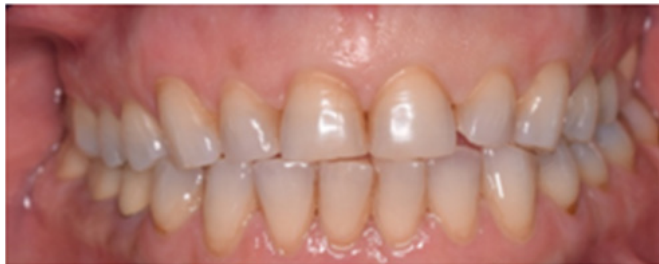
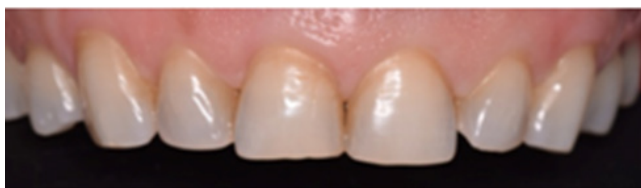
Figure 1

55 years old female presented to the clinic complaining of bad aesthetics in her anterior teeth, patient had general mild attrition, lower mild crowding and abfractions in lower premolars (Figure 1 & 2). Primary impression was taken with alginate (palgat, 3M-Germany) and sent to the lab for diagnostic wax up. Patient was satisfied with the mock up appearance, and wanted to carry on with PLV (porcelain laminate veneers) procedure. A lighter shade was chosen with the patient's contribution. A 0.5 mm supra gingival finish line was prepared for all anterior teeth except for premolars with abfractions, the finish line was extended below the gingival line (Figure 3). No local anesthetic during preparation. An impression was taken using a stock tray with additional silicon putty and wash (elite HD+, Zhermack- Germany). (IPS e.max, Ivoclar vivadent-USA) laminate veneers were made in the laboratory, tried in the patients mouth then sent for sand blast with aluminium oxide of 50 microns (Figure 4). (Rely x veneer cement, Zhermack-Germany) resin cement was used for cementing following the manufacturer's instructions (Figure 5-6). Finishing and polishing were done 3 Days later, then the patient was fitted with a night guard.

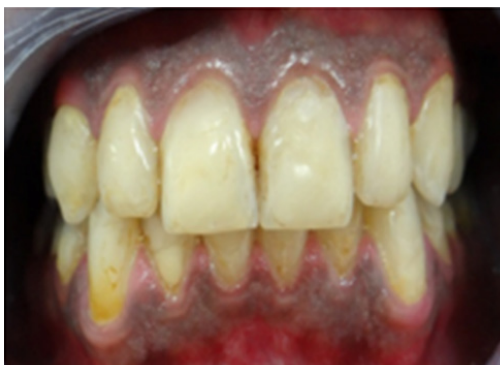
Figure 7

A 24 years old non smoker male presented to the clinic complaining of stained anterior teeth, which he had veneered with composite 1 year ago. Patient has deep bite and class 1 occlusion (Figure 7). Primary alginate impression was taken for diagnostic wax mock up purposes. Patient was satisfied with the mock up appearance of upper six anterior teeth, and wanted to carry on with PLV (porcelain laminate veneers) procedure. Shade was taken with the conventional method plus the digital Vita shade. A diamond chamfer was used to remove the existing composite revealing the underlying enamel, yet in few areas of the upper right central and lateral there were carious lesions which were removed as well and restored with composite, a supra gingival preparation with incisal bevel. Impression was made in a stock tray with additional silicon putty and wash (elite HD+, Zhermack- Germany). (IPS e.max, Ivoclar vivadent-USA) laminate veneers were made in the laboratory, tried in the patients mouth then sent for sand blast with aluminium oxide of 50 microns (Figure 8). (Rely x veneer cement, Zhermack-Germany) resin cement was used for cementing following the manufacturer’s instructions finishing and polishing were done 3 Days later (Figure 9).

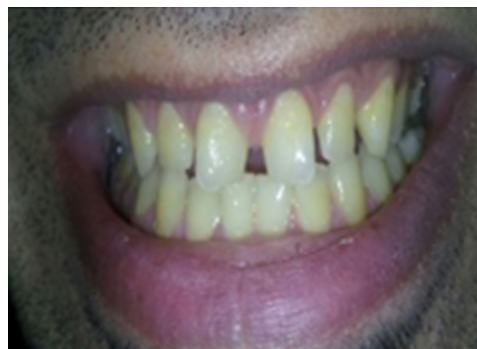
Figure 10

28 year-old male presented to the clinic with spacing in the anterior teeth and rotation in the upper central incisors (Figure 10). Patients was given the option of orthodontic space closing and aligning and refused it due to its time consuming nature and cost. An alginate impression was taken and a diagnostic mock up made and shown to the patient. An index was taken and acrylic resin temporary veneers were made to mark the most protruded part of the centrals (Figure 11 & 12). Patients was satisfied with the appearance and wanted to carry on with the porcelain laminate veneers. An overlap veneer design was made with 0.5 supragingival chamfer finish line, impression was taken with a stock tray with additional silicon putty and wash (elite HD+, Zhermack-Germany) (Figure 13). No local anesthetic agent or retraction cords were used. (IPS e.max, Ivoclar vivadent-USA) laminate veneers were made in the laboratory, tried in the patients mouth then sent for sand blast with aluminium oxide of 50 microns (Figure 14). (Rely x veneer cement, Zhermack-Germany) resin cement was used for cementing following the manufacturer’s instructions. Finishing and polishing were made 7 Days later (Figure 15).
