The challenge of restoring a fractured central incisor: a staged approach

Volume 9 Issue 4 - 2018

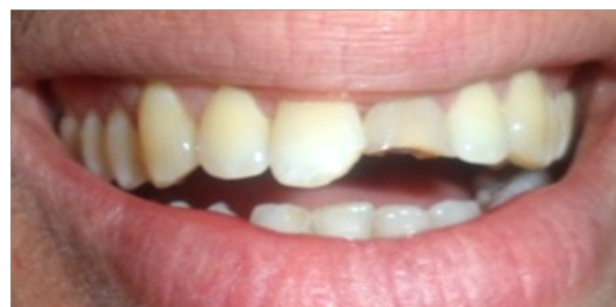
1. The left central incisor was fractured in the middle-third of the crown, involving enamel and dentin fracture with pulp exposure. It was discoloured and the vitality test was negative.
2. The right central incisor was fractured at the mesial incisal angle.

Figure 1 Facial view of initial situation.

We proposed to restore the fractured angle of the 11 with a direct composite resin restoration because of the satisfactory residual volume of coronal tooth structure. In the other hand, the treatment plan of the 21 included intentional root canal treatment followed by a definitive restoration made of metal-free crown. In such a clinical scenario, Zirconia is probably, the best option thanks to its semi-opaque aspect which mimics the adjacent opaque high value teeth. In addition, it helps us to mask the dyschromic aspect of the tooth.

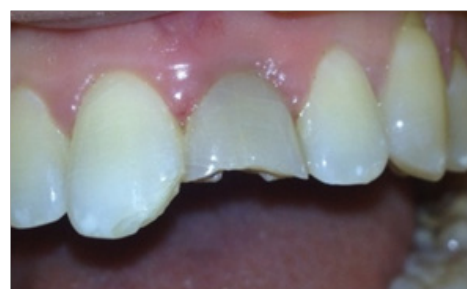
Figure 2 Intra oral views.

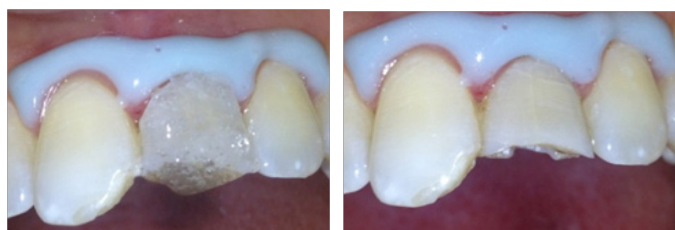
Figure 3 & 4 During end after an internal and an external tooth.

First, the patient was recommended to take up initial periodontal preparation and to intensify oral hygiene before starting the rehabilitation process. Final dental restoration of the 11 using composite resin was performed in the first visit: After cleaning the tooth with pumice and water, hybridization of enamel and dentin was performed using a two-step total-etch system (Adper Single Bond 2; 3MESPE, Sumare, Brazil). A multilayer technique with freehand sculpting was used to build up the restoration (Anatomic stratification technique). An endodontic treatment was realized on the 21 under rubber dam isolation. An internal and an external tooth bleaching were performed in order to decrease the degree of dental discoloration (Figure 3) (Figure 4). There are certain recommendations, which had to be known to realize the preparation of a zirconia -based all ceramic restoration, we had to respect the guidelines of preparation design (no sharp angles, smooth margins ...). The preparation was achieved using flat and tapered diamond bur. Then, a complete arch impression was made with a silicone impression material (HydroC, Detax, Germany) (a combination of heavy -low and light silicon). And, it was transferred to the laboratory to be casted (Figure 5). The shade was determined with a shade guide (Vitapan 3D Master-Vita). The provisional crown was elaborated by isomoulage technique using a silicon index and auto polymerized resin (Texton:SS White, Ce 0473, Prima Dental Group,England) ,it had to be precisely fitting and have highly polished margins. Finally it was cemented with temporary non eugenol cement (Temp Bond:Type I Class 1Ce 0086, Kerr, Italy). In laboratory, the working cast was scanned and framework was manufactured after step of computer-assisted design CAD/CAM indirect technique. Zirconia framework always requires a try-in step to confirm fit, insertion, retention, marginal integrity and mostly the space left for cosmetic ceramic (Fig. 6).Then, ceramic stratification was performed in the lab (Figure 7). A final try-in, of the zirconia ceramic crown was achieved again to verify esthetic, occlusion relationship and marginal integrity (Figure 8). Once validated, the zirconia crown was cemented using adhesive cement.

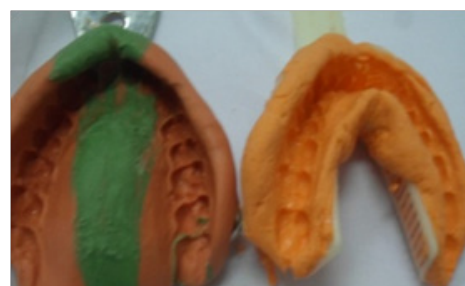
Figure 5 Arch impression.

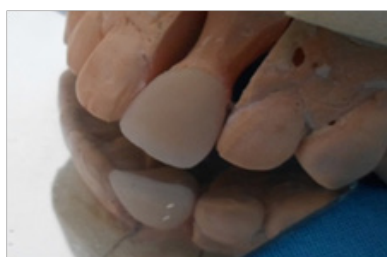
Figure 7 Final restoration.

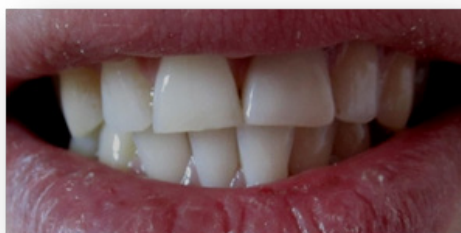
Figure 8 Final result.
