# Re-intervention on a restored fractured central incisor after one year of restoration replacement: from direct to indirect approach

Volume 10 Issue 6 - 2019

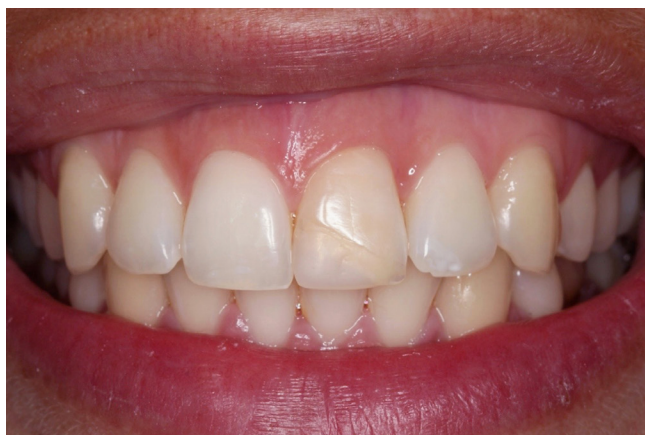
A female patient, twenty years old complaining about the esthetic involving her left maxillary central incisor tooth sought for restorative treatment. A poor marginal adaptation and mismatching color of the resin composite class IV restoration was observed, which was placed

due to a traumatic dental injury, in which part of the enamel and dentin was lost but without tooth vitality impairment. During clinical inspection, it was noticed that this central incisor was darker than the other teeth and the restoration was too translucent (gray expect), with no signals of resin stratification to mask and give naturalness to the restoration (Figure 1). Radiography acquisition was taken and new endodontic tests were performed to ensure that the pulp tooth was still vital. A dystrophic calcification of the pulp chamber was observed, but without any periapical alterations, by the radiography image (Figure 2). The pulpal response was positive to the tests and no pulp necrosis or signs of infection were detected.

Figure 1 Initial aspect of the post-traumatic restored tooth.

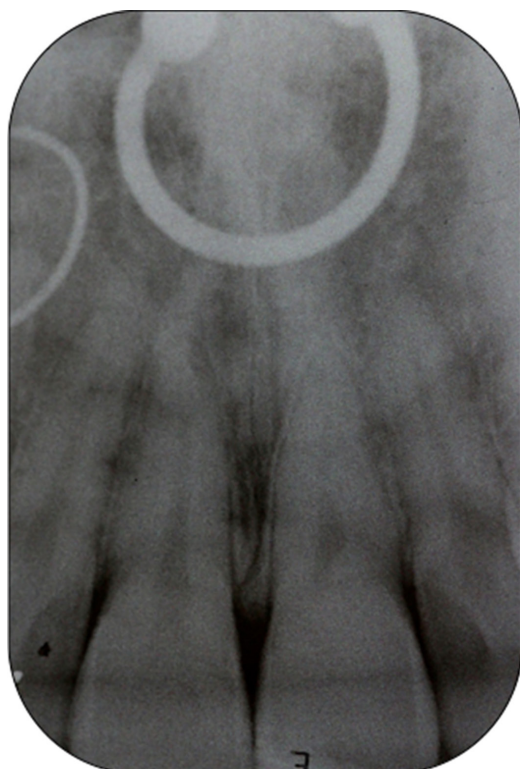
Figure 2 X-ray images.

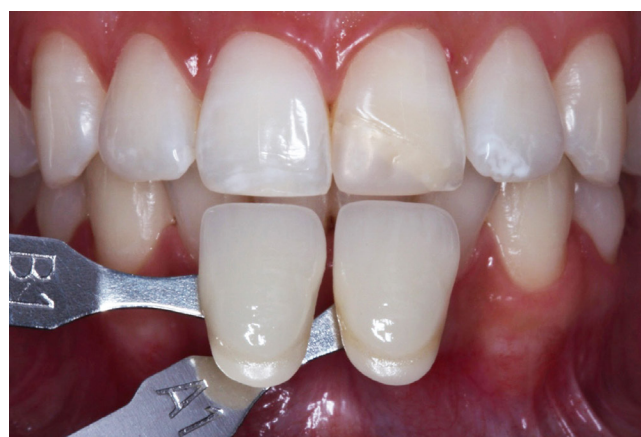
Figure 3 Final teeth color after bleaching procedures.

In attempt to homogenize the teeth color, external tooth bleaching was indicated, and for that, the initial shade (A2) was identified and a home bleaching and an in-office bleaching were used as combined

treatment. The home bleaching (Whitess Perfect 10% –FGM Produtos Odontológicos Ltda.) was carried out for 2 weeks and the in-office bleaching (Polla Office–SDI Limited) was applied twice, in which the first application ranged from second pre-molar to second pre-molar (superior and inferior), and the second time it was applied just on the superior left central incisor and canines. The final shade obtained after these procedures was A1 to the left central incisor and canines, and a lighter shade was obtained for the other teeth (Figure 4).

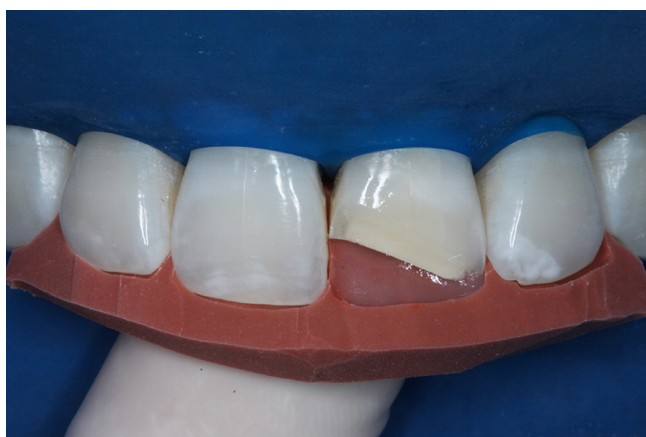
**Figure 4** Barrier placed in position with an increment of resin composite (enamel shade).

The resin restoration was replaced after two weeks, to prevent bleaching sub products to interfere in the bonding process. In order to facilitate the incisal reconstruction, an addition silicon impression material was used to obtain a barrier (Aquasil EasyMix Putty – Dentsply Sirona), coping the initial palatal and incisal anatomy restoration. Thereafter the old restoration was removed with a spherical diamond bur, leaving the margins in enamel, and a bevel was done on all buccal surface, obtaining a small area with enamel in progressive depth to disguise the restoration margin (class IV). Restorations with margins in enamel are preferred to those with margins in dentin, due to greater bonding mechanism to enamel. All the restoration steps were done using rubber dam isolation to control saliva contamination and to avoid deglutition of restorative waste. Following the restoration procedure, the tooth was etched with 37% phosphoric acid for 30s in enamel and 15s in dentin and, after the acid gel rinsing (30s) and dentin moist control with absorbent paper, a single bottle adhesive (etch-and-rise: Gluma Confort Bond - Heraeus Kulzer) was applied twice with gentle air blow to evaporate the water and organic solvent. The adhesive was then light-cured using Radii-Cal (SDI Limited – Radiant exposure: 17 J/cm<sup>2</sup>). The light tip was placed as close as possible to the restoration to achieve an adequate degree of conversion of the resin material.

Four resin composite shades were utilized to reconstruct the incisal (Estelite Omega–Tokuyama Dental), matching the dentin, enamel, the incisal white halo and the translucence area. A thin layer of enamel resin shade (EB1) was placed at the silicon template, in the same area to be reconstructed, and this set of barrier and resin was adapted to the teeth and light-cured (Figure 4). After that, the dentin resin shade (DA2) was placed on top of this first increment and the dental mamelons were carved to give a natural aspect for restoration. The white halo was obtained placing a line of white shade resin (BL1) to the very end of the incisal portion, and to obtain translucence in this

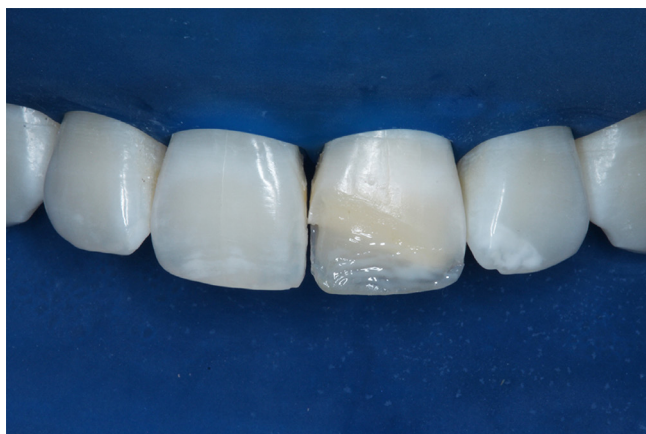
**Figure 5** Resin composite restorations with incisal white halo and white pigment to mimic the white spots.

area, a translucent shade (Trans) was placed covering the area between the white shade and the dentin shade. To mimic the white spots found at the homologous central tooth, a white pigment (GC Corporation) was placed over the translucent resin reproducing the white lines observed in the homolog tooth (Figure 5). Covering all shades used, another thin layer of enamel resin composite was placed to finalize the restoration stratification. Each increment was light-cured separately with the same light-curing unit and its tip was positioned as close as possible to the increment. After removing the rubber dam, the occlusal contact was verified and the finishing and polishing was performed following these steps: excess removal with multi-blade tungsten bur and interproximal resin sandpaper, polished with enhance (Dentsply Sirona), extra thin Sof-Lex (3M), silicon carbide (Ivoclar Vivadent) and a diamond paste (Poli I and II - Kota) with felt (Kota).

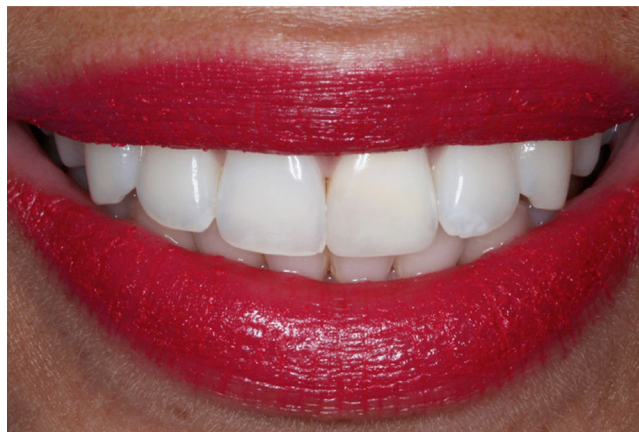
**Figure 6** final smile aspects after teeth hydration.

The appearance of the restoration right after the polishing procedure is shown on Figure 6. The patient was glad with the final result although a thin yellow dark line was still present. However, after one year of follow up, the patient returned presenting recurrent staining of the traumatized central incisor, which was darker than the resin restoration and the margin was more evident than the beginning, not matching the resin shade with the tooth color anymore Figure 7. For this reason, the patient agreed on removing the composite restoration and replacing it with an indirect restoration to avoid the

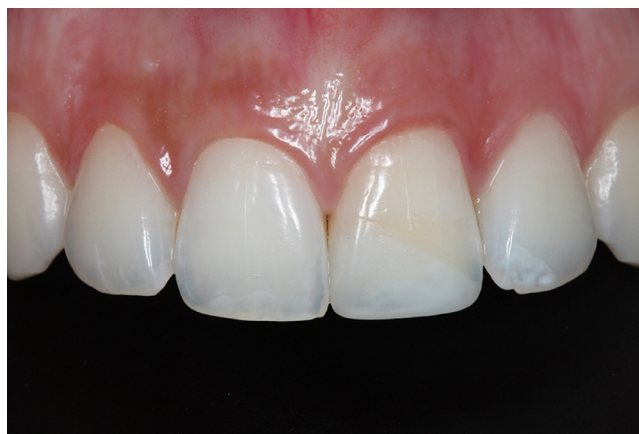
**Figure 7** Resin restorations after one year of replacement.

recurrent bleaching treatment that would be required periodically. Ceramic veneer would achieve the desired esthetic, due to the better characterization and coverage of the fracture margin, which now would be placed near the gingival area.

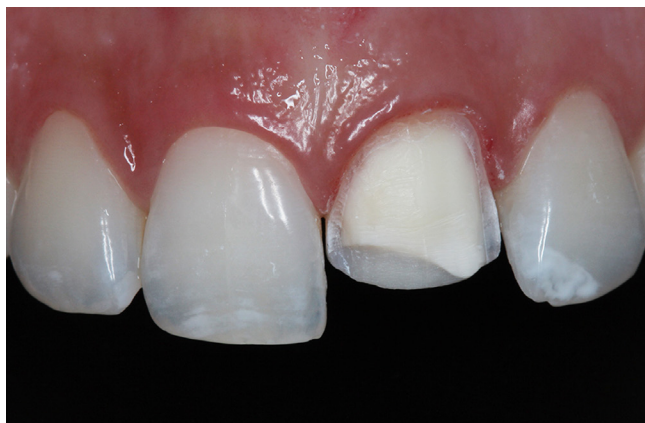
**Figure 8** Tooth preparations for indirect restoration.

A ceramic veneer preparation was performed maintaining margins mostly in enamel, and conserving part of the composite restoration, which was partially kept to give better palatal support (Figure 8). The amount of removed hard tissue was verified with a silicon barrier (obtained from the wax-up) to check if the thickness of the ceramic material would be able cover the discolored tooth. The prepared tooth and adjacent teeth were molded with addition silicon impression material (3M), using two dental retracting cords (Ultrapak–Ultradent Products Inc.) at the aim tooth, #000 over #00. Only the #00 cord was removed before the molding. The retraction cord facilitates the gingival finish lines molding. A resin composite provisional restoration was then temporary cemented.

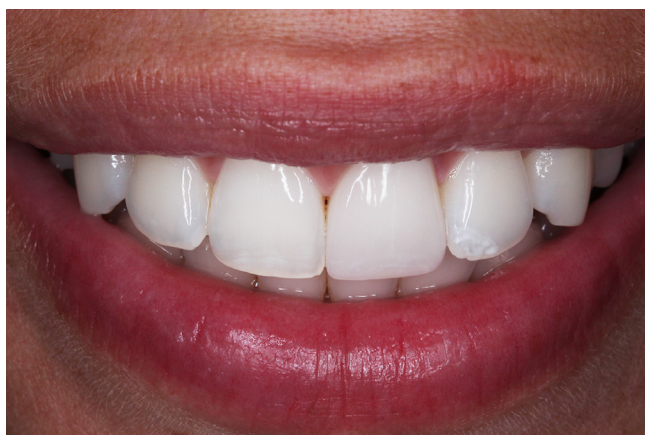
**Figure 9** indirect restorations after cementation.

Following the cementation steps, the resin cement Rely-X Veneer (TR color–3M) was applied over the adhesive-coated tooth and the ceramic veneer was placed in position with hand-pressure. The excess of resin cement was removed using a resin spatula and just than the hole set was light cured (34 J/cm<sup>2</sup> at each surface). The final result was again approved by the patient and fulfilled the function and esthetic goals (Figure 9). After 4 years of cementation, the ceramic veneer does not show any signal of discoloration or cracks, and the gingival margin has a healthy aspect with no gingival recession (Figure 10).

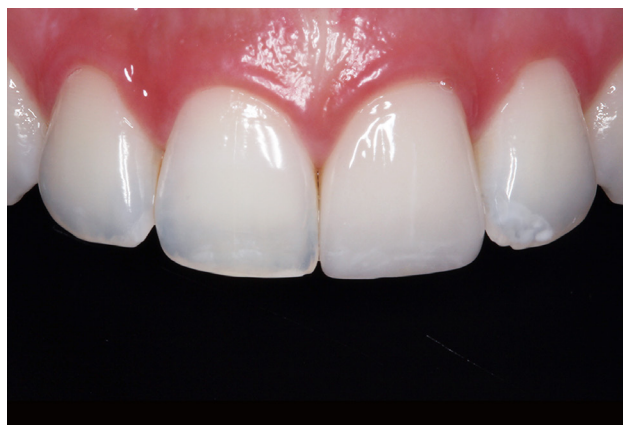
**Figure 10** indirect restorations after 4 years of cementation.
