Success tips for renewing fractured ceramic veneer on central incisor

This clinical report describes how to achieve a successful rebonding of a debonded porcelain veneer successfully using several procedures such as grinding enamel to eliminate the remaining adhesive from the first bonding and ultrasonic treatment of the veneer's surface. Care is given the bonding protocol in order to optimize the durability of the interface.

Volume 13 Issue 1 - 2022

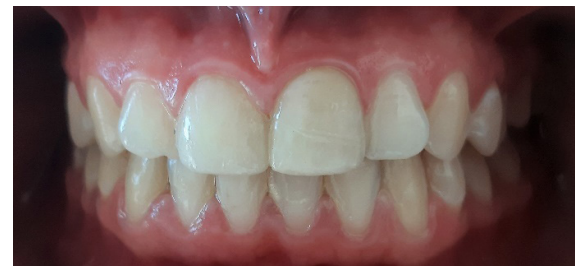
A healthy 23-year-old woman presented to our department with fractured veneer on the left central incisor 21. Clinical examination

revealed a static fracture, the remainder of the veneer still remains intact on the tooth. According to the patient fracture occurred while she was eating a sandwich and since then teeth has become sensitive.

Figure 1 Intraoral front view (fractured fragment temporary cemented).

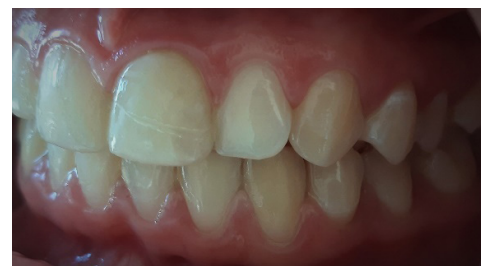
Figure 2 Intraoral lateral view.

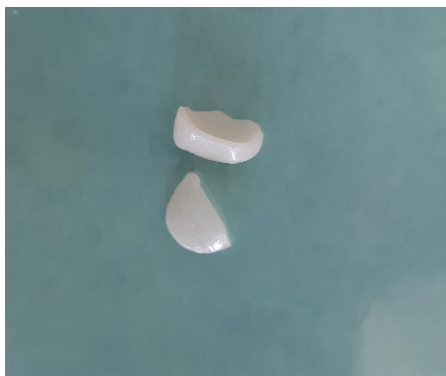
Figure 3 Fractured veneer.

Then, debonding was performed using ultrasonic devices, the 2 fragments of fractured veneers were retrieved (Figure 3). After that, the enamel was grinded to eliminate the underlying layer of previously treated enamel (mechanically) using diamond burs (Figure 4) and chemically using pumice polishing powder (Figure 5).

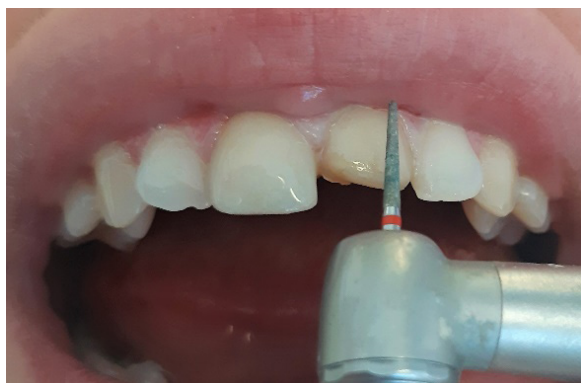
Figure 4 Grinding enamel using diamant burse.

When rebonding porcelain veneer, the properties of the underlying layer of previously treated enamel can affect the rebonding strength. Probably, the surface of the enamel can contain adhesive remains even after removing all visible adhesive. The remaining adhesive can decrease the roughness of the enamel surface and therefore reduce also the rebonding strength. It has been reported that reetching does not remove this residual adhesive, so another method should be employed. Literature has shown that grinding enamel refreshes the surface for rebonding and improves bonding's properties.¹⁵

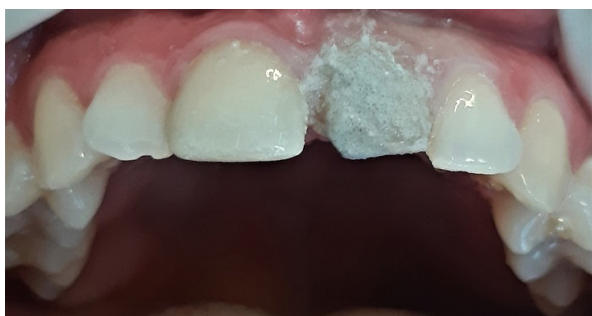
Figure 5 Grinding enamel using pumice powder.

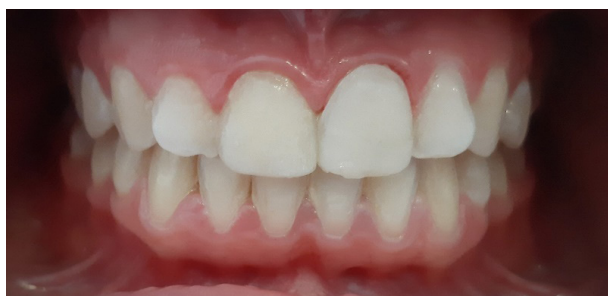
Figure 6 Temporary restoration.

Consequently, final impression was made using light-body and heavy-body consistency polyvinylsiloxane (Virtual 380, Ivoclar Vivadent, Amherst, NY, USA) as well as temporary restoration using self-cured temporary composite material (Structur Premium, VOCO GmbH, Cuxhaven, Germany) (Figure 6). The following appointment, before bonding, the restorations were evaluated in terms of adaptation (Figure 7).

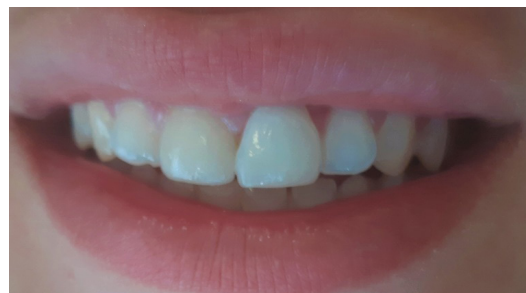
Figure 7 Fitting session.

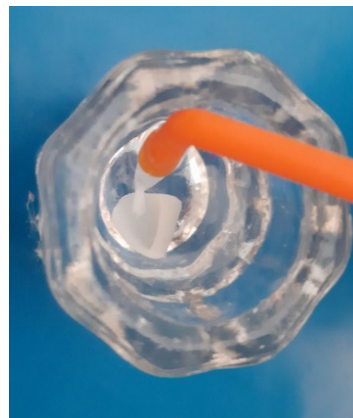
Figure 8 Immersing the restoration into alcohol.

The color of the adhesive cement was selected using a try in cement (Variolink II, Ivoclar Vivadent). Cementation of the restoration was performed using the appropriate cement color (color A1). Firstly, the try-in was removed, washing it under running water, and, subsequently, 10% hydrofluoric acid was applied (Ceramic Etching Gel, Ivoclar) for 60 seconds. The sample was then rinsed thoroughly, then the restoration was immersed into 95% alcohol for 4 minutes (Figure 8). Consequently, silane (Monobond-Ivoclar) was applied for 60 seconds (Figure 9a & 9b). An operating field was then set, the tooth surface was first treated with 32% phosphoric acid gel (Condac, FGM) for 30 seconds (Figure 9 c), then rinsed, and dried. The adhesive system (Syntac-ivoclar) was applied for 30 seconds (Figure 9 d). The light color cement (Variolink Esthetic LC, Ivoclar Vivadent) was applied to the restoration which was placed onto the tooth (Figure 9 e). Excess cement was removed with a micro brush and using a floss in the interproximal surfaces before light curing for 20 seconds on the facial surface. Finally, a glycerin layer (Liquid Strip, Ivoclar Vivadent) was applied between the union piece and tooth, and resin cement was light cured for another 20 seconds, aiming at blocking the oxygen entrance (Figure 10a & 10b).

After acid etching the surface is rinsed and dried. However SEM studies (scanning electron microscopy) showed that, even after the etched surface is rinsed with copious amounts of water, a great number of acid crystals will stay deposited on the etched surface that may affect the bond strength. In order to eliminate this, the veneers should be placed into the ultrasonic cleaner. All residual acid and dissolved debris can be removed from the etched surface with an ultrasonic cleaning in 95% alcohol for 4 minutes, or acetone or distilled water.

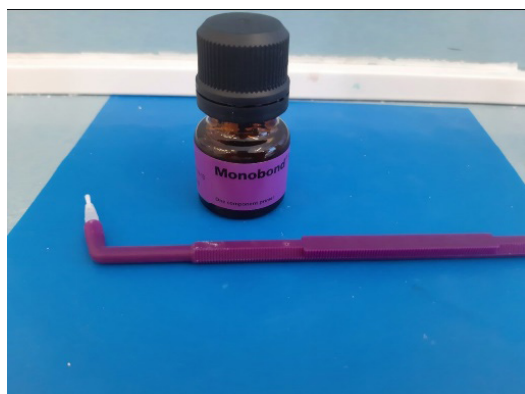
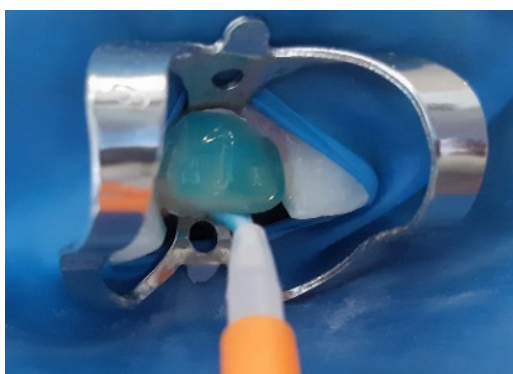
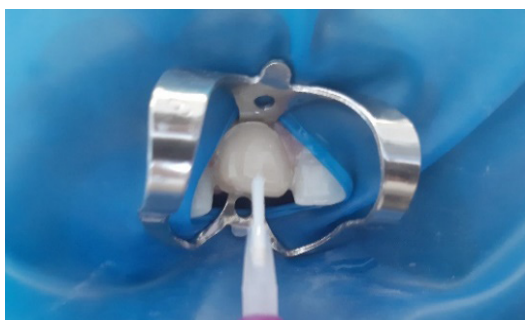
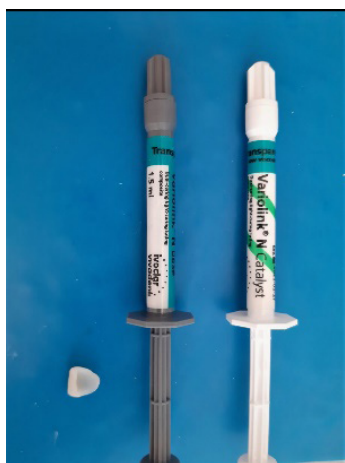
Figure 9 Bonding protocol.

Figure 9a Silane application.

Figure 9b Silane.

Figure 9c Etching.

Figure 9d Adhesive application.

Figure 9e The cement.

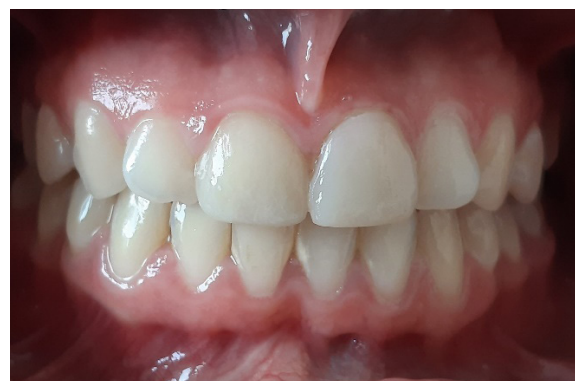
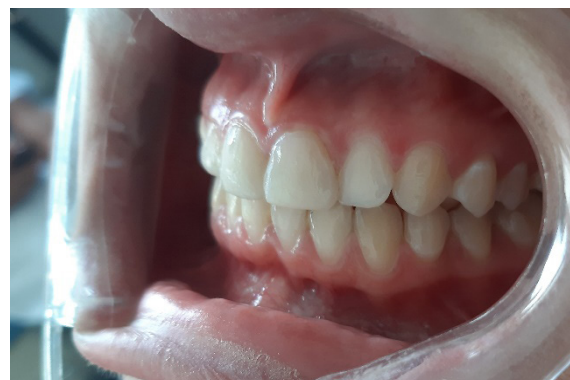
Figure 10 Final result.

Figure 10a Front view.

Figure 10b Lateral view.
