# Proposal studies of using eco-protection for the highway embankment side slope erosion in Sudan by applying native vegetation

**Altaeb Mohammed, Xu Wennian, Xia Zhenyao, Dig Yu**

College of Civil Engineering &amp; Architecture, China Three Gorges University, China

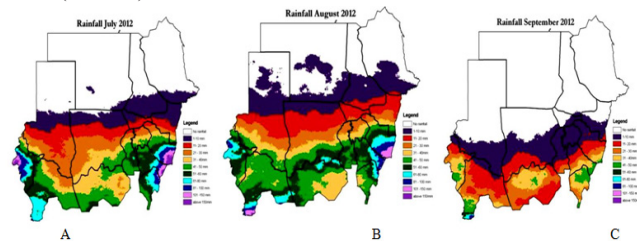
Figure 2 Monthly Rainfall amounts in June, July, August, and September.

According to the Meteorological Authority annually in Gezira State, the average of rainfall intensity is 350mm and the humidity percentage is 180- 70% and decreases during the dry season reach 32-18% the annual average high temperature is 36.5° and the annual average minimum temperature is 20.6°.<sup>6</sup> Rainfall commenced earlier this season in the southern part of Sudan, with high amounts across the western states during May, associated with below average rainfall and drier conditions in most parts of central and eastern states. Consistence rainfall started in June in most parts of the country with good rainfall amounts. Rainfall reached the northern part of Sudan as a consequence of the northward movement of the humid air masses During May and early June. Suitable early planting conditions were favourable during late May and early June in the southern areas<sup>5</sup> (Figure 2).

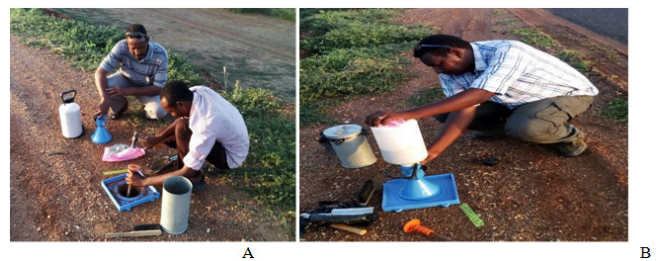
Figure 3 Preparing and Doing for Field Density Test.

They most types of Al Gezira soil are alkaline - clay soil as in (Figure 3), and for studying the slope, soil Geotechnical properties, they are many experiments conducted as:

A soil fertility test evaluates the nutrient-supplying power of a soil. The results of the test are used to predict if, or how much fertilizer is required for optimum plant growth. Soil tests as civil engineering requirement. Some soil tests were done on the site and in laboratories, the (Soil Density) done on site using the method of replacing and cone on the compacted gravel layers in road shoulders. Soil samples were taken to the Wad Medani Technological College (WMTC) laboratories to test the (Moisture Content) of the site soil.<sup>7</sup> Also, the samples of road base and sub-base (Upper Gravel layers) to check these two layers graduation (Sieves Analysis) for the road.<sup>7</sup> All experiments have been done in Wad Medani Technological College (WMTC) in Civil Engineering Department laboratories and in Gezira University College of Agricultural Science laboratories. In the suite test of road is the soil field density, done by using (sand replacement method) according to the American Society for Testing Materials (ASTM 1992ao).<sup>8</sup> Sieve analysis for determining the graduation of upper layers (gravel layers base and sub-base) of road pavements. (Figure 4) The sieve analysis did because to ensure the homogeneity of gravel materials and to know the situation of the upper pavement compaction of the road.

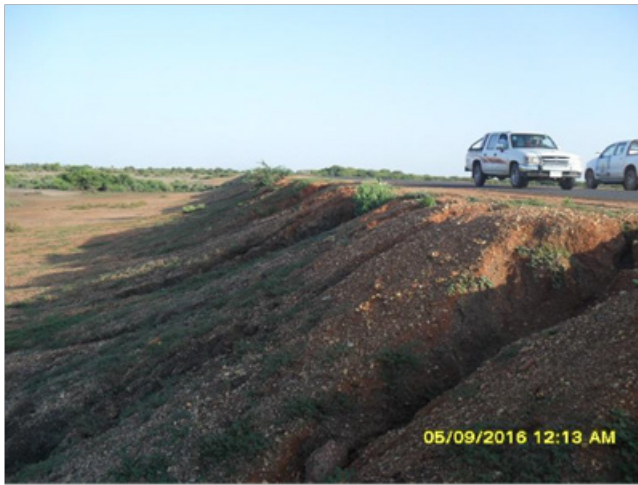
Figure 7 Picture shows the eroded side slopes of National Road.

Engineering measures of the eroded roadside slope and Surveying measures. The study measured the eroded area on the road slope by surveying measures, the effective slope area, and the length of most eroded 350m as shown in (Figure 7) and the cross section in (Figure 8). Two cross section shows the height and the slope angles. This done after studying the nature of side and is mentioned before the climate and microclimate. And study and surveying measures of national road side slope as in (Figure 9) showed how the degree of the eroded soil. During the autumn season the shoulders of the road are very dangerous, and there are no side ditch channels to discharges the surface water coming from rainfall. And these cause the side slope erosion for the road (Figure 10).

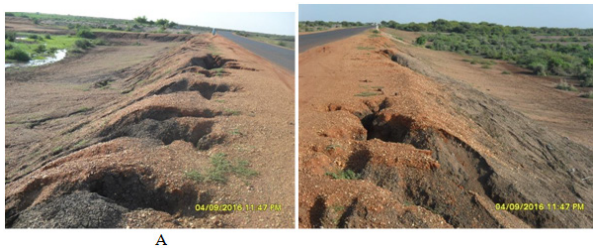
Figure 8 Pictures show the degree of eroded slope along National road.

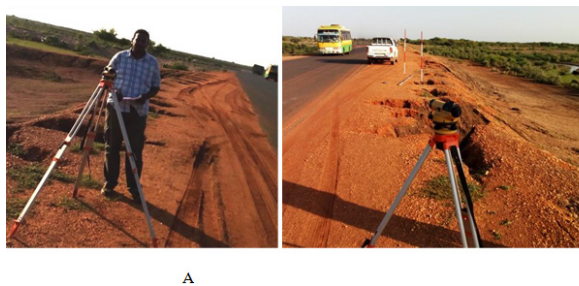
Figure 9 Surveying & Engineering measures Studies showing the eroded section of the Road.

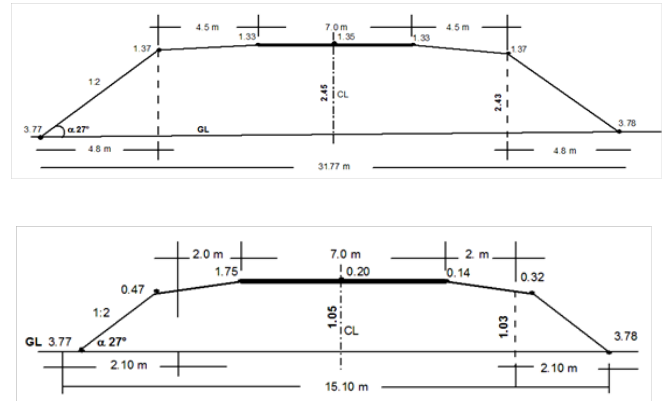
Figure 10 National Road tow cross- sections.

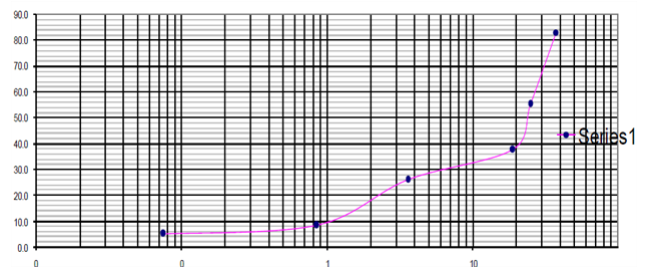
Figure 11 Grain Size - Distribution.

Sieves Opening (mm) & Passing Diagram.

- The soil of the upper gravel layers, is not well graded, according to the sieve analysis showed a gap gradation. And makes a poor soil compaction.
- The road does not have side ditch to discharge surface water.
- No any type of slope protection as slope Mechanical protection.

is stated of soil experiments and soil data supported by all tables and figures (Table 3) (Table 4). Present the experiment results which done at Wad Medani Technical College (WMTC) (Figure 11).

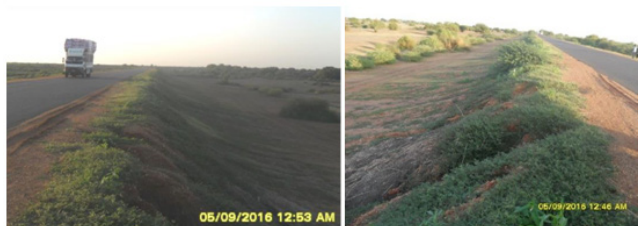
**Figure 12** Existing natural local grass and (Mesquite) plant covered part of National Road side slope.

The local grass and small bushes around the road are the grass belonged to Poaceae family it called in Sudan (Nigella) Cynodon Dactylon, transvaalin sis, and some kinds of Cyperuses as Cyperus focus and Cyperus Capitates (Figure 12). And the small bushes call in

English (Mesquite) scientific name is (Prosopis) and it covers a wide area in the Gezira state, which has the ability to stabilize the soil any it can grow in the areas have a lack of rain as shown below:

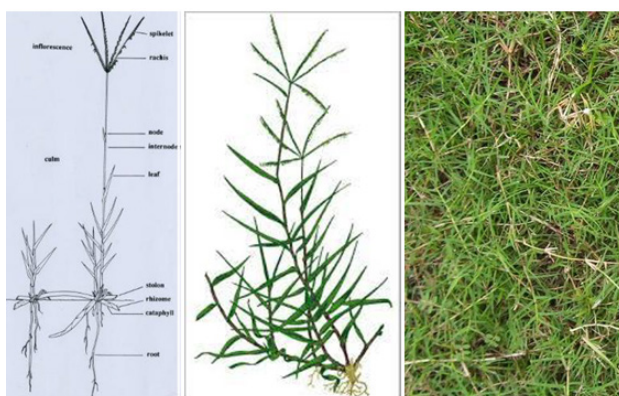
**Figure 13** Cynodon Dactylon.

The original home of the Cynodon Dactylon is tropical regions of Africa, in the zone of p the main weeds in crops of (Aldrua, sugar cane and many other cops), and in many of countries have registered Cynodon Dactylon as a problem in 40 agricultural crop land. In spite of this, some trains are very useful these plants graze cattle. Some of it can use to prevent soil erosion, and others give a wonderful promoter of sports as hiking of golf.<sup>15</sup> So it is better to use Cynodon Dactylon and mixing with other plants and grasses in the Eco-protection of the Road from erosion. It is adopted with a broad range of soil types from sandy to heavy clay, although it would preferred modules and heavy soil moist and rain. Also, it grows in alkaline soil and acidic alike and can withstand flooding and drought conditions. But it also grows in arid areas along waterways and in areas water rights. In Srilanka as an example, it cultivated on the edge of ponds to help bind the soil around it. And near Roosevelt Dam, in Arizona at the USA, it stands at the high floods, water and it can stand like that for a whole year. Soil testing to determine the chemical components to know fertility of the soil on site, so it's helpful to know the types of grass family and plants that can use in future to slope ecological protection in the high embankment of the road. This chemical soil test did in the Gezira University–college of agricultural sciences and water resources (Figure 13). From collaborating with teachers from Gezira University we discussed the possibilities of using vegetation (plants and grass family) according to soil fertility, knowing the existing natural plant grasses in the site, determining the suitable Poaceae as Cynodon Dactylon is also known as Vfastella.<sup>15</sup>

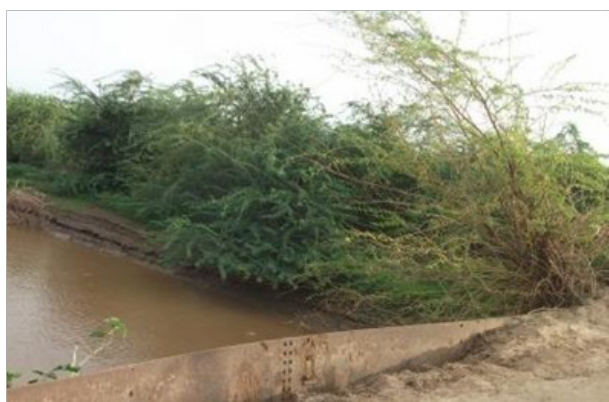
**Figure 14** Prosopis (mesquite) in black rain area, and beside irrigation channel in Gezira scheme.

Prosopis (mesquite) is a tropical and subtropical tree and shrub, mainly found in the arid and semi-arid regions of the world.<sup>16</sup> The introduction of Mesquite into the Sudan Mesquite was introduced into the Sudan in 1917 by the government botanist E. Massey. The purpose was to find exotic fast growing tree species resistant to drought and grazing, have value for the conservation of ecological balance, the source of fuelwood and fodder and other economic values (Figure 14). The first plants were planted in a small agricultural research farm on the outskirts of Khartoum. Field trials were made in 1928 outside the city where the results were not very promising, but in the same trial Prosopis proved successful on the sands under rainfall not exceeding 150mm per annum.<sup>9</sup> Mesquite contributes to environmental stability

through stabilization of sand dunes, hedging, windbreaks, shelterbelts around villages and agricultural schemes. Mesquite as *Prosopis* can use in the areas with shortages of rainfall, Mesquite is an integral part of the desert ecosystem in both North and South America.<sup>17</sup> Also, they are many studies of evaluating mesquite and its adaptation to the environment, according to global climate changes, and states the effects of Mesquite in agricultural areas in Sudan.<sup>18</sup> The study expects to use Mesquite plants because of its ability to stabilize soil and it can plant in the place of lack rainfall. Even Mesquite trees can drought tolerance and grow well in full to reflected sun as well as in partial shade.<sup>19</sup> This study can continue by doing other extension researchers focusing on the same purpose of the paper research area, and also special studies of design seeds and plant species (vegetation on the slope covering) for using in highway embankment slope protection as Biotechnology slope protection.<sup>20-22</sup>
