# Statistical quantification of Zanjan City structures based on FEMA 154

**Keywords:** urban vulnerability assessment, building defects, visual rapid inspection, Zanjan City

Volume 3 Issue 2 - 2017

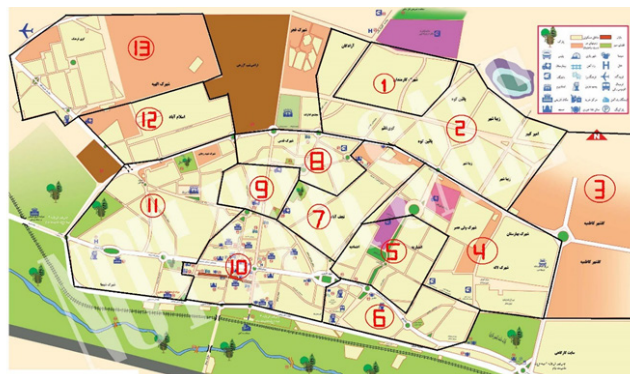
Figure 2 Different regions of the city of Zanjan.

In this study, the mentioned vulnerability level estimation procedures could be utilized for any city in general. In order to better evaluate the seismic vulnerability of Zanjan's buildings, some of the buildings throughout the city were randomly chosen. To be consistent through the sampling, the city of Zanjan was divided into 13 regions in which each region has relatively the same economic, social, and cultural characteristics as well as relatively the same construction year. Figure 2 represents the city divided into 13 regions. Table 1 summarizes the characteristics of each region, i.e. the number of the chosen buildings, the general characteristic, and the general types of the buildings, and a rough estimate of the construction year. Randomly selected buildings in each region were evaluated regarding both the level of seismic vulnerability as well as the type of the defects. In the following section, an example of a safe building and an example of a vulnerable building are represented.

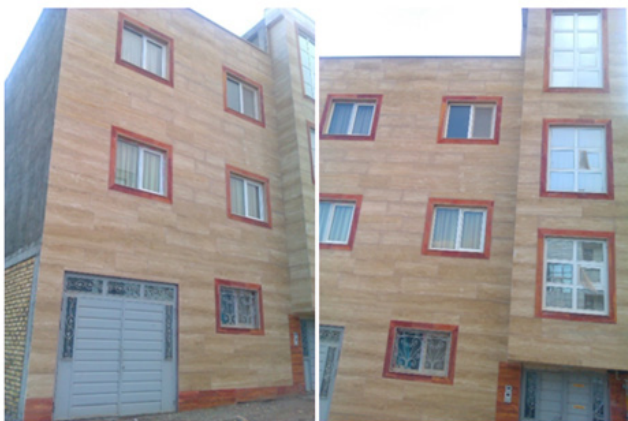
Figure 3 indicates an example of safe building located in Region 3 with a RC-frame. The building does not have any problem such as irregularity in plan or height. In addition, this building is built based on seismic codes and has a soil type C. The seismic vulnerability index for the mentioned building is 3.7 which implies the satisfactory safety of the building. The vulnerable buildings are located in all parts of the city specifically in region 12. The major issues associated with these buildings as indicated in Figures 4 & 5, are utilizing masonry material and problematic distribution of the mass leading to irregularities through the height of the buildings and causing premature fractures. The seismic reliability factor for these buildings located in region 12 of the city is approximately 0.2 which is considered low.

**Figure 3** Safe building.

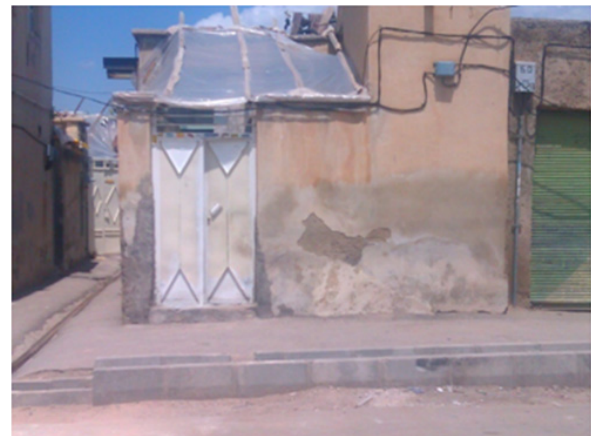
**Figure 4** Vulnerable building with irregularities through the height of the buildings.

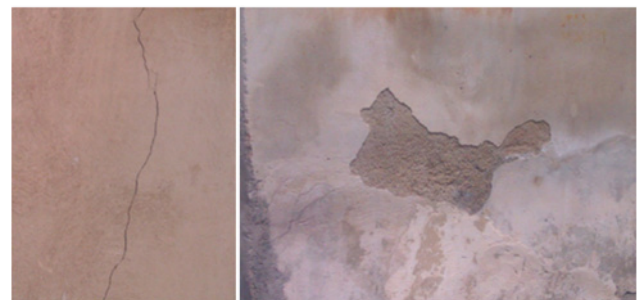
**Figure 5** Issues in investigated buildings fracture poor material quality.

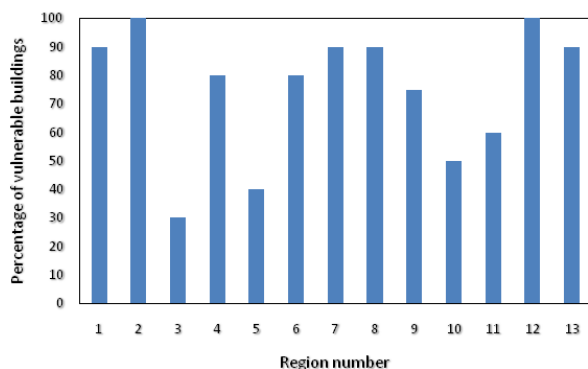
The percentage of vulnerable buildings over the total buildings in a specified region is represented in Figure 6. Based on the field observation and the gathered information from the curves the older regions show more vulnerability. This is due to the reason that the major material used for these building is masonry. The regions 2 and 12 with 100% vulnerability are appropriate examples of regions with mostly masonry structure having significant vulnerability issues. It is noted that, in some recently-built regions such as region 1, the frame systems are used but the structure have still noticeable vulnerable issues due to the irregularities in height or plan. The least vulnerable structures are those ones having frame systems as well as no irregularities in plan or height such as region 3.

**Figure 6** The percentage of vulnerable buildings over the total buildings in a specified region.

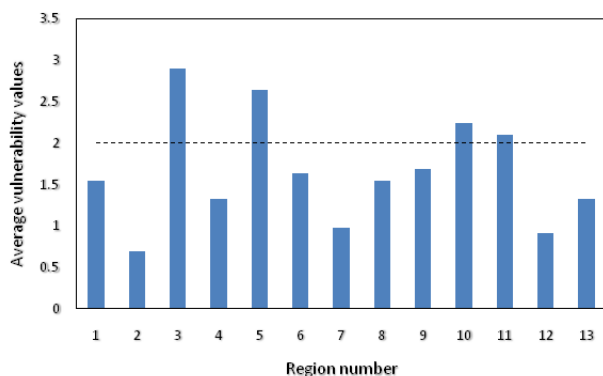
Figure 7 indicates the average vulnerability factor for different regions. If this factor is less than number 2.0, then there would be no need to have detailed assessment of the structure. Having no irregularities in plan and height of the building and having any sorts of concrete or steel frame would be highly important in increasing the vulnerability factor. However, the irregularities in seismic resisting systems are not effective in assessing the vulnerability factor. In addition, the consistency of the load path is considered as an important parameter under seismic loading conditions, which is ignored in masonry structures to some extent. Figure 8 represents the statistical investigation of the buildings in Zanjan city based on FEMA P-154. The material deficiency and the fracture in walls would make insignificant effect on vulnerability ratio factor estimation, but obviously could lead to more deterioration of the structure. The opening criteria are assumed as architectural considerations which is extensively investigated after occurrence of the events. It is noted that 75.4% of the total buildings in Zanjan city are considered vulnerable according to FEMA P-154 indicating that there is a huge need of retrofit and reconstruction Figure 8.

**Figure 7** The Average vulnerability values.

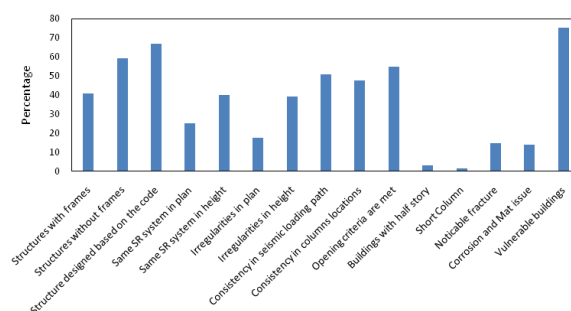
**Figure 8** The collected information from the all structures.

New procedure to evaluate the seismic reliability of the buildings are implemented to evaluate all the regions of the city. The procedure elaborated in this study could be utilized for different cities to have a quick but reliable assessment of how much building are seismic resistant. Based on the assessments of collected data, more than 80% of the regions and 75% of the constructed building are considered as vulnerable. It is worthy of notice that recently-built regions (e.g. region 1) are also evaluated as vulnerable indicating that the new methods of constructing building needs significant improvements. The major reason for such issues is due to sacrificing several criteria for having better architectural aspects; hence, the buildings are vulnerable under seismic conditions. It is worthy of mentioning that, in some newer parts of the city not only the seismic code is met but also the architectural aspects are considered; therefore, the structures are safe in overall. In general, the most significant common problem associated with the buildings are the irregularities in height of the buildings and not considering the seismic code instructions. The first problem is mostly observed in several buildings with concrete or steel frames, while the second issue is observed in masonry buildings. It is recommended not to sacrifice seismic codes and provisions for any architectural aspects, and construct the newer buildings without any irregularities in plan and height.
