Developments in river bank protection schemes in the lower Niger delta basin

This paper evaluates the performances of four revetment schemes at Sagbama, Otuokpoti, Sagbagraia and Opokuma/Opokuma in the lower Niger River Basin. The evaluation criteria are; reconnaissance survey, physical examination of revetment components, review of design calculations, and action photographs of defective components. The Sagbama and Otuokpoti schemes were designed for 2% annual exceedance probability (AEP) using Pilarczyk 1990 equations and constructed in Profix mattress revetment. Edge failure occurred at Sagbama due to deflected river flow caused by an upstream depositional bar. The Sagbagraia scheme was constructed of rock – filled gabion mattress, in PVC coated twisted wire mesh. The entire revetment system was constructed inside the potential failure surface. Due to combined effects of reduced effective stresses, high pore pressure and poor drainage bank triggered deep – rotational failure 5years after construction. The Kolokuma/Opokuma revetment was constructed in anchored steel – sheet pile. The choice of anchored steel – sheet pile is incompatible with shore bathymetry resulting to insuffi

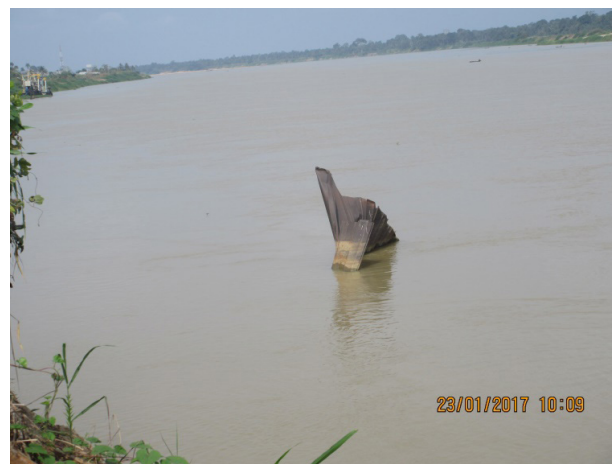
Plate 1 Collapsed sheet pile wall at Opokuma/Kolokuma.

Revetment Components										
S/N	Location	River	Revetment	Armour Layer	Filter Layer	Subsoil Condition	Crest	Toe	Edge Detail	Year
4	Okokuma Kolokuma	Nun	Anchored steel-sheet piles	Wrong choice of revetment, steel-sheet pile option not compatible with site bathymetry, caused restricted access to the river and berthing of canoes.						Insufficient embedmen depth and collapse during flood conditions.

Other factors such as flexibility and permeability are related to the ability of the revetment structure to transfer pressure forces to and fro the river bank. Considering columns 8 and 10 in Table 1), that the banks are very steep and slopes greater than 34o degrees with moderate to very heavy hydraulic loading and low permeabilities. Consequently, the sheet-pile revetment option adopted for Opokuma/ Kolokuma shore protection is in-appropriate. Sheet-piles are available in standard length of 39ft ($\approx 13\text{m}$), given the existing bank heights, they were not driven to the required embedment depth. The result was failure and collapse under flood conditions (Plate 1–3). Furthermore, sheet-piles offer restricted access to the foreshore and have adverse effect on the community lifestyle.

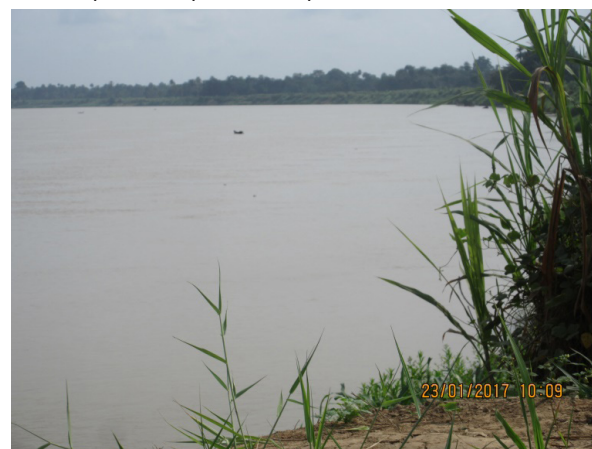
Plate 2 Typical view of concave bank of Nun River.

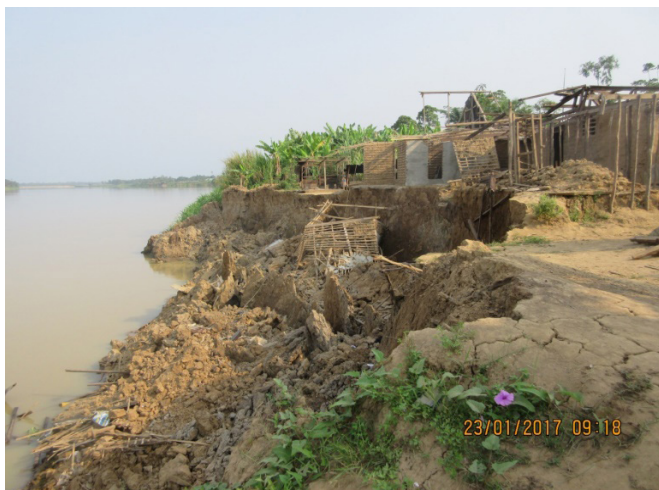
Plate 3 Composite bank failure at Sagbagreia.

The Sagbagreia scheme was constructed of box gabions (Maccaferri Gabions). The gabion protection was laid on non-woven geotextile filter fabrics. The main problems with this scheme are:

1. The whole protection system, including geotextile was constructed inside the potential failure surface.
2. Existence of high hydraulic gradient and seepage flow with low hydraulic pressure during flood recession.
3. Insufficient to anchorage to counter balance hydraulic forces and scour erosion during flood. The high pour water pressure in the bank material during flood recession (rapid lowering of the water level in the river) reduces effective stresses in the bank material causing desiccation and deep-seated rotational failure (Plates 4–6).

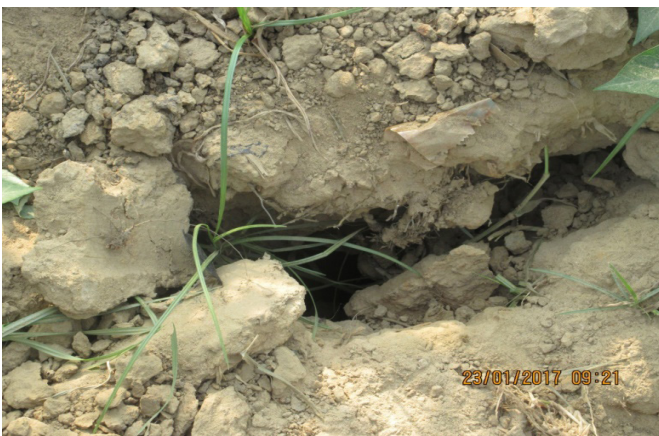
Plate 4 View of tension crack Sagbagreia.

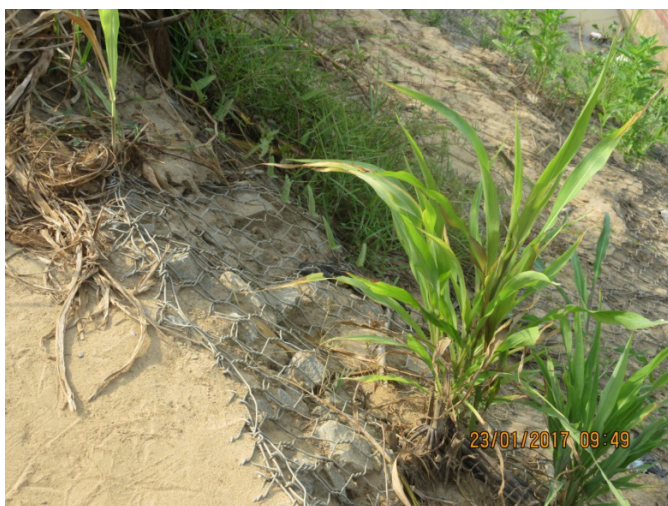
Plate 5 Deep-rotational failure at Sagbagreia.

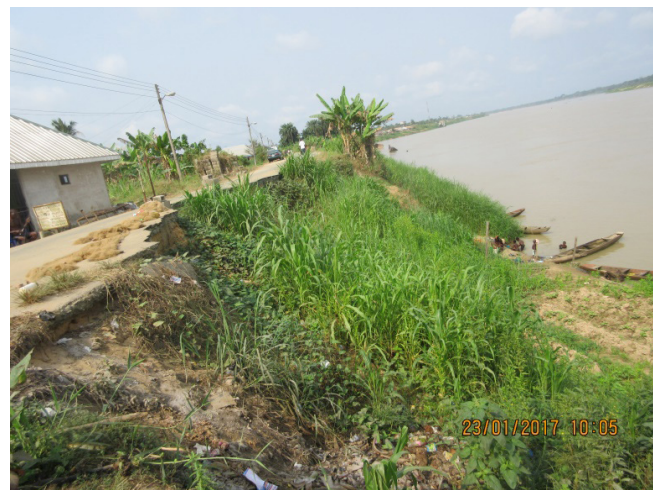
Plate 6 Southwards migration of R. Nun at Opokuma/Kolokuma.
