Feasibility of using a vibrating machine for laying ceramic tiles

Volume 7 Issue 1 - 2023

Gabriel Dal Ross, Francielle Coelho dos Santos

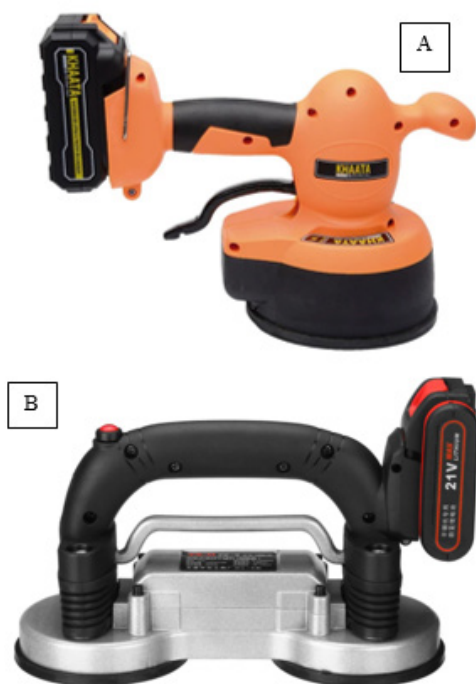
Figure 1 (A) Machine for laying ceramic tiles, brand Khaata Tools and (B) equipment used for the development of this research, brand YS-H.

At the same time, in the Brazilian market, the company Khaata Tools has introduced equipment that vibrates the piece to generate the density of the adhesive mortar and perform a quality fixation,

seeking to maintain the high productivity index without infringing the normative recommendations, as shown in Figure 1A. In this research, a similar equipment imported from China by the YS-H brand (Figure 1B) will be used, due to the unavailability of the Brazilian version.

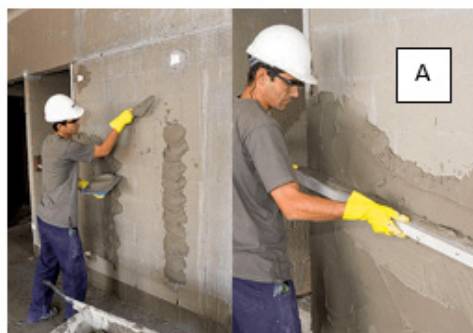
Figure 2 (A) Exemplification of the practice of manual plastering and (B) illustration of the mechanized process of projected plastering.

Among them, we can mention the study carried out by Souza (2018), who analyzed the service of coating walls executed in industrialized projected mortar, the commonly known projected plaster, which is a mechanical system for executing the plastering service of masonry in a modern and productive. Similar to the conventional procedure where the employee sprays the mortar on the wall in small amounts, manually as seen in Figure 2A, the mechanical system uses a machine that works as a kind of mortar jet, projecting the mortar on the wall, continuously, exemplified in Figure 2B.

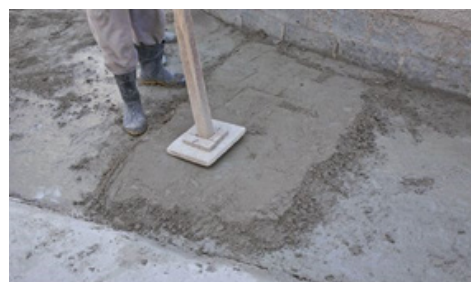
Figure 3 Exemplification of the dry and heterogeneous aspect of conventional subfloor mortar.

The subfloor is the smoothing layer that precedes the ceramic coating on floors, and its conventional method of execution is the use of a dry mortar, called “farofa” on site, due to its heterogeneous appearance, seen in Figure 3. It is evenly mirrored through the base where the regularization will be carried out, and compacted in order to thicken and promote resistance.

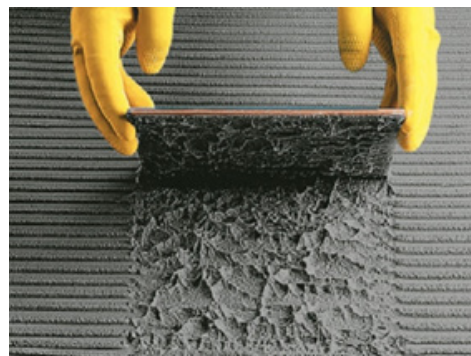
Figure 5 Exemplification of broken mortar cords promoting impregnation of the piece.

In item 5.7.8, the standard complements by determining that “in the application of ceramic tiles, the mortar cords must be completely undone, forming a uniform layer, configuring total impregnation of the back by the adhesive mortar”.⁴ This process is illustrated in Figure 5.

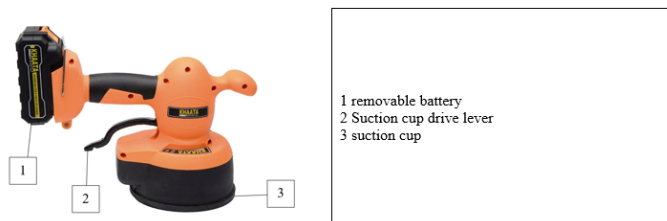
Figure 9 Machine for laying ceramic tiles sold by the brand Khaata Tools.

Version sold in Brazil: In Brazil, the company Khaata Tools sells a version similar to that found in the aforementioned patent application, but with differences such as the power supply, in which the Khaata model (Figure 9) is powered by a portable and rechargeable battery, whereas the patent model is powered by power cord. Another difference is the fact that the Brazilian model has a suction cup in its contact area, contrary to the patented one, which only has a rubberized base plate.

Comparing both versions one finds subtle but important differences between them. The chosen model (Figure 9) presents better characteristics in relation to the Brazilian model (Figure 8), such as, for example, the chosen model is equipped with two suction cups with a total load capacity of 200 kilograms and a battery of five thousand milliamps, whereas the version Brazilian has only one suction cup with a total load capacity of 25 kilograms and a battery of two thousand five hundred milliamps.

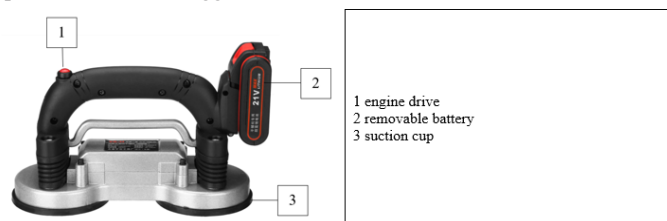
Figure 10 Variant of the YS-H ceramic tile laying machine marketed in Brazil by the Banggood website.

The commercially available coating laying machine models are comprehensive, but for the most part they are only available in the foreign market. As seen so far, there is only one model sold in Brazil, sold by Khaata Tools. However, due to the unavailability of this model at the time of purchase, it was decided to import equipment from the YS-H brand (Figure 10), sold in the Chinese market and available for purchase on the Banggood website.
