# Accidental high-speed hand piece bur buried during surgery of mandibular third molar: a rare case report

Volume 4 Issue 6 - 2016

Fareedi Mukram Ali,<sup>1</sup> Muzaffar Ali Khan,<sup>2</sup> Ali Ebrahim Shtaifi,<sup>3</sup> Sultan Mohammed Namis<sup>3</sup>

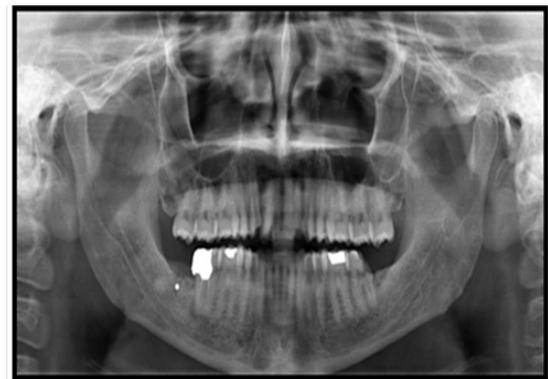
A 35-year-old male patient reported to college of Dentistry, Jazan. In routine examination of the other teeth on OPG (Orthopantomogram), it was found that a sharply defined radiopaque mass in the right mandibular third molar area (Figure 1). On history, patient had undergone surgical extraction of the third molar at a private clinic one year back. There was no history of pain, swelling, discharge or paresthesia in that region. Based on history, clinical and radiological correlation, the object was assumed to be a broken fragment of bur. The broken bur fragment was buried in the region approximately 5 to 7mm from the upper border of alveolus and 7 to 8mm away from the distal root of right mandibular second molar. As patient was not

having any of the signs and symptoms related to that broken bur fragment, no treatment was done and patient was kept on constant observation.

**Figure 1** OPG showing the buried broken fragment of round bur in the right mandibular third molar area.
