Spontaneous fragmentation and embolization of chemoport catheter- a case report

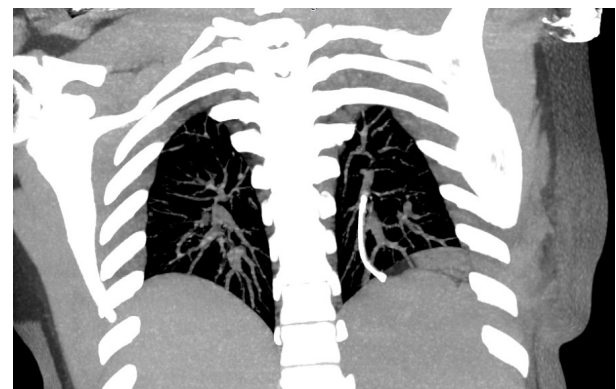
Figure 1 Magnified Intensity Projection (MIP) image coronal view NCCT Chest showing distal fragment of chemoport catheter in the left pulmonary artery lower lobar branch.

In our patient, no specific cause of catheter fragmentation could be identified. The fragmentation took place through the middle of the catheter. The catheter fragment embolized to the left pulmonary artery lower lobar branch.

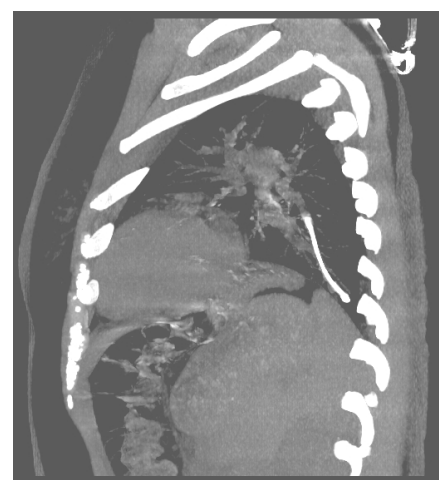
Figure 2 MIP image sagittal view NCCT Chest showing distal fragment of chemoport catheter in the left pulmonary artery lower lobar branch.

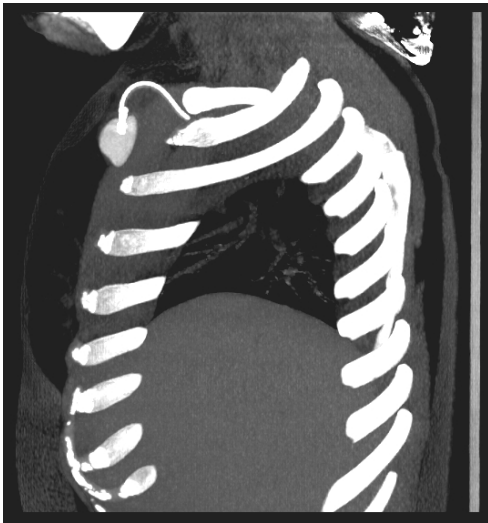
Figure 3 MIP image sagittal view NCCT Chest showing chemoport reservoir in the chest wall.

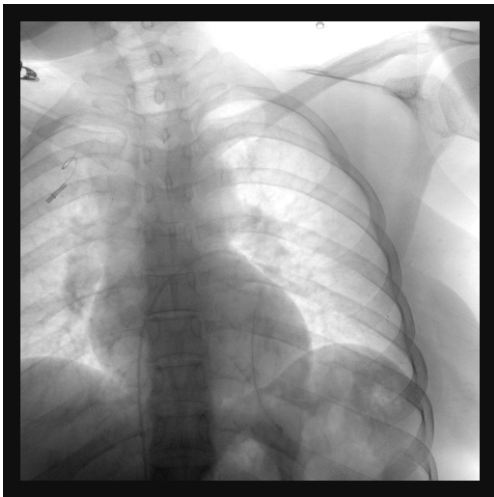
Figure 4 Fluoroscopy image showing snare catheter in left pulmonary artery with foreign body in left pulmonary artery branch.

Any fragment of the chemoport catheter must be removed early. This is best done using percutaneous endovascular techniques under fluoroscopic guidance with specific catheters and snare loops. If these techniques fail, open surgery should be considered.

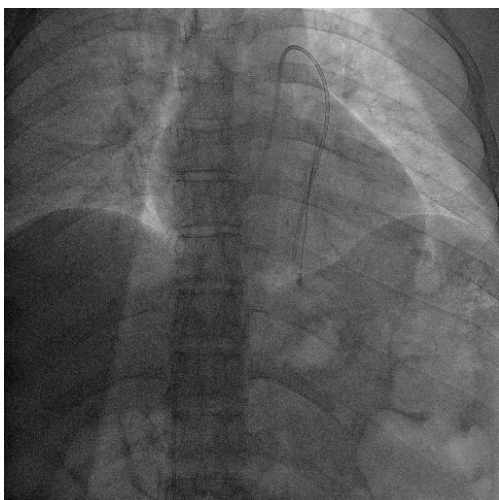
Figure 5 Fluoroscopy image showing snare catheter adjacent to the foreign body in left pulmonary artery branch.

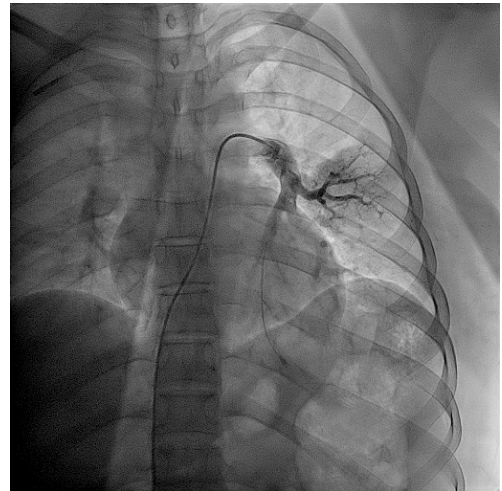
Figure 6 Fluoroscopy image of Catheter pulmonary angiogram showing the foreign body in left pulmonary artery branch.

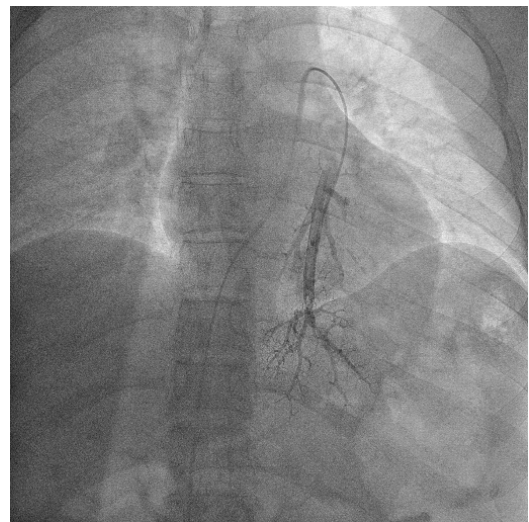
Figure 7 Fluoroscopy image of Catheter pulmonary angiogram showing foreign body as a filling defect in the lower lobar branch of left pulmonary artery.

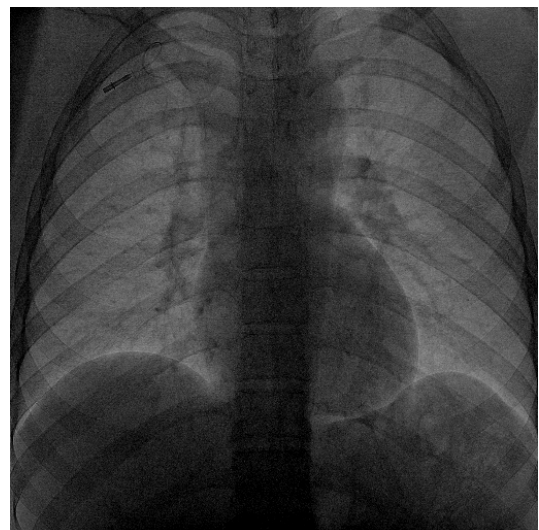
Figure 8 Check fluoroscopy image after removal of foreign body.

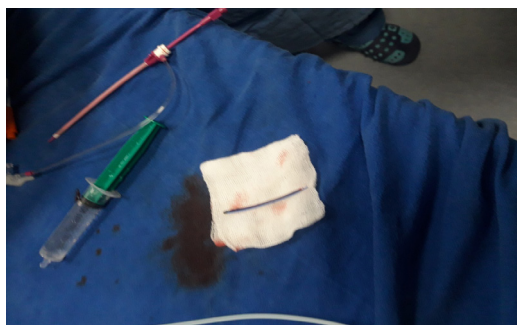
Figure 9 Distal fragment of the chemoport catheter retrieved.
