# Simple measures for the environmental restoration of areas degraded by mining – case report

## Case report

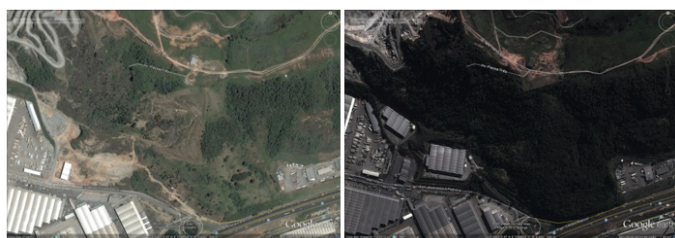
The following Google Earth images allow for a comparison of the hillside's condition before and after the environmental restoration was carried out.

Hillside in December 2005 and July 2012 following the recovery.

Hydraulic barriers made of granular materials and plant matter were constructed along with embankments to cover overburden piles, surface drainage systems, and small erosion-control dikes; measures such as manual or mechanized filling of erosion gullies and site restoration were also implemented, as well as the grading of soil slopes via manual excavation and the manual or mechanical removal of rock blocks. The treated areas were revegetated using grass, plant-fiber mat to erosion control blankets, native species, pines and eucalyptus.<sup>2</sup>

To gradually mitigate the siltation processes occurring at the base of the slope by controlling erosion and reducing instability risks, remediation measures began at the top, extended across the mid-slope, and finally addressed the lower hillside. By implementing restoration and drainage works starting from the headwaters of the drainage channels, it was also possible to control downstream erosion processes, thereby reducing the number and scale of the remaining interventions.

The revegetation of the hillside was based on the principles of ecological restoration; in other words, it did not simply involve planting native trees. A set of strategies was implemented to initiate the restoration of vegetation cover and pave the way for forest succession, taking into account soil permeability and fertility, wind intensity, solar exposure, terrain slope, soil moisture, and the prevalence of large rock blocks and outcrops.<sup>1,3</sup>
