# Surgical stabilization of per-trochanteric proximal femur fracture with birmingham hip resurfacing implant in-situ

Volume 5 Issue 6 - 2016

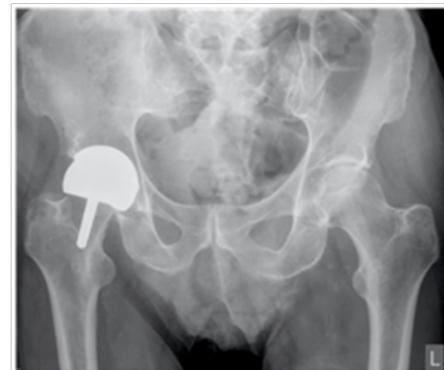
**Figure 1** AP pelvis plain radiograph showing original right hip resurfacing implant position.

Standard investigations were performed and the patient was managed using the hospital proximal femur fracture pathway according to National Institute of Health and Clinical excellence (NICE) recommendations. The radiographs (Figure 1 & 2) show the type and location of fracture with a well-seated prosthesis. It was felt the prosthesis did not show any radiological evidence of loosening; the bone stock appeared of good quality. The patient had been asymptomatic and well functioning to date, the decision was

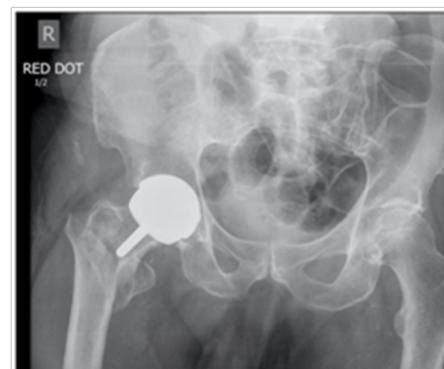
**Figure 2** AP pelvis plain radiograph showing a per-trochanteric proximal femur fracture with right hip resurfacing implant in-situ.

made to fix the fracture rather than revise the implant. The surgical options considered were either intramedullary fixation using a long cephalomedullary nail or extramedullary device using a dynamic hip screw (DHS) device. Given the patient's medical frailty and anesthetic risks, the decision was made to perform the shortest and safest procedure possible, thereby choosing a DHS.
