Bicon Threaded Acetabular Cup Fracture, Case Report, Mode of Failure and Review of the Literature

Case Report

Volume 6 Issue 5 - 2016

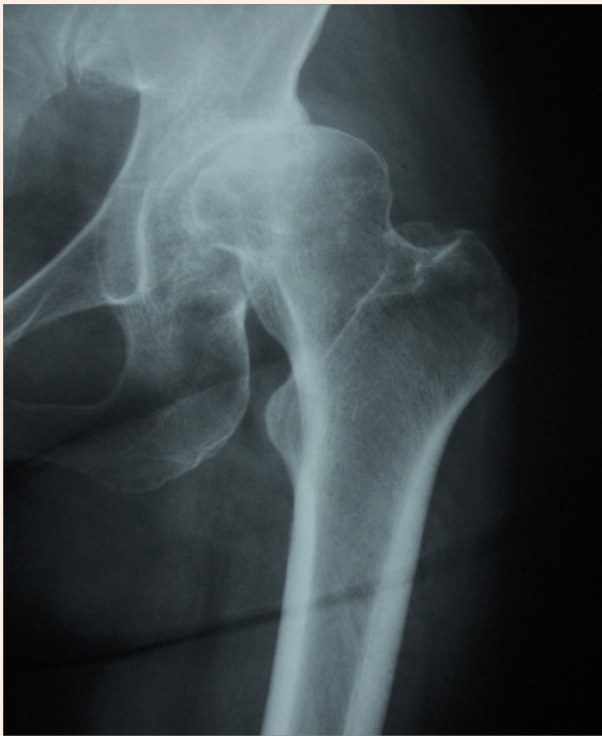
Figure 1: Preoperative X-Ray showing severe hip dysplasia.

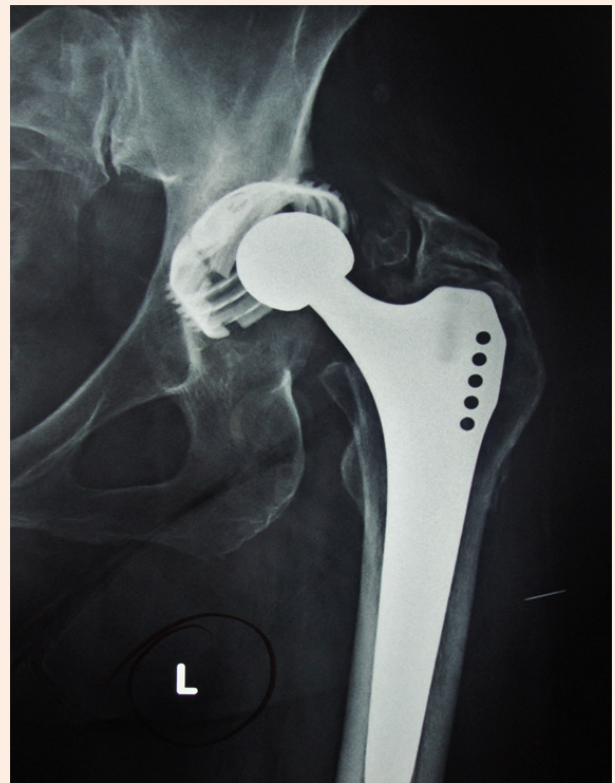
Figure 3: 13 years postoperatively, X-Ray shows an anterior-superior fracture of the insert, without any signs of loosening or migration.

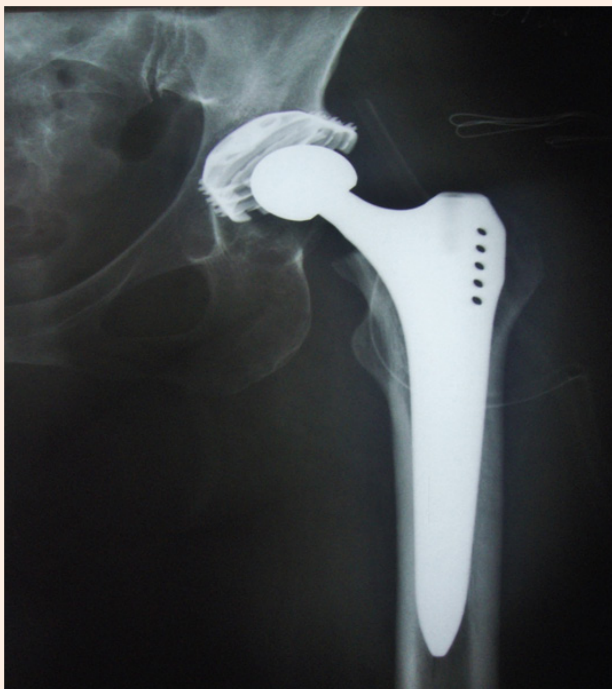
Figure 2: Immediate postoperative X-Ray showing a somewhat high hip center of rotation, and uncoverage of the implant superiorly.

stability is supposed to be over 70% [16-18], this percentage refers to the thicker hemispheric cups and may not apply to the thinner Bicon threaded cup. In our case a somewhat high hip center was used as well to achieve as much coverage as possible (Figure 2). In case of revisions the use of this cup was not advised if peripheral segmental acetabular margin defects are present because all the implants have showed signs of migration [15].

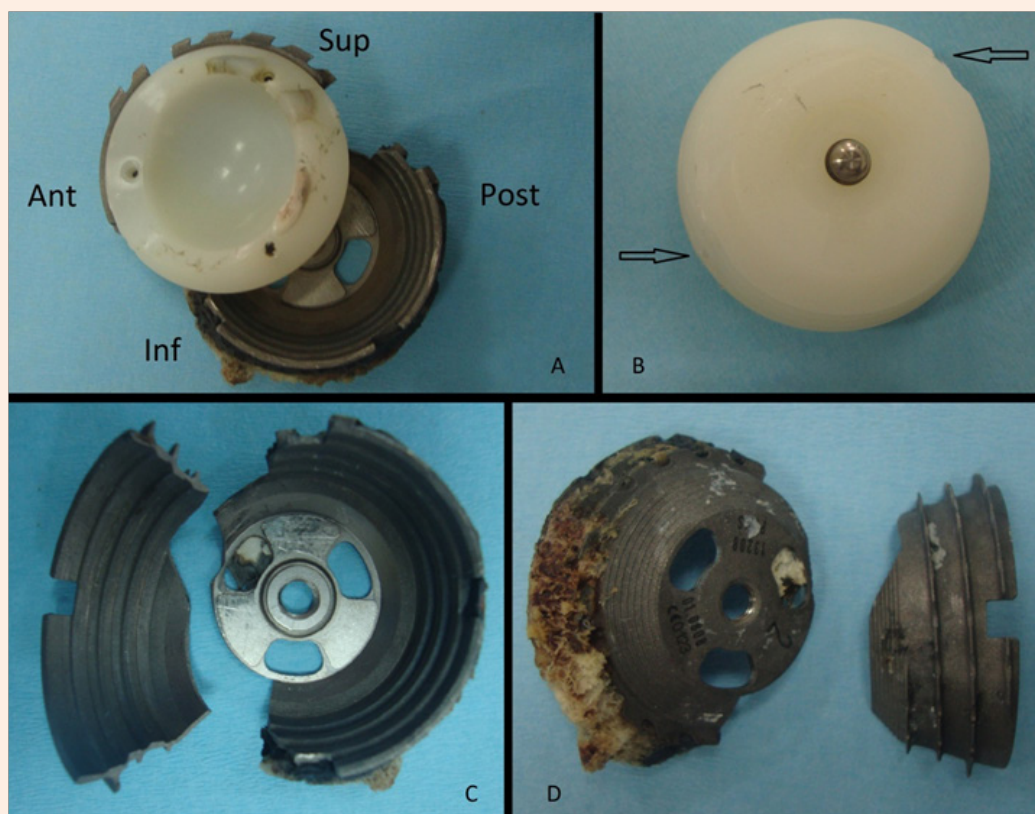
Figure 4:

Figure 4A: Reconstituted retrieved implants showing the direction of the fracture, which was anterior-superior from 8 o'clock to 1 o'clock (Left hip). There was no significant wear of the PE, and some signs of impingement and delamination of the elevated lip.

Figure 4B: Backside of the Polyethylene insert showing the lines where the fracture occurred.

Figure 4C: Metal insert showing that the fracture line was through diametrically opposed notches.

Figure 4D: On gross examination there was osteointegration at the level of the threads of the well-fixed part and no sign of osteointegration of the rest of the implant or the fractured part.

This is contrary to our findings, in which the defect was anterior-superior (Figure 4A). Our patient has been neglecting her follow-ups, since she had no clinical problems with her hip, up until the day the cup failed. The fact that almost two third of the circumference of the cup were well osteointegrated and thus were rendering the cup stable, may have been the reason why the patient had a well-functioning hip replacement without any complaints. The anterior-superior part of the cap fractured due to

repeated loading of a non-osteointegrated area, secondary to the lack of bony support. We believe that the mechanism of fracture is superior stress loading of a partially well fixed cup, on its inferior side, transforming compressive loads from the femur to shearing stresses, for a longer period of time. All the other cases reported are early to mid-term failures compared to our patient, which was a late case of fracture.

By looking at our cup and at the images of the fractured cups provided by the two other reports, the arc of the fractured piece or pieces passes through the notches for the seating instrument, which makes them a weak point of the cup (Figure 4C). This coincides with the supposition in the case series by Korovessis et al. [6], that the notches at the peripheral rim of Bicon shell represent points of stress concentration that create fatigue fracture, resulting from acetabular remodeling, independently from the biologic fixation of the cup.

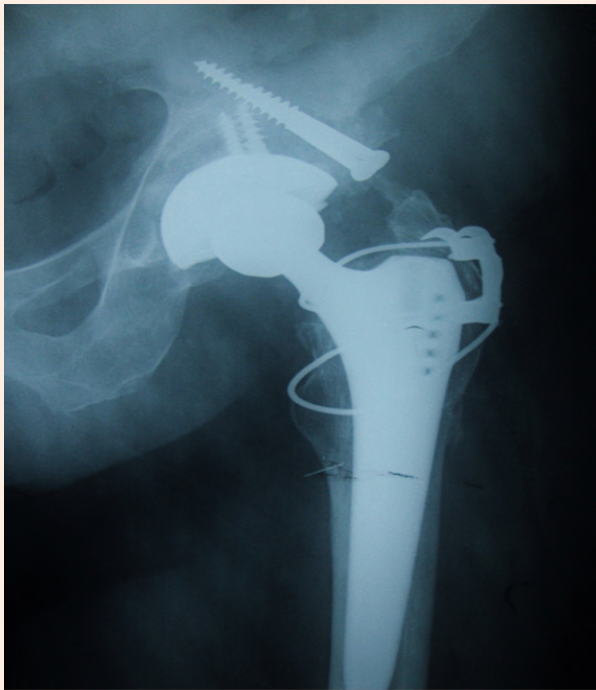
Figure 5: Immediate postoperative X-Ray showing anterior-superior reconstruction of the acetabulum with a femoral head allograft and a hemispheric acetabular implant in the correct hip center of rotation.
