# Fracture of a cemented modern titanium alloy tibia baseplate: a case report

**Keywords:** tibia tray fracture, AP instability, revision knee, rotating hinge knee

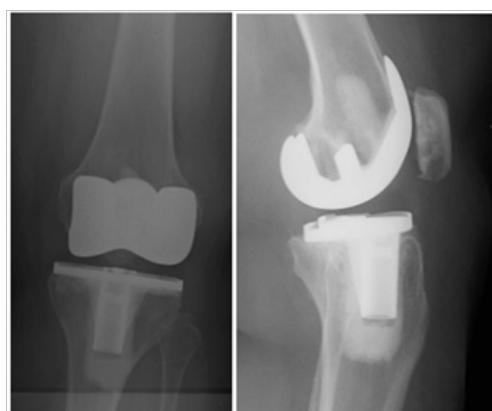
**Figure 1** AP/Lateral left knee 5years from TKA with medial joint space narrowing and anterior translation of the tibia.

She did well for a year and a half following her revision surgery then presented with knee pain located medially on the joint line, over the pes bursae as well as along her distal IT-band. It was also noted in flexion that her excess soft tissue from her posterior thigh impinged on her posterior leg. Radiographs were obtained (Figure 3), and revision surgery to a hinge type knee was recommended to control AP instability, particularly given the posterior impingement of her soft

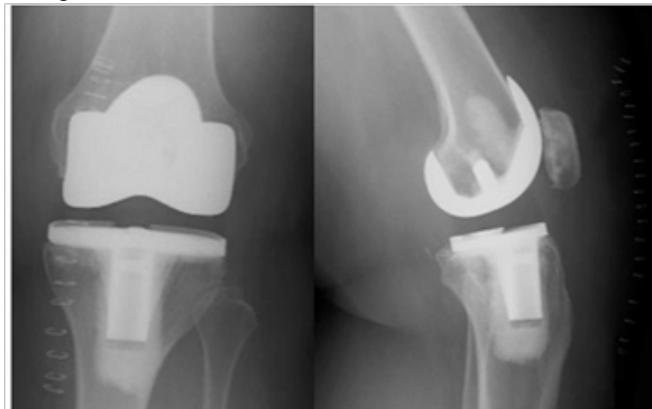
**Figure 2** AP/Lateral left knee, status post revision TKA to a 14mm AC constrained polyethylene with resolution of joint space asymmetry and appropriate alignment on the lateral view.

A 52-year-old woman underwent a left total knee arthroplasty 7-years prior with a cemented CR Zimmer® NexGen® total knee system (Zimmer-Biomet, Warsaw, IN) secondary to rheumatoid arthritis. She had a history of rheumatoid arthritis, lymphoma, COPD, deep vein thrombosis as well as obesity (5'5", 226Lbs, BMI 37). She presented for follow up 5-years after her original surgery with symptoms of pain, difficulty ambulating, and an audible clunk. She demonstrated abnormal AP mechanics with significant anterior tibia translation. She was noted to have near complete wear through the posterior medial corner of her polyethylene (Figure 1) and was subsequently revised to 14mm AC polyethylene with resolution of her abnormal mechanics (Figure 2).

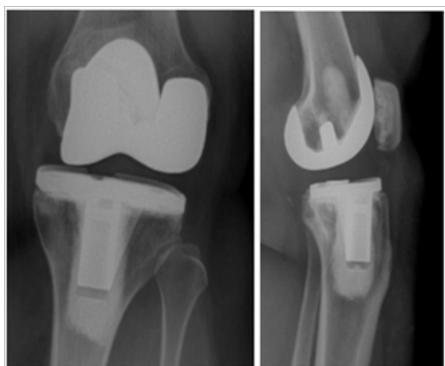
**Figure 3** AP/Lateral left knee, 16months following revision surgery, again demonstrating anterior tibia translation and joint line asymmetry concerning for mechanical failure of the polyethylene.

tissues in the popliteal region secondary to her body mass distribution, which on exam appeared to be causing anterior tibia translation and likely contributing to the catastrophic posterior medial tibia failure.

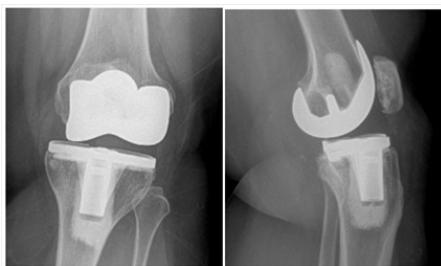
**Figure 4** AP/Lateral left knee 20months from revision surgery demonstrating increased anterior tibia subluxation and medial joint space narrowing. There is also evidence of posterior medial tibia tray fracture.

The patient waited, given her symptoms at this time frame were only mild; however, 4 months later she presented for follow up, as she was having significant instability (Figure 4). She was then scheduled for revision TKA.

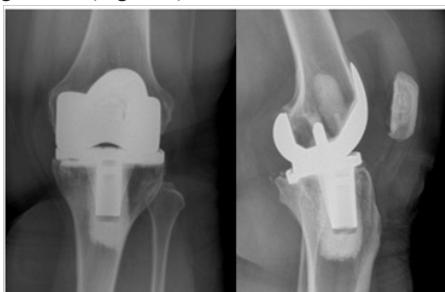
**Figure 5** AP/Lateral Left Knee showing metal on metal articulation of the femur on the tibia, disengaged polyethylene in the suprapatellar pouch as well as fracture of the posterior medial corner of the tibia tray.

Prior to the patient's chosen surgical date, she twisted her leg, felt a shift in her knee, and had severe pain along with the sensation her knee being locked (Figure 5).

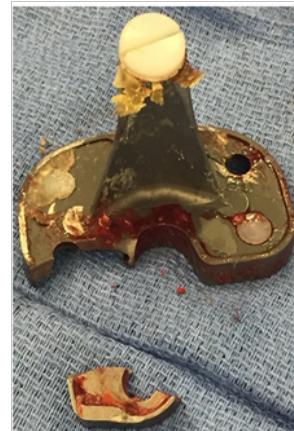
She was taken to the operating room the following day. Her polyethylene was found in the suprapatellar pouch with damage particularly to the posterior medial region (Figure 6). The tibia tray was found to be well fixed but was found to be fractured in the posterior medial corner (Figure 7). Both component revision was undertaken using Zimmer® NexGen® RH knee with cemented stems as well as a trabecular metal femoral cone in the metaphysis (Figure 8).

**Figure 7** Intraoperative photograph showing fracture of the posterior medial corner of the tibial tray, medially, through a hole which allows for optional augment attachment and into the PCL recess of the tray.

In this case, the holes in this modern tray, designed for augments, were a weak point in the design and after asymmetric loading, led to fracture of the tray itself. The BMI of 37, which had significant distribution in the posterior thigh and calf regions, led to not only increased load on the tibial tray itself, but also was a potential driving force for the tibia to translate anterior, thus loading the posterior tibia. These factors combined, likely contributed to this current failure. Catastrophic tibia failure secondary to AP instability was managed here utilizing a rotating hinged knee arthroplasty.

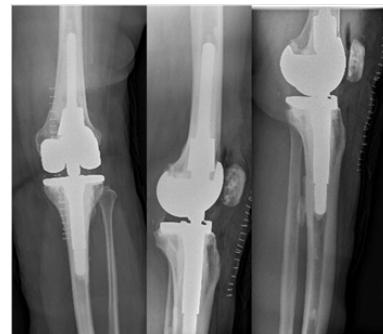
**Figure 8** AP/Lateral femur/Lateral tibia of the left knee following revision to a rotating hinge with cemented stems and femoral metaphysical cone.
