Failure due to metallosis after cruciate retaining total knee replacement

Volume 13 Issue 4 - 2021

Ali M Maziad, Ahmed Nageeb Mahmoud, Ebied Wessam

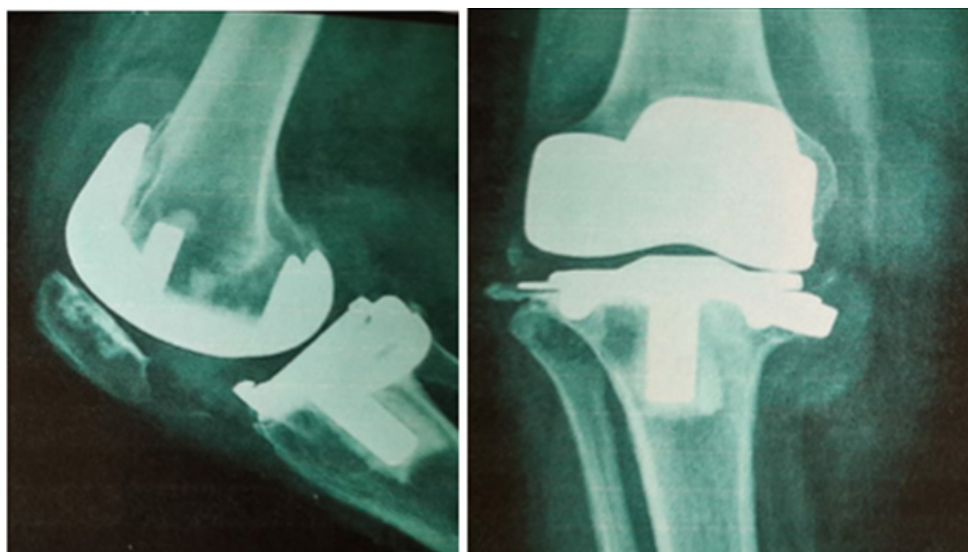
**Figure 1** A case of TKR metallosis showing severe osteolysis beneath the tibial component, which is broken, amorphous curved densities “Cloud sign” and advanced plastic wear.

Metallosis can appear radiographically as a thin rim of linear increased density outlining the capsule and the suprapatellar pouch, this is called the metal line sign. Other radiographic findings include circular radiodensities called (bubble sign), amorphous, cloudy, periprosthetic soft tissue densities called (cloud sign), osteolysis, loosening and metallic fragmentation.⁵

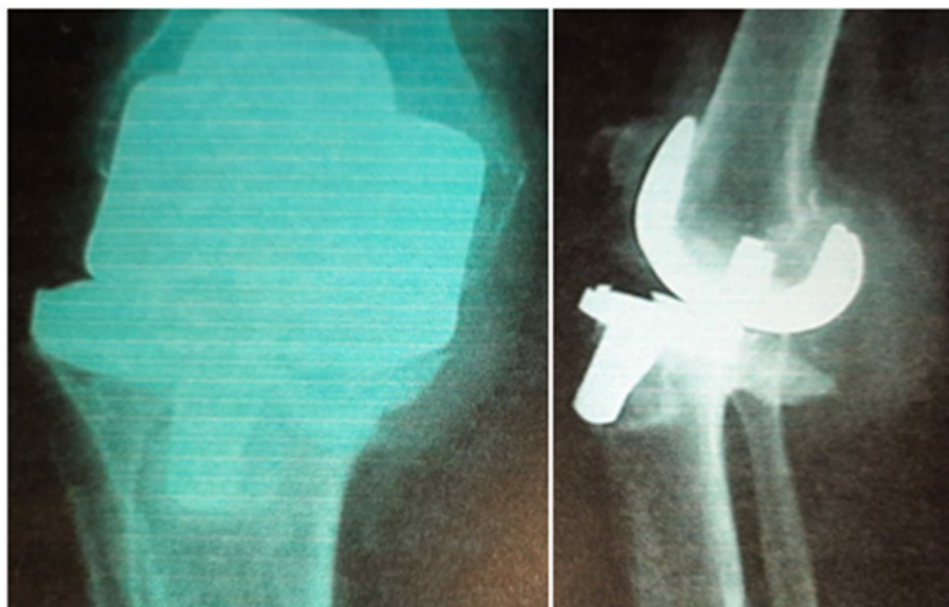
**Figure 2** A case of metallosis on TKR showing sever osteolysis beneath the tibial component which is loose, semicircular radio densities “Bubble” sign and advanced plastic wear.

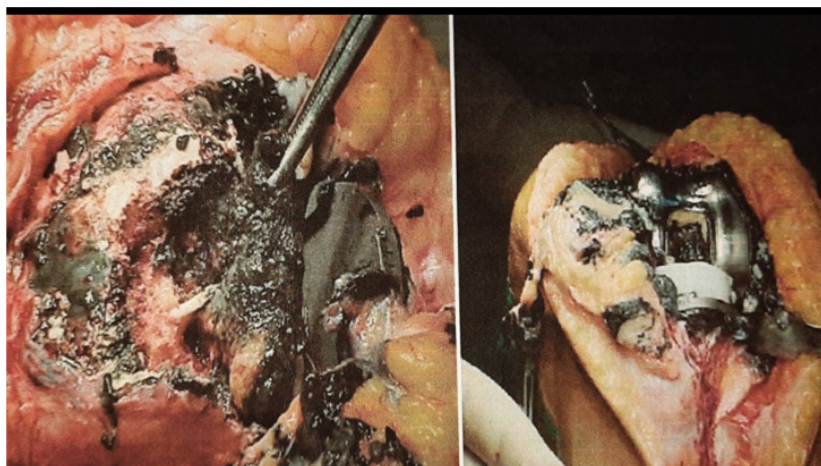
During the revision surgery all cases showed direct tibiofemoral articulation with advanced polyethylene wear in addition to severe metallosis with black staining of the synovial tissues, cystic cavities, and metal-debris tumor-like formation (Figures 3, 4). A profound synovectomy was carried out in all cases and tissue samples were sent for histopathology which showed chronic inflammatory reaction and metal debris. Extended culture and sensitivity showed no bacterial growth. The implants were found to be loose in all cases. The retrieved

implants showed visible scratches and advanced plastic wear. After removal of the prosthesis, advanced osteolysis with holes filled with black debris was seen. Local debridement was carried out and cysts were curetted.

Figure 3 Intraoperative photos showing extensive black staining of the synovial tissues and advanced osteolysis with holes filled with metal debris beneath the prosthetic components.

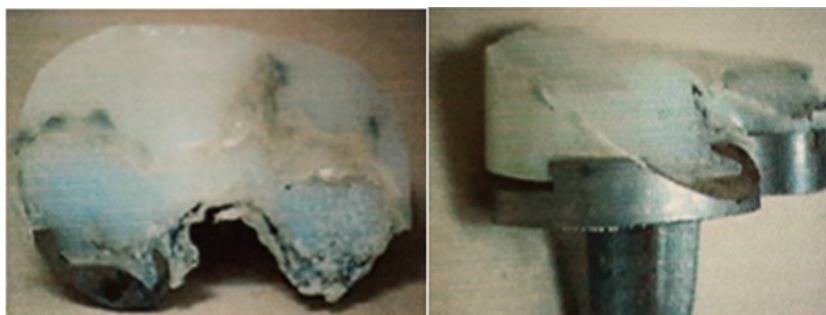
Figure 4 Retrieved tibial component showing a full thickness polyethylene wear.

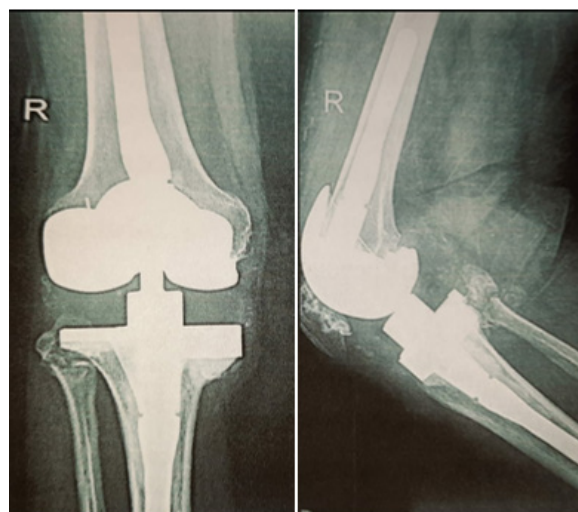
Figure 5 Revised metallosis case with LCKK system and metal augment for the medial tibial condyle.

All cases were revised using a cemented Legacy constrained condylar knee (LCKK, Zimmer, Warsaw, IN) (Figure 5). Metal augments has been used in 6 cases to reconstruct bony defects. After a mean of 14.7 months follow up, all the cases had stable revisions and none of the cases needed re revision. The Oxford knee score has improved from a mean of 22 to 38 (out of 48) on the last follow up.
