# Broken prosthetic distal inter-locking modular femur stem: a case report of rare implant type failure

Volume 14 Issue 2 - 2022

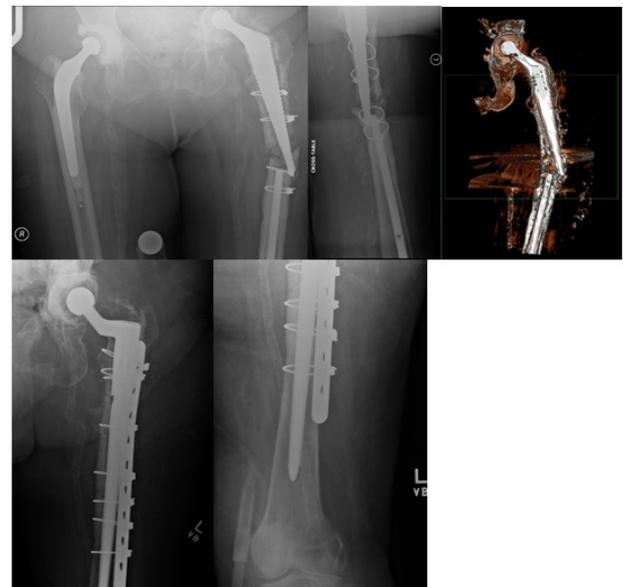
- i. Radiograph- sufficient to arrive at the diagnosis in this case (Figure 1)
- ii. A CT (computed tomography) scan with 3D reconstruction -for surgical planning

**Figure 1** Pre-operative (above) and post-operative (below) images.

Detailed consent involving risk to life and discussion with family members was done as an essential part of surgical pre-operative planning. The patient underwent a complex hip arthroplasty revision via previous scar and posterior-lateral approach to the hip using a RECLAIM™ Stem system (Depuy) along with plate (as added strut support) and cable fixation. This prosthesis recommended in severe metaphyseal bone loss (Paprosky III and IV) where fixation is needed

- i. Superficial wound infection post-surgery- managed with intravenous and oral antibiotics successfully over 6 weeks
- ii. Satisfactory post-operative radiographs- fracture union seen (Figure 1)
- iii. Followed up to 1 and half year post operatively
- iv. Could stand with a walking frame with assistance
- v. Right above knee amputation for peripheral vascular disease 1 year after this hip surgery; passed away of urosepsis at 81 years.
