Abandoned borrow pits; risk factors and reclamation procedure

Volume 2 Issue 3 - 2017

**Nwachukwu MA, Nwachukwu MI,
Ahiarkwem CO, Nwankwo GI**

Department of Geosciences, Federal University of Technology, Nigeria

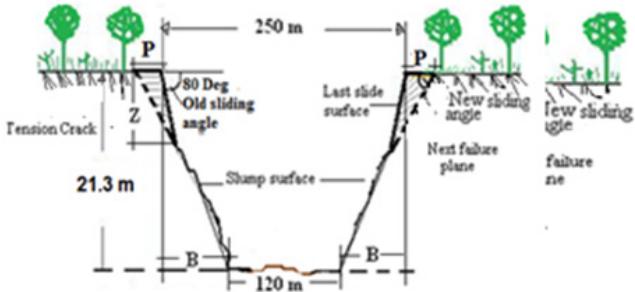
Figure 3 (A) Cross-sectional geometry of Emekuku pit (Left) and **(B)** Cross-sectional geometry of Ihiagwa pit (Right).

Field coordinate data were converted from degrees, minutes and seconds to digital coordinate values and then transformed to Geographic Information System (GIS) map using ArcGIS 10.1. Elevation data obtained were also applied to the ArcGIS software to obtain a topographic map of the study area (Figure 3). Electrical resistivity data were subjected to Advanced Geosciences Incorporation (AGI) 1D inversion technique analytical software was used for processing. Geotechnical data, Microsoft Excel 2007 software was used to plot the graphs. The environmental field assessment and the analytical results became integrated, such that a comparative analysis of the Ihiagwa and the Emekuku borrow pit sites was carried out. Integrating the Ihiagwa and Emekuku site conditions with the field

assessment of Obulubi and Iho sites, brought about a detailed geo-environmental assessment of borrow pit activities in the project area.

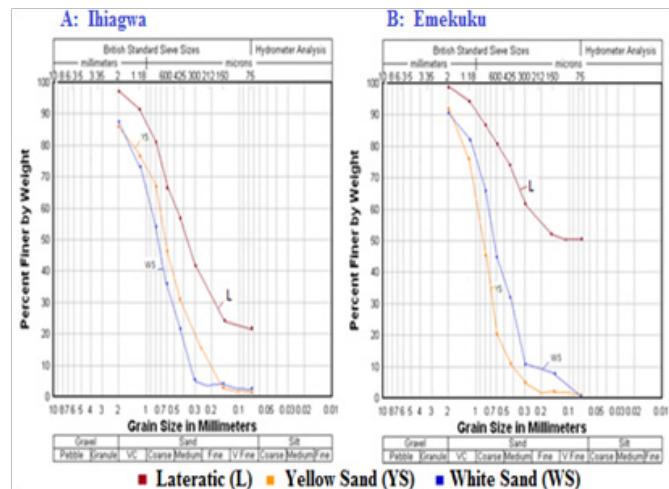
Figure 9A & 9B Graph of Percentage Passing (%) against Grain Size (mm).

For effective reclamation of a borrow pit, the original properties of the soil must be determined and technically applied in the reclamation process. Most important parameters include: Grain size distribution, Moisture content, Density, Shear strength and Bearing capacity. Laboratory tests on soil samples obtained from the pits under investigation show grain size ranges from very fine to very coarse, with significant clay silt content (Figure 9A & 9B). This implies that the lateritic soil is plastic, can be generally described as cohesive, and suitable as road fill material for which it is being used. A maximum dry density (MDD) range of 1.84 to 1.93mg/m³ was measured at the two sites, with optimum moisture content (OMC) of 13.9% for Ihiagwa and 14.3% for Emekuku (Figure 10A & 10B). Of the two samples tested, plasticity index (I_p) of 18.2% and 21.2% were obtained for the Ihiagwa and Emekuku samples respectively (Figure 11A & 11B). Shear strength of 99.6KN/m² was obtained for Ihiagwa sample and 95.7KN/m² for Emekuku sample with angles of internal friction of 27 and 26 degrees, respectively (Figure 12A & 12B). These values are significant to be considered when using the soil for road fill material and during reclamation.

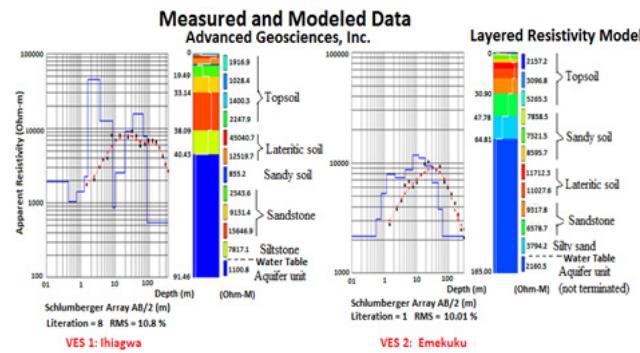
Figure 13 Showing 1-D Inversion Model Curves with 6 lithologic Units.

The resistivity measurement of the Emekuku study site also shows that the area consists predominantly of sand- sandstone after the topsoil and the lateritic soil overburden. The sandstone starts at a depth of 30.89m and persists to a depth of 165m (Table 2). Similar to the Ihiagwa area, the lateritic soil occupied depths between 0.5 to 19m (Average thickness of 18.5m). This thickness is significant for borrow pit development. The soil is adequate for road fill while the sand and

The model interpretation (VES 1 and 2) represent the depth, resistivity, lithology and colour codes, resulting from the inversion of the resistivity measurements (Figure 13). It emphasizes the resistivity response of the various geo-electric layers identified at Ihiaigwa. Its lithology is in order of topsoil, lateritic sand, silty sand, sandstone, sand and gravel beds. The resistivity measurement at the road failure section of Ihiaigwa study site shows that the area consists predominantly of sandy lateritic soil of variable texture and resistivity values after the topsoil; starting 0.5m to 19.5m and below this depth be the base sandstone (Table 1). Similarly, the resistivity measurement at the Emekuku site presented sandy lateritic soil with variable texture and resistivity values at depths below the topsoil; starting 0.6m to 19.2m (Table 2).
