Design optimization of head cover of vertical francis turbine from maintenance perspective in context to sediment laden river projects

Volume 2 Issue 1 - 2018

Balendra Chhetry, Bhola Thapa, Biraj Singh Thapa, Ravi Koirala

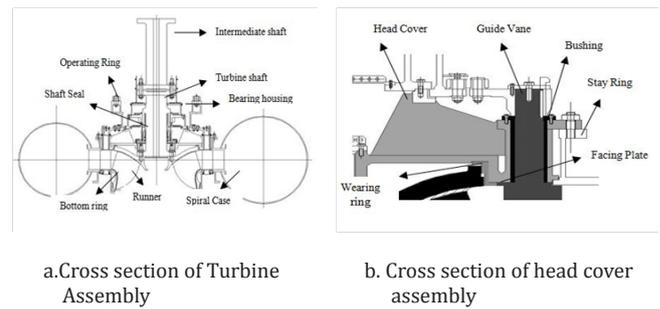
Figure 2 Detail of component assembly of reference case.

The turbine assembly design has facilities to dismantle the turbine parts from downwards as well as from turbine pit. The first approach facilitates the removal runner from downwards through a recess below the spiral case foundation whereas the latter allows the removal of turbine parts from upward through an access of turbine pit. The combined maintenance approaches have been in practice for disassembly and assembly of turbine components during machine overhauls. The Figure 2 shows the sectional view of turbine and head cover assembly of reference case.

The disassembly work during overhauls, removal of intermediate shaft, guide vane operating mechanism, head cover and turbine shaft including turbine bearing housing and shaft seal assemblies are taken out from upward approach through turbine pit. Whereas, the bottom rings, guide vanes and runner are taken out from downward approach. Removal of turbine guide bearing, shaft seal assembly, operating ring including intermediate shaft are required prior to head cover disassembly.

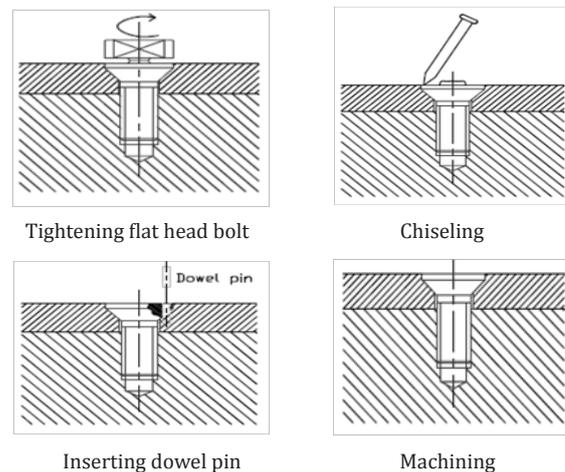
Figure 3 Assembly sequence of flat head bolt on facing plate.

Similarly, fasten of bolts to the facing plate requires tightening of flat head bolts, removing the burrs from head of bolts by chiseling, inserting the dowel pin to fix the bolt and facing plate and finishing by surface grinding process. The Figure 3 shows the sequence of fixing flat head bolts on facing plate.

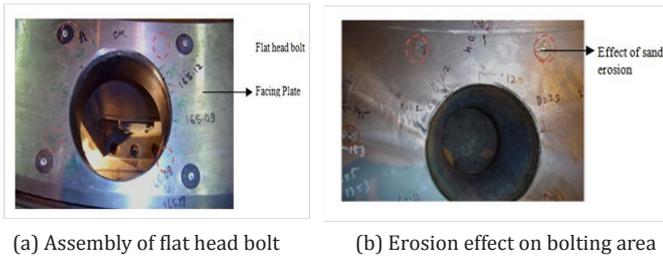
Figure 4 Observation of effect of sand erosion on bolting area of facing plate.

The difference of surface level between flat head bolt and facing plate surface due to the thickness of coating may be another reason that favors sand erosion. Figure 4 presents photos of initial effect of sand erosion on facing plate of reference case design. Figure 4A shows the fasten area of flat head bolts on facing plate during the replacing work of turbine overhauls. Figure 4B shows the effect of sand erosion starting on the same area of bolting after operation of one flood season.

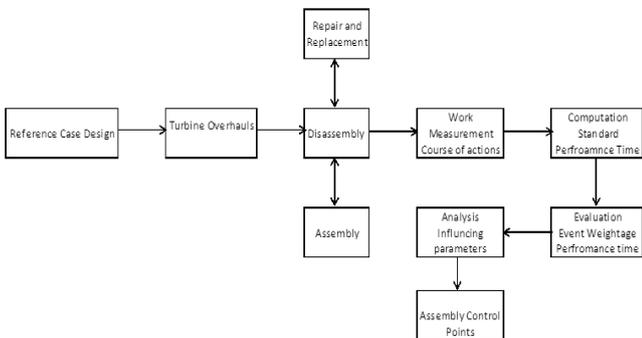
Figure 5 Flow chart of method analysis.

The details of method used for identifying the influencing parameters of assembly design and results for the reference case has been presented in earlier works by the same author Chhetry B.¹⁴ In that work, efforts are made to study the control points on reference case assembly design. A method has been developed to identify the influencing parameters of reference case. Figure 5 shows the flow chart of method analysis to establish the assembly control points followed.

Each modification has followed the method analysis as presented in Figure 5, and analyzed through performance analysis tool and sequence analysis method, with respect to standard performance time of reference case. Four courses of actions, preliminary work preparation, disassembly, repair- replacement and assembly work, has been considered for work measurement during turbine overhauling.

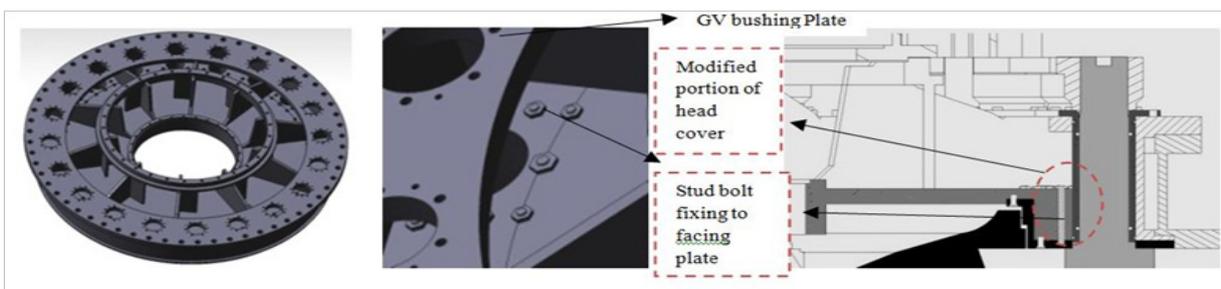
Figure 6 Head cover assembly design modification -1.

Figure 6A shows the isometric view of head cover design modification 1. The space has been generated between guide bushing plate and lower plate of head cover as shown in Figure 6B. A through-hole is made to insert a stud bolt and screw it with facing plate as presented in Figure 6c. This modification has provision to remove the stud bolts of facing plates from turbine pit.

The facing plate can be taken out from the downwards at the opening side of draft tube cone, hence requirement of dismantling head cover is eliminated from event sequence analysis. The modified design significantly reduces the outage time of disassembly and assembly of head cover during turbine overhauling. It also contributes to minimize the work of dismantling and fixing the bolts to facing plate.

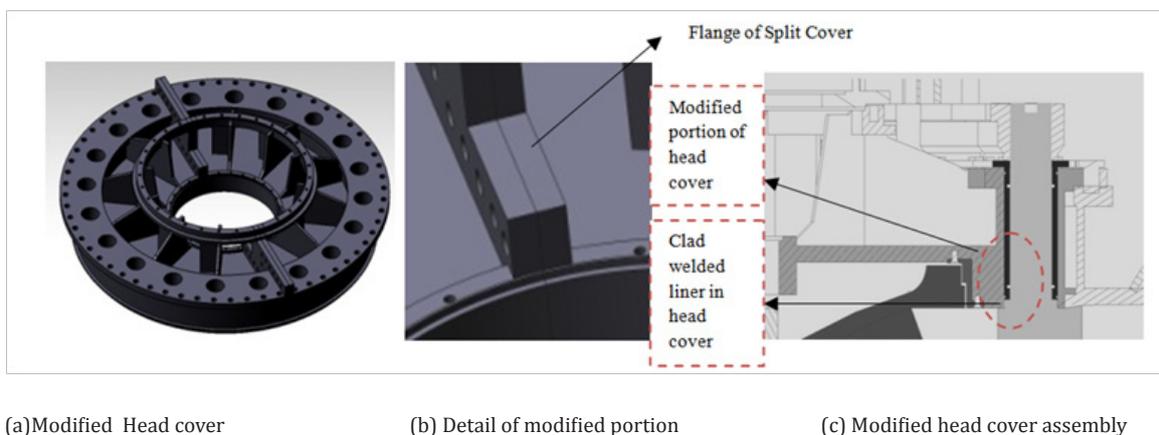
Figure 7 Head cover assembly design modification -2.

The head cover dismantling may be required to repair the liner, if effect of sand erosion is severe on the liner. Turbine assembly design with modification 2 is considered the event for dismantling the head cover to compute the standard performance time, as high sediment load has been observed in reference case. The modification has provision to split the cover into two halves from joint flange, as shown in Figure 7A. Splits are bolted transversely to the flange with stud bolting, as shown in Figure 7B. The provision has made for loosen the stud bolts of head cover from the turbine pit can be taken out from the downward approach. Figure 7C shows the cross section of head cover with clad welded steel liner.

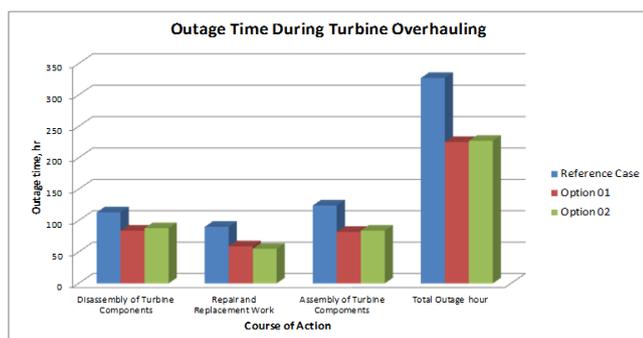
Figure 8 Assembly design outage time during overhauling.

Modified turbine assembly design is compared with the reference case design to analyze the down time of the machine for each course of action. The comparison of outage time for turbine assembly design during overhauling works and presented in Figure 8.

Three hundred and twenty-seven outage hours has been computed to carry out the turbine overhauling works for reference case design whereas two hundred twenty five and two hundred twenty seven outage hours are estimated for design modification 1 and 2 respectively. Design modification 1 contributes 37.33%, 26.22% and 36.44 % of standard performance time for disassembly, replacement and assembly work respectively. Similarly, design modification 2 contributes 38.76%, 24.22% and 37.00 % of standard performance time for disassembly, replacement and assembly work respectively.

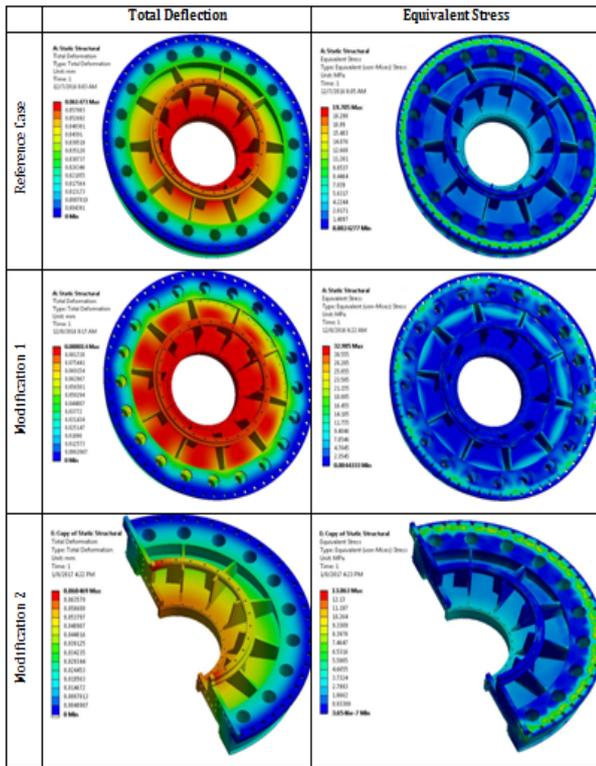
Figure 9 Total deflection and equivalent stress in Reference case, Design Modification 1 and 2.

- Results: Resultant equivalent stress and total deformation were plotted as shown in Figure 9.

In contrast to the reference design, von-mises stress of both modified design 1 and 2 are in allowable range as defined in Equation 1 and computed in Figure 9. Design modification 1 has largest value of maximum stress, 32.91MPa, as a section of metal has been removed from the region underneath plane of guide vane flange bushing. The region of maximum stress is scattered as shown in Figure 9. Design modification 2 has smallest value of maximum stress, 13.06MPa, as they have been externally in forced through flange bolting. In all of the cases maximum stress is around fixed point of head cover bolting to stay ring.

The maximum and minimum observed stress is in design modified 1 and 2 are 32.91MPa and 13.06MPa respectively, whereas reference case has 18.205MPa. Modification 1 and Modification 2 has slightly over scattered maximum stress limit distributed unevenly over the region. Modification 1 has an internal reinforcement at material removed part, which may have caused this distribution but since the range of variation is within the limit and the condition is in stationary component, it will not have significant effect on operation life of head cover. Regarding Modification 2 the variation in distribution pattern is an added effect of split condition, where the stress has been transferred radially and circumferentially.

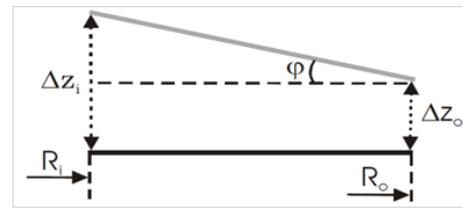
Figure 10 Angle of deflection.

For allowable deformation limit, a terminology; angle of deflection is used as expressed in Figure 10 and defined by equation 2.²² As a rule, value of angle of deflection should be less than 8×10^{-4} ° for low head Francis and 5×10^{-4} ° for high head Francis turbine.²³ The

$$\delta = \left(\frac{\Delta Z_i - \Delta Z_o}{R_o - R_i} \right) \quad (4)$$

It can be observed from Figure 10, the maximum deflection is at the region near cover plate of turbine shaft and it is found to be gradually decreasing with increasing radius of head cover. In contrast to reference and modification 1, modification 2 has a localized region for deformation concentration at the tip of the flange. Localized concentration is generally ignored as the deflection effect is a direct function of area. The tabulated angle of deflection shows that both modification 1 and 2 are within the allowable range. Design optimization of head cover is required to ease of assembly design of vertical Francis turbine during maintenance for sediment laden river projects.²⁴
