The first filling of the Laúca hydroelectric power plant reservoir

The Laúca hydroelectric power plant (2070MW) has been constructed on the Kwanza river in Angola. The general layout of the power plant comprises a concrete dam on the riverbed, in which are located the bottom outlet, the spillway and the intake structure of the ecological powerhouse. Near the dam, in the same alignment, around the right bank of the river, is located the intake structure of the main powerhouse. The ecological powerhouse, with one Francis turbine, is located immediately downstream of the dam. The project has an underground main powerhouse with six Francis turbines and six underground hydraulic circuits (one for each unit). To allow the construction of the dam, two diversion tunnels were constructed on the right bank and operated during two and a half years, from September 2014 to March 2017 when the process of filling the reservoir started. The reservoir filling occurred from the water level around 730.00m to the normal water level of the reservoir which is 850.00m, lasted about 1 year and 3 months (from March 2017 to June 2018) and was successfully completed. The present paper describes and shows th

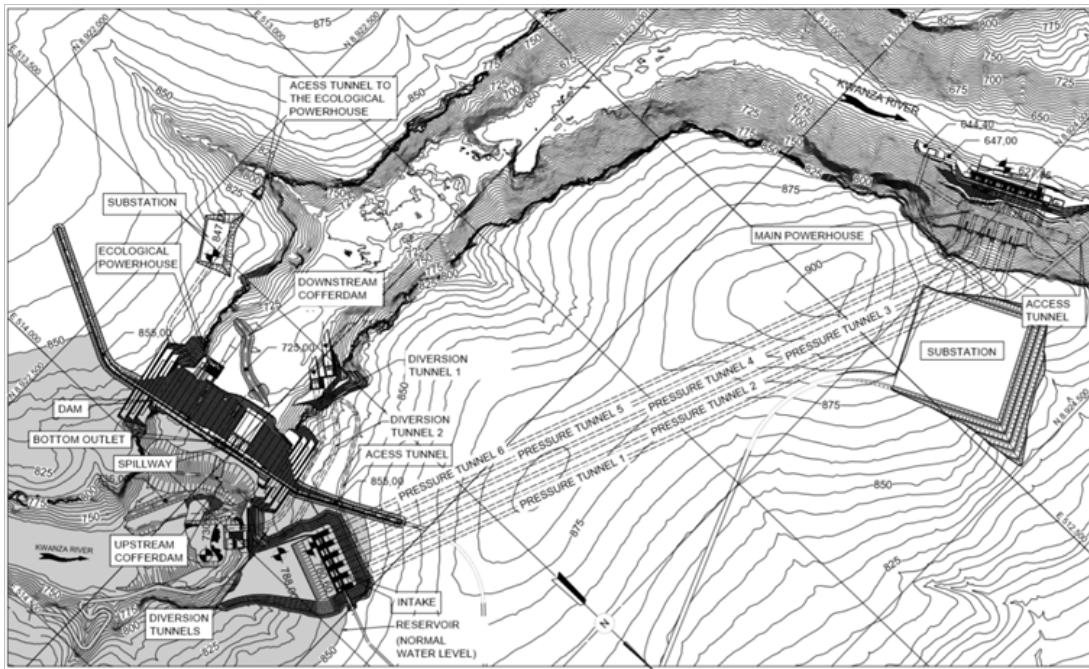
Figure 2 Main structures of Laúca HPP at Angola (Source: Intertechne Consultores Associados S.A., 2017).

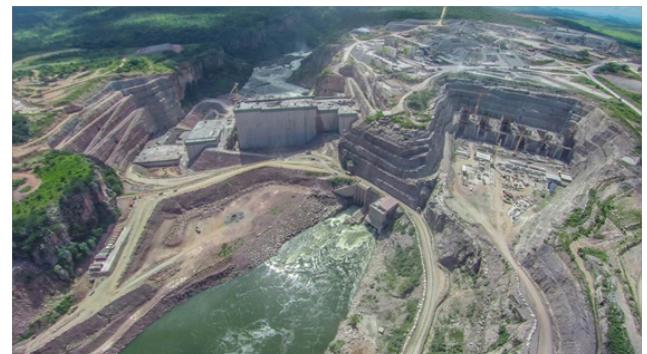
Figure 3 The second stage of the river diversion, January 21th, 2016.

Figure 3 shows both tunnels operating during the dam construction phase.

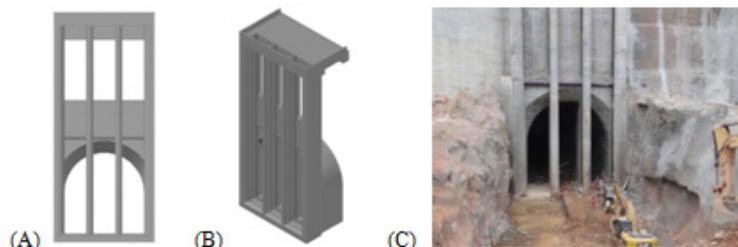
Figure 4 Inlet structure of the diversion tunnel 1. Figures (A) and (B) correspond to the design of the structure and figure (C) shows this structure during its construction phase.

The intake structure of tunnel 1 was provided with three steel gates 3.9m wide and 16.5m high with sill at elevation 723.00m (Figure 4). Tunnel 1 was designed to be plugged prior to reservoir impoundment (while tunnel 2 was still open) so, the structure was designed to support the loads during this diversion phase (water level near elevation 755.00m). The intake structure of tunnel 2 was provided with three steel gates 3.9m wide and 14.0 m high (Figure 5). Since this structure was used to initiate the reservoir impoundment, it was designed to support the load of the full reservoir, leading to a more robust structure when compared to the one designed for tunnel 1. The

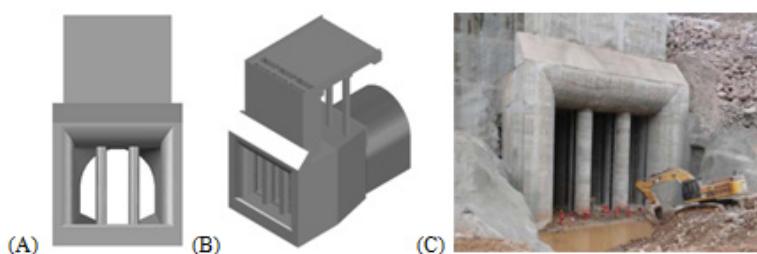
Figure 5 Inlet structure of the diversion tunnel 2. Figures (A) and (B) correspond to the design of the structure and figure (C) shows this structure during its construction phase.

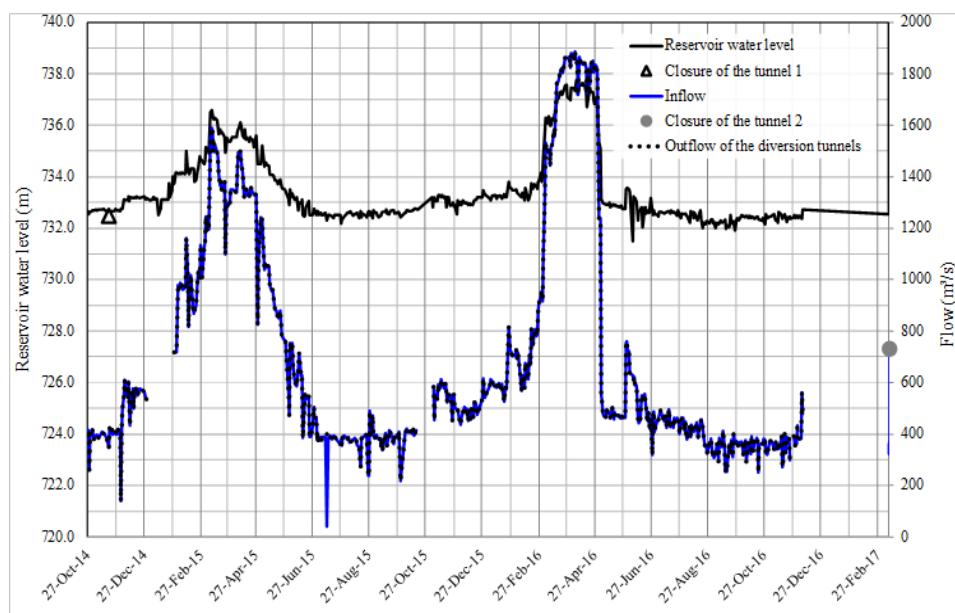
Figure 6 Reservoir level, inflow and outflow during the operation of the diversion tunnels.

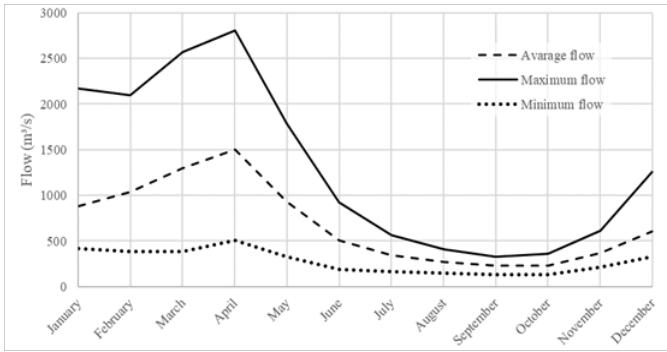
Figure 7 Monthly average flow at the Laúca HPP (Source: Intertechne Consultores Associados S.A., 2012 to 2018).

regime of the river Kwanza occurs in such a way that the driest months are the months of June to November and the wet months are those of December to May. The Figure 7 shows the average, maximum and minimum flows at the Laúca HPP based on the monthly average flow data from 1951 to 1974. Therefore, since the intake structure of the tunnel 1 was not designed to withstand high loads, its closure should occur in the dry period. In general, this means that this tunnel should be

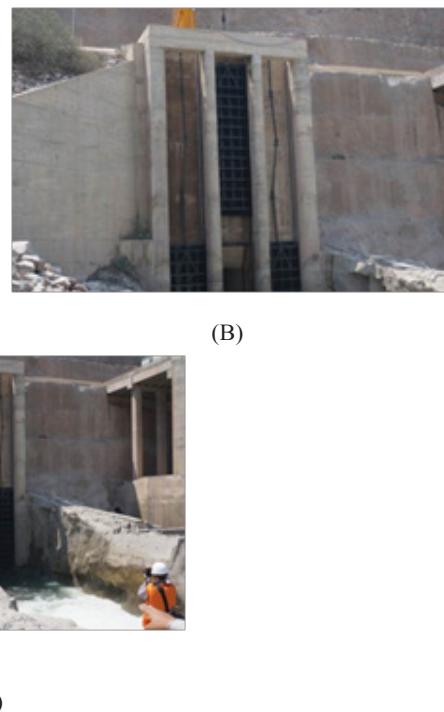
Figure 8 Closure sequence of tunnel diversion 1. (A) The closure of the first gate of the inlet structure; (B) The closure of the last gate of the inlet structure. (C) The conclusion of the closure.

Both diversion tunnels operated simultaneously until October 2016, when the tunnel 1 was closed on October 8th, 2016. The flow through the Kwanza River on that moment was approximately $375\text{m}^3/\text{s}$. In sequence, the plug construction inside of the tunnel 1 was started and concluded successfully. The tunnel 1 closure sequence is shown in the Figure 8. The diversion tunnel 2 was successfully closed on March 11th, 2017, starting the reservoir filling. Figure 9 illustrates an upstream view of the reservoir after the closure of the tunnel 2 (the tunnel 1 was already closed). At that moment, the dam was not completely finished and the spillway's mechanical equipment (gates) were not fully operational yet. The decision to initiate the impoundment, without the completion of these structures, was assisted by hydrological studies based on routing simulations of synthetic series of daily flows data. An unusual wet season could eventually impound the reservoir too fast and could cause the dam overtopping. When the diversion tunnels were closed the dam construction had not been concluded yet and these studies allowed the evaluation of the risk during this phase of the construction.¹

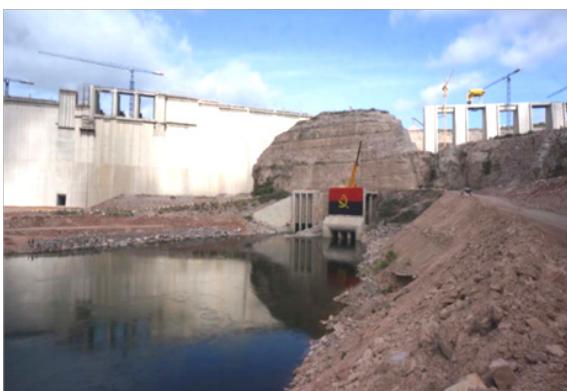
Figure 9 Upstream view of the diversion tunnels 1 and 2 after the closure of the tunnel 2. March 11th, 2017 (Source: Intertechne Consultores Associados S.A., 2017).

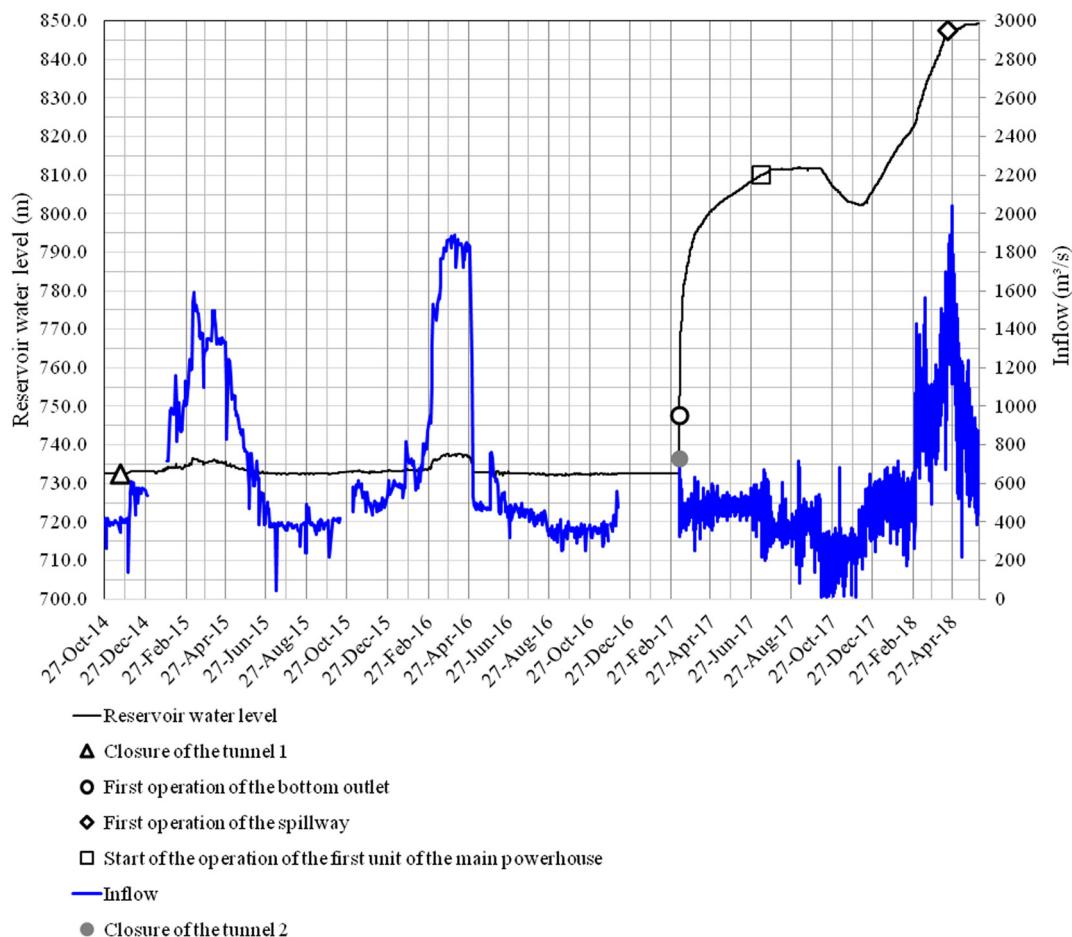
Figure 10 Reservoir level and the inflow during the reservoir filling process.

The Figure 10 shows the reservoir water level during the filling process which had been initiated with the closure of the diversion tunnels. This figure also shows the inflow at the reservoir during the reservoir filling from the water level around 730.00m to the water level 850.00m, which is the normal water level of the Laúca HPP. The same figure presents also important events during the reservoir filling, such as: the closure of both diversion tunnels, the start of the operation of the first unit of the main powerhouse, the first operation of the bottom outlet and the first operation of the spillway. During the initial stages of the impoundment, the ecological flow was released by valves located at the steel gates of the diversion tunnel 2. Then, as soon as the water level in the reservoir reached the bottom outlet, the ecological flow was maintained by this structure. The moment of the first operation of the bottom outlet, on 11th March, 2017, was registered according to the picture shown in the Figure 11. With the rise of the reservoir water level, the flow discharged by the bottom outlet also increased

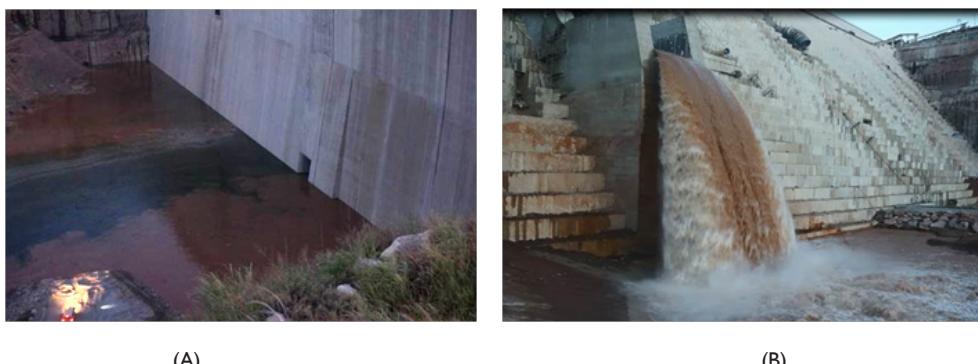
Figure 11 The first operation of the bottom outlet during the reservoir filling. A) Upstream view of the bottom outlet entrance. B) Downstream view of the bottom outlet. March 11th, 2017.

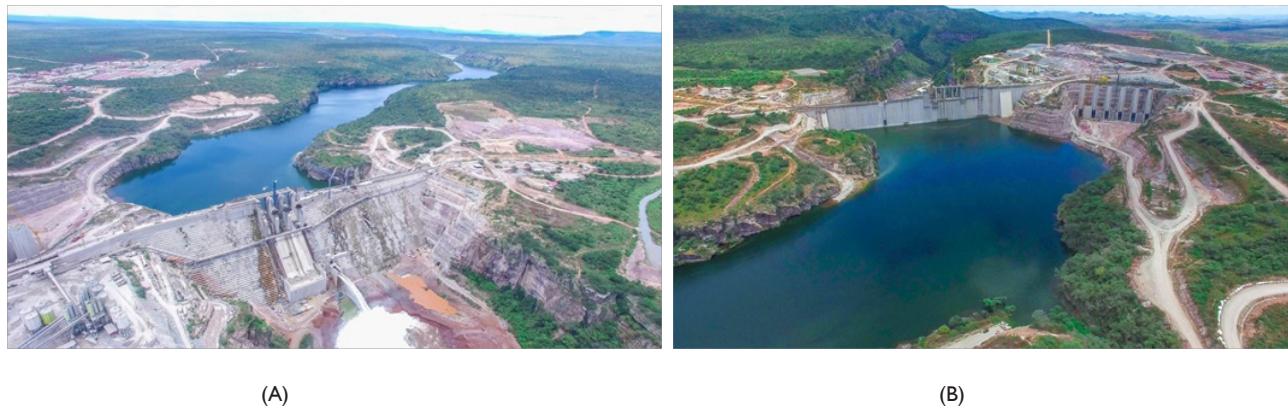
Figure 12 Reservoir filling process. (A) Downstream view of the bottom outlet operation. (B) Upstream view of the reservoir filling process. March 17th, 2018.

as schematically exposed in the Figure 14. The Figure 12 shows an upstream view of the dam on March 17th, 2017 and the bottom outlet discharging around 260m³/s on the same date.

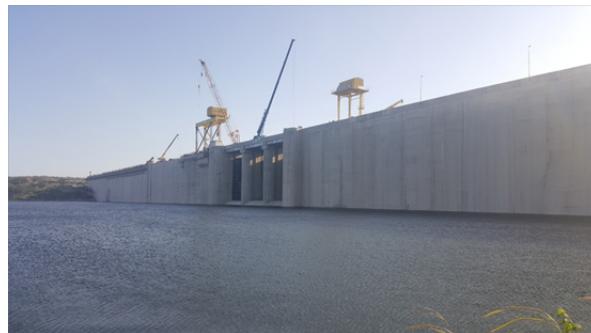
Figure 13 Upstream view of the reservoir filling process. March 8th, 2018.

The graphic of the Figure 14 shows the reservoir water level, the inflow in the reservoir and the outflow through the bottom outlet, the spillway and the main powerhouse of the Laúca HPP. The minimum operational water level of the HPP, elevation 800.00m, was reached on April 25th, 2017. The Figure 13 illustrates the reservoir almost reaching the elevation of the spillway crest

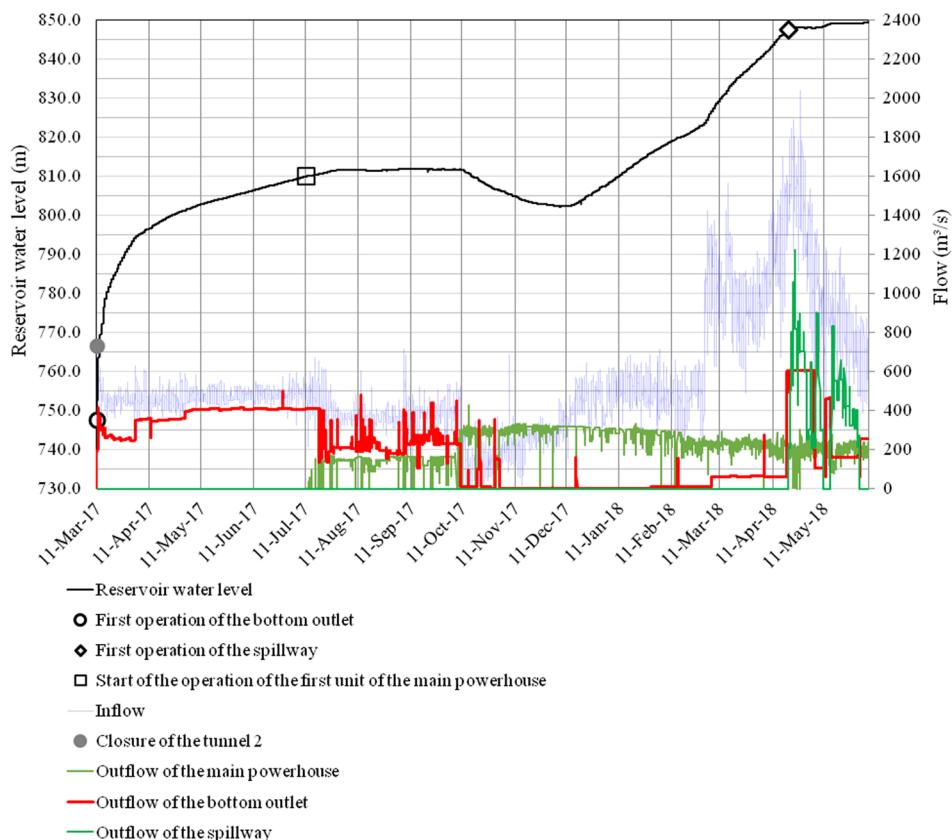
Figure 14 Reservoir level, inflow and the outflow through the bottom outlet, spillway and the main powerhouse.

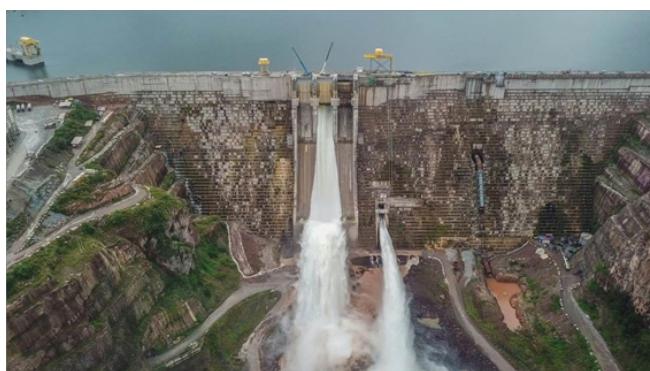
Figure 15 The first operation of the spillway during the reservoir filling. April 20th, 2018.

(830.00m) during the reservoir filling process. On April 20th, 2018 occurred the first operation of the spillway of the Laúca HPP (Figure 15). In the first days of June of the year 2018, the reservoir of the Laúca HPP reached the elevation 850.00m which is the normal water level of the reservoir. This was an important milestone of the project and it is possible to say, at the end of this important stage, that is the reservoir filling, that the whole process occurred well, without major intercurrences. The picture of the Figure 16 shows an upstream view of the reservoir after the conclusion of the reservoir filling process.²⁻⁵

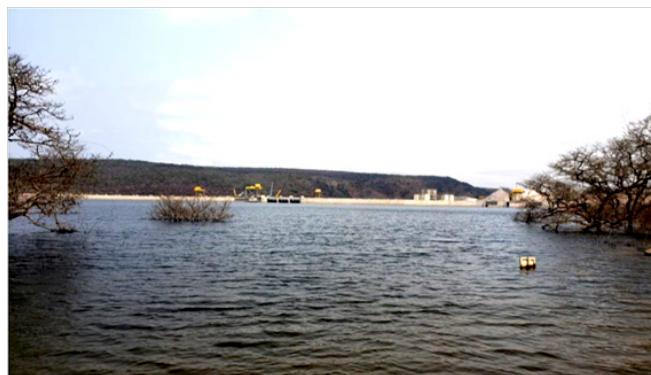
Figure 16 Upstream view of the reservoir of the Laúca HPP. September 2th, 2018. (Source : Intertechne Consultores Associados
