Stability of slopes at the agua Dulce tailings dam in Potosí, Bolivia

The Agua Dulce tail dam located in Potosí, Bolivia, belonging to the Santa Lucia Mining Company Ltda., it stores conventional tailings and has been constructed by the Aguas Arriba method. During its operation stage, the geometrical characteristics proposed in its original project were not met; Therefore, for the stability analysis of slopes, different models are proposed according to four parameters: section geometry, drainage condition, load condition and analysis method, through the GeoStudio 2012 program. The obtained results allow to define relations and influence between the variations of the parameters analyzed; agreeing that the closure of the tail dam is feasible under a ratio of the last slope of 1:2.34 to the closing level, guaranteeing the correct functioning of the bottom drains.

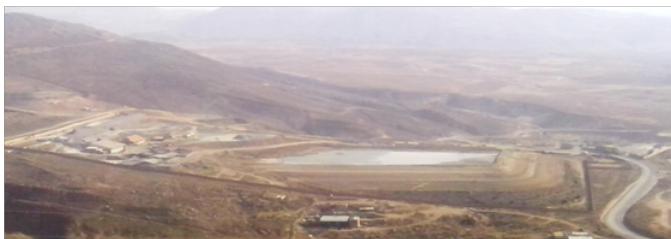
The tailings dam Agua Dulce (Figure 1) is located in the community of Agua Dulce, Tomás Frías Province, Department of Potosí, Bolivia. Tailings stored come from the treatment plant of the same name, which deals minerals zinc (Zn), lead (Pb) and silver (Ag), mainly from the Cerro Rico de Potosí and Melena Mina.

The dam is located at a site 60,000m², which stores 5000000m³ of conventional tailings built by Upstream method; reaching 15meters high from the crown of the dam to a height boot closing. According to Law No. 1777,⁵ of the Mining Code of Bolivia, this dam is classified as a dam high volume because accumulations of waste exceed 50,000m³.

Figure 1 Tailings freshwater.
