# Corrosion and biocorrosion in carbon steel

The present study had as objective to evaluate the corrosion and biocorrosion in carbon steel ASTM A283 immersed in a biphasic system, containing Diesel S10/ tap water in proportions of 1:1, under static conditions, over 90 days. Scanning electron microscopy (SEM) techniques were used to monitor these processes. The results indicated that there was localized corrosion, especially on surfaces that were immediately below the diesel/water interface, where corrosion products and biofilm adherence were formed. Therefore, the results revealed that the presence of water in the diesel can be an aggravating factor in the processes of corrosion and biocorrosion.

Volume 7 Issue 3 - 2018

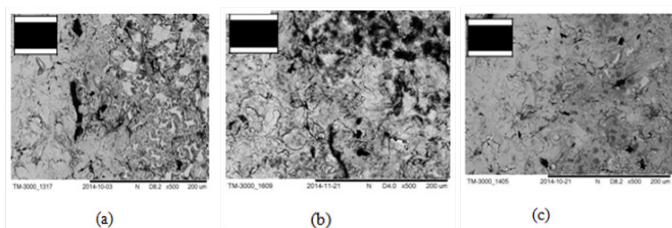
**Figure 1** Micrograph of the interface deteriorated by the corrosion process, after cleaning (without surface products) (a) after 30 days; (b) after 60 days; (c) after 90 days.

Figure 1 shows the surfaces of the specimens that went through the biphasic immersion process for 30, 60 and 90 days, respectively, after the cleaning process. The images correspond to the surfaces that were immersed in the interface between diesel and water, whose deterioration was more intense. The metal surfaces were found to be excavated and furrowed. This behavior suggested the presence of alveolar corrosion mechanisms.<sup>1</sup>

Initially, the metal surface was in direct contact with the electrolyte (water), providing the process of electrochemical corrosion, due to a greater ionic exchange. After 30 days it was possible to observe corrosion and biofilm products adhered to the surface, acting as a protective barrier. In this way, the corrosion was more intense initially, and there was a reduction of the corrosive process over time. Probably, due to the lack of accessibility of the electrolyte to the substrate, due to the deposits of suspended particles, the corrosion products, the microorganisms, which were adhered to the surface, leading to the formation of the biofilm, and consequently, reducing the corrosion

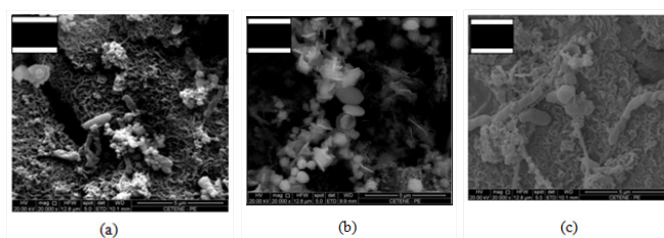
**Figure 2** Micrographies of the surfaces of the test specimens - (a) after 30 days with adherence of MPE, corrosion products and bacterial cells; (b) after 60 days with higher incidence of corrosion products; (c) after 90 days with isolated bacterial cells and MPE.

Figure 2 presents images corresponding to the biofilms deposited on the specimens exposed to the water/oil immersion system, at times 30, 60 and 90 days, respectively. Stretches of the surface of the specimens, which suggest to be corrosion products, extracellular polymeric material (MPE) involving some cells, and the presence of microbial forms, which suggest to be isolated bacterial cells, were observed.

Similar results were found by Vieira<sup>10</sup> in his study on corrosion and biocorrosion in API 5LX60 steel exposed to crude oil and produced water, whose immersion time was 15 and 90 days, resulting in the same detachment and adhesion behavior of new cells, due to the biofilm formation process being dynamic. Their MEV images showed surfaces also worn and with the presence of excavations and furrows. In addition to corrosion products, extracellular polymer material and isolated bacterial cells were observed.
