Paradoxical right bundle branch block morphology in right ventricular apical pacing- is it really concerning?

RBBB pattern on surface electrocardiogram after right ventricular pacing is always concerning for lead malposition in left ventricle. However it can be a variant of normal pacing and careful assessment with chest X-ray, 2 D ECHO and ECG reassures normal pacing and can prevent unnecessary interventions.

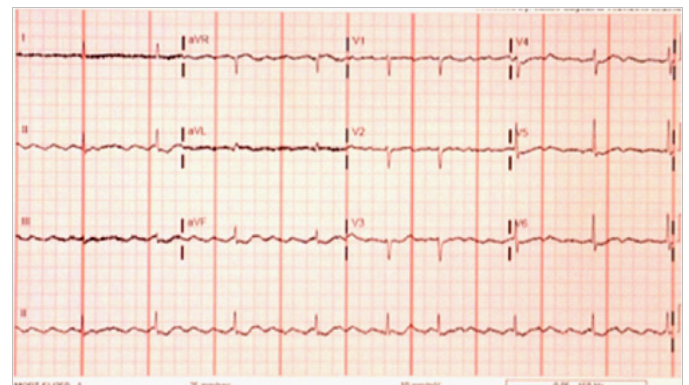
Figure 1 Atrial flutter with slow ventricular rate

75year old man presented with gradually worsening exertional shortness of breath and easy fatigability. Nuclear stress test was abnormal for reversible ischemia and a cardiac catheterization was performed which showed a proximal Left anterior descending artery stenosis which was stented. He also had an atrial Flutter with slow ventricular rate of 50-60bpm which occasionally dropped to 30bpm (Figure 1). This was suggestive of significant Atrio-ventricular conduction abnormality. He underwent Flutter ablation after a Trans esophageal echo ruled out any intracardiac thrombus. Post successful ablation he had a HR of 40-50bpm with complete AV dissociation hence a dual chamber pacemaker was implanted. St. Jude's pacemaker was used with RV lead fixed to RV apex and Right atrial (RA) lead fixed to RA appendage and mode set at DDDR at lower pacing rate of 70/min. Measurements obtained were RA p-wave 2.7mv, RA pacing atrial threshold 1mv at 4m. RV lead impedance was 980ohm.

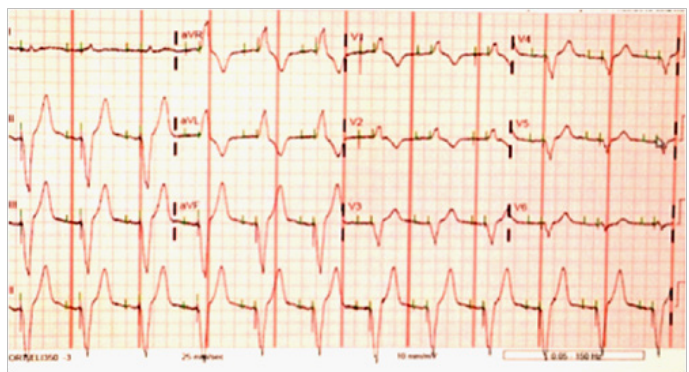
Figure 2 Post-operative ECG showing RBBB pattern.

Post-operative chest X-Ray confirmed correct lead placement. However the ECG was done which showed a RBBB morphology with mean QRS of -86degrees (Figure 2). Repeat PA and lateral chest x-ray next day (Figure 3) and a 2D echocardiogram (2D ECHO) (Figure 4) were done to confirm the lead placement as well to r/o any inadvertent position of the lead. All modalities confirmed RV apical lead placement and uncomplicated RV pacing. Following Pacemaker

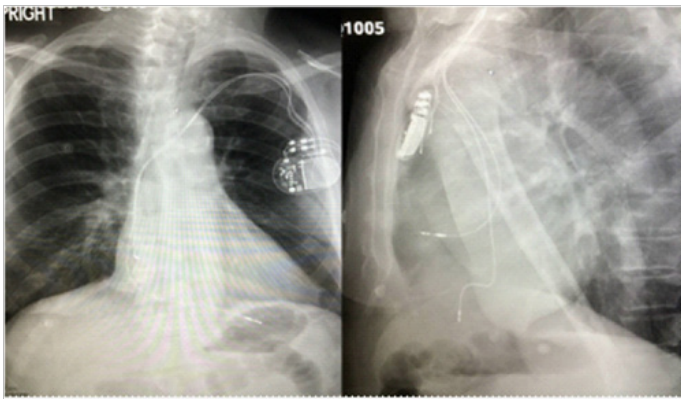
Figure 3 PA and lateral Chest X ray showing normal position of lead.

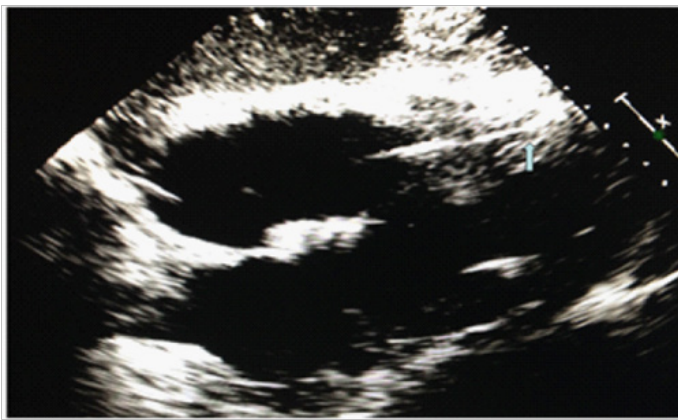
Figure 4 2D ECHO-sub costal view showing insertion of RV lead.
