Review Article

Neiwan hydro powerhouse (A conceptual reconstruction study)

Volume 5 Issue 1 - 2019

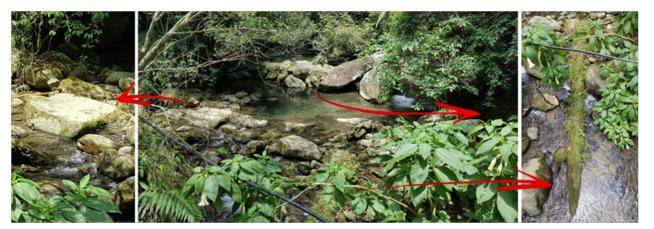
Figure 4 Former diversion weirs. Elements of spillway could be found on left and right. Diversion canal is also clearly traceable however the entire riverbed use to be much higher judging from the current level of diversion canal and inflow opening (Source Author).

The entire Neiwan powerhouse water structures started by naturally formed pond (Figure 4). Where a concrete spillway (Figure 4). Was constructed to divert water to the less steep bank on the right

side of the valley. The diversion canal is still traceable (Figures 4 & 5). Based on the on–site mapping results, there was and still is an inflow opening (Figure 5). Made of purposely scrapped 120x40x40cm rocks that further led water into the headrace canal which was built along the old Matai road. Here is where theory splits. After the intake opening the clear traces disappears thus there was either a supply canal which led the water down to the forebay and then to the penstock connecting the powerhouse but using up only about 20m head between the forebay and the powerhouse or there was a second configuration. In this second option the Neiwan powerhouse was responsible for supplying the entire Hsinchu Ài yŏng line thus a strategic military element hence the theory that the power output had to be higher and the only way how to attain it was to use the entire head available. Thus in the second assumed configuration, there was a forebay after the intake that led water to the penstock right away

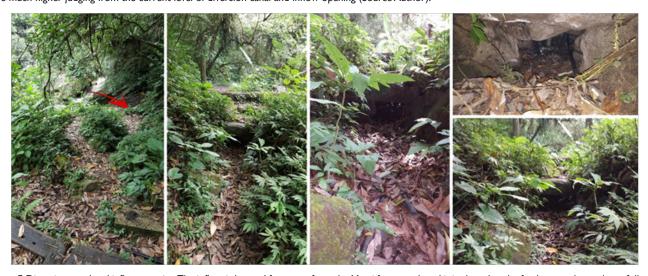
Figure 5 Diversion canal and inflow opening. The inflow is located few steps from the Matai forest path and it is clear that the further supply canal was following the path underneath the current pavement.

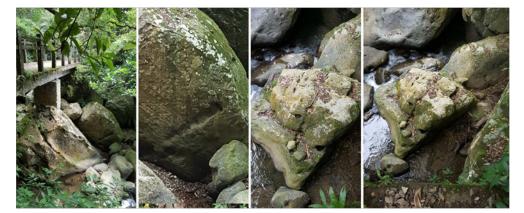
Figure 6 A series of stone marks around the current 2nd bridge on Matai forest path showing traces of bamboo supports. During Japanese occupation period, due to lack of steel a bamboo reinforced concrete was quite common. Bridge no. 2 was also the place where supply canal crossed the valley most likely via aqueduct possibly supported by exactly bamboo reinforced concrete.

An on–site survey was carried away in three separate sessions, on August 25th, 2017, May 18th and 30th, 2018. As a result several remains of the water structures were found including the old stones with bamboo holes, intake opening, inflow canal and spillway (Figures 4–6). All the elements were measured and documented. Pictures were taken during the all three mapping events. Gathered information was matched with available documents, historical maps and photograps to create a presumption about the water strucutres.
