Indirect posterior adhesive restoration: criteria to success

Case Presentation: A patient presented with esthetic and functional demand. His chief complaint was to replace the overflowing amalgam restoration on the first right mandibular molar. A ceramic onlay was performed using the IPS e.max CAD system and bonded with a resin bonding agent.

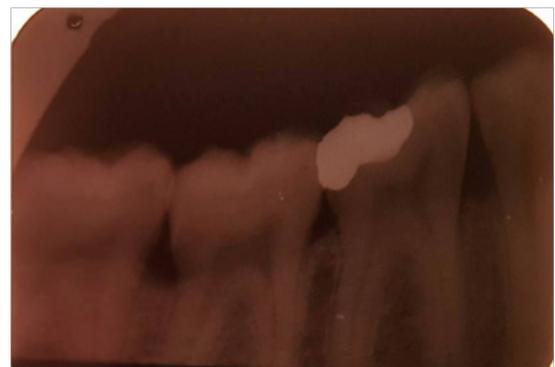
A 25years old male patient with unremarkable medical history, presented to the department of fixed prosthodontics with esthetic and functional demand. His chief complaint was to replace the defective amalgam restoration on the first right mandibular molar (Figure 1). A comprehensive clinical examination revealed good hygiene, a defective amalgam restoration on the first right mandibular molar, which caused a papilla inflammation between the 46 and the 47.

Figure 1 Defective amalgam restoration on the first right.

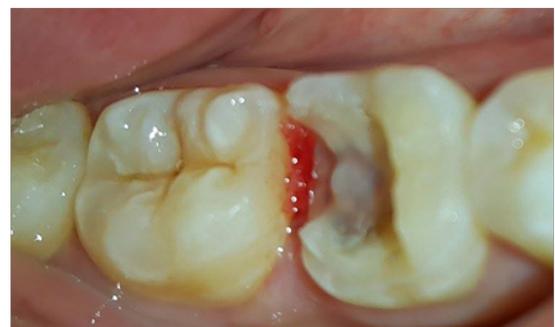
The vitality test revealed a positive response of the 46. The radiological examination showed a large-scale amalgam restoration at a distance from the pulp (Figure 2). After clinical examination, the appropriate treatment option was a ceramic onlay restoring the 46 using the IPS e.max CAD system.

Figure 2 Periapical radio on the 46: a large-scale amalgam.

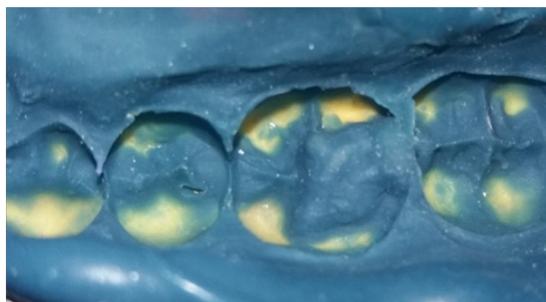
On the buccal surface of the restoration, the margins were located 0.5mm sub-gingivally for esthetic reasons and supra-gingivally on the lingual side. All sharp edges were rounded and smoothed (Figure 3). After a double gingival cord retraction, a simultaneous double mixed impression was made using light and heavy silicon A (Figure 4).

Figure 3 Tooth preparation.

After elimination of the amalgam the molar was prepared respecting the preparation guidelines for ceramic inlays/onlays.⁴

- a. The angles between the floor and the axial walls had to be rounded.
- b. The divergence of the internal walls should not be too limited ($\geq 10^\circ$).
- c. The cavo-superficial boundaries shall be sharp, without bevel.
- d. Occlusal areas should not be located at the tooth restoration interface.
- e. The width of the main isthmus should be ≥ 2 mm.
- f. The proximal box had to have a mesio-distal width of at least 1mm.
- g. The thickness of the restoration had to be of the order of 2mm at the level of the occlusal groove.
- h. The width of the residual walls had to be at least 2mm at the cervical level and 1 mm at the occlusal level.
- i. The thickness of the restorative materials (composite or ceramic) should be at least 1.5 to 2mm at the level of the covered cusps.
- j. A rounded shoulder is recommended at the level of the covered cusps.

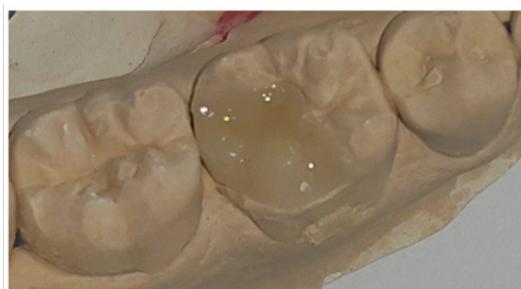
Figure 4 A simultaneous double mixed master impression.

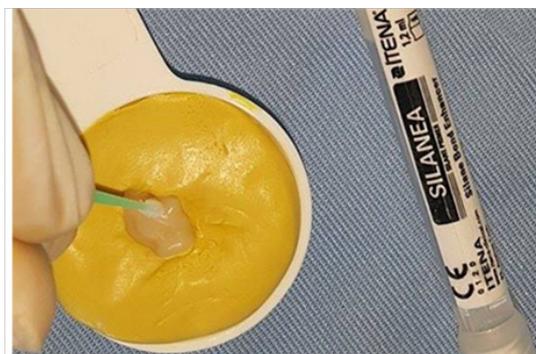
Figure 5 ceramic inlay/onlay by the system E max CAD.

Then working cast was performed, and scanned, the onlay was designed referring to the corresponding shade matching, milled by CAD/CAM (Figure 5), and checked Intraorally.⁵

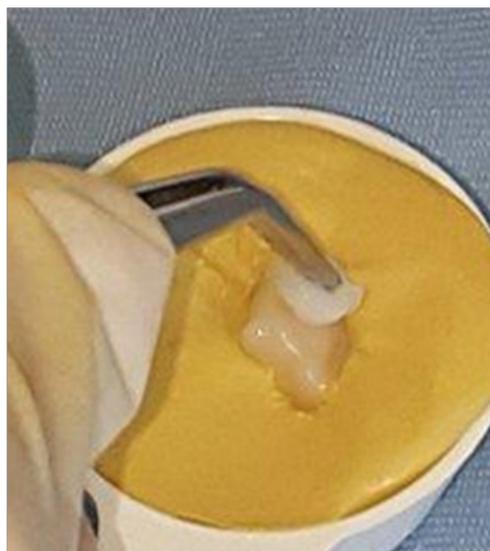
Figure 6 The internal surface of the restoration.

The preparation is cleaned, rinsed, and dried. The internal surface of the restoration is then etched with hydrofluoric acid during 20seconds, after which it is again rinsed and dried (Figure 6). A silane coupling agent is applied and allowed to air dry (Figures 7-9). Recommendations for the time of silane application vary from 30seconds to 2minutes. The chemistry of each system is variable; therefore, following the manufacturer's directions and not mixing products is advisable⁶

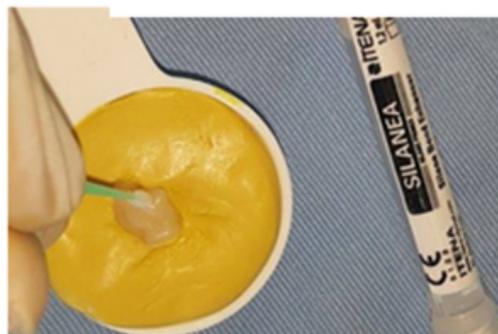
Figure 7 A silane coupling agent is applied and allowed to air dry.

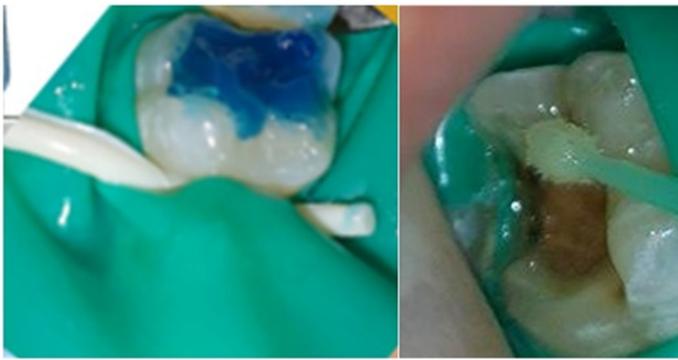
Figures 8,9 Resin bonding agent is then applied to the inlay or the preparation.

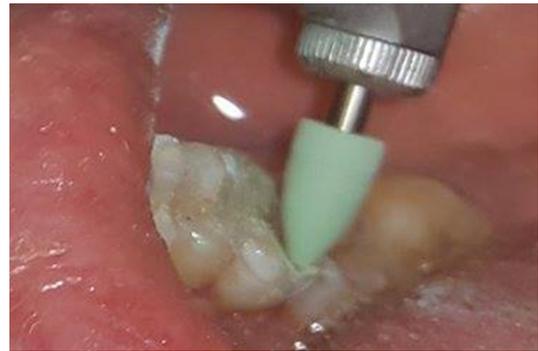
Figure 13 Intraoral checking of occlusion.

The use of Teflon tape inter proximally is a convenient way to protect adjacent teeth. Alternatively, a soft-metal matrix can be used. The tooth surface is prepared as recommended by the manufacturer, with the proper etch, prime, and bond (Figure 10 & Figure 11). Resin bonding agent is then applied to the inlay or the preparation. The inlay is seated and excess bonding material is removed. The restoration should be supported while the resin is cured (Figure 12 & Figure 13).

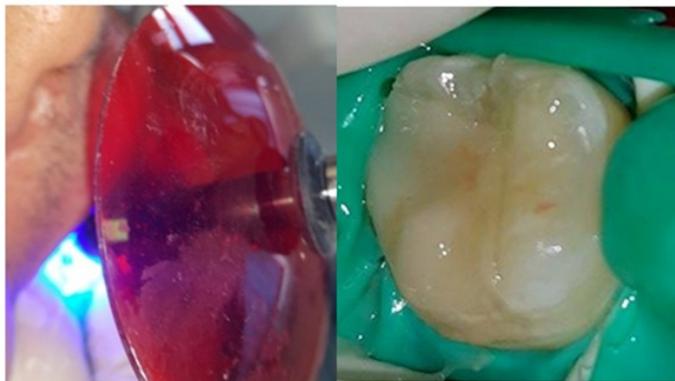
Figures 10,11 Bonding of ceramic only.

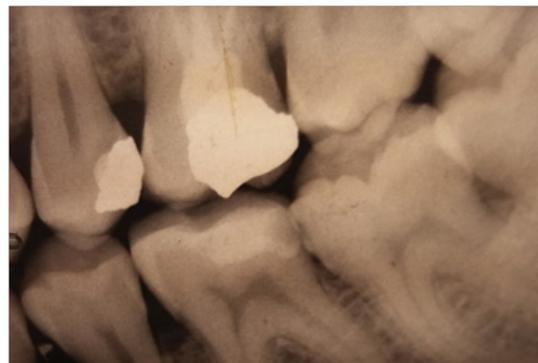
Figure 14 Periapical view after bonding.

Gross excess resin can be removed after a spot cure, prior to completely curing the resin. Light curing is then done in accordance with the resin manufacturer’s recommendations. Any residual flash can be removed with a scalpel or suitable curette, but care must be taken not to cause inadvertent deficiencies at the tooth restoration interface.^{2,7} after which the occlusion is evaluated and adjusted as necessary. Any adjusted surfaces can be polished with a suitable polishing system, such as diamond polishing paste or rubber points (Figure 14 & Figure 15).⁷

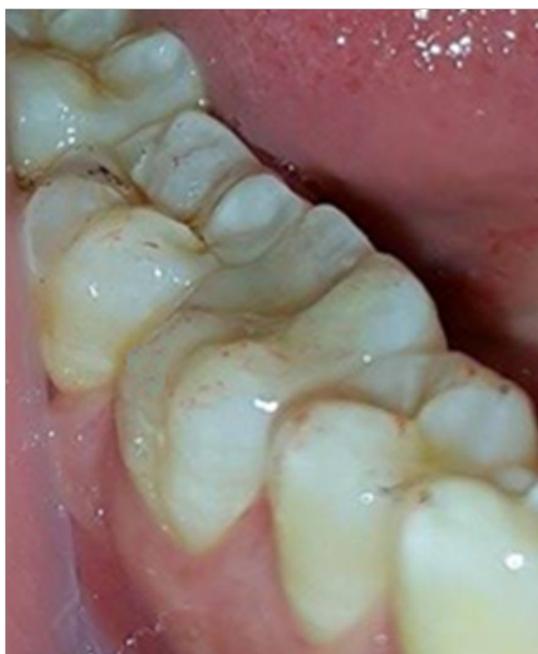
Figures 12 Intraoral checking of occlusion.

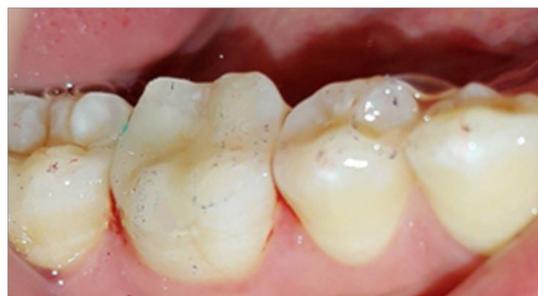
Figure 15 Aesthetic and biological integration of the final restoration.
